# UNITED STATES COAST GUARD

## REPORT OF INVESTIGATION INTO THE CIRCUMSTANCES SURROUNDING THE INCIDENT INVOLVING

### THE COLLISION BETWEEN THE M/V SUMMER WIND AND THE T/B KIRBY 27706 PUSHED BY THE UTV MISS SUSAN ON MARCH 22, 2014

**THE COLLISION AND RESULTING MARINE FUEL OIL SPILL BETWEEN THE  
MOTOR VESSEL SUMMER WIND (O.N. 9114139) AND THE TANK BARGE KIRBY  
27706 (O.N. 1116758) BEING PUSHED BY THE UNINSPECTED TOWING VESSEL  
MISS SUSAN (O.N. 1026248) IN THE HOUSTON SHIP CHANNEL, TX  
ON AUGUST 13, 2014**

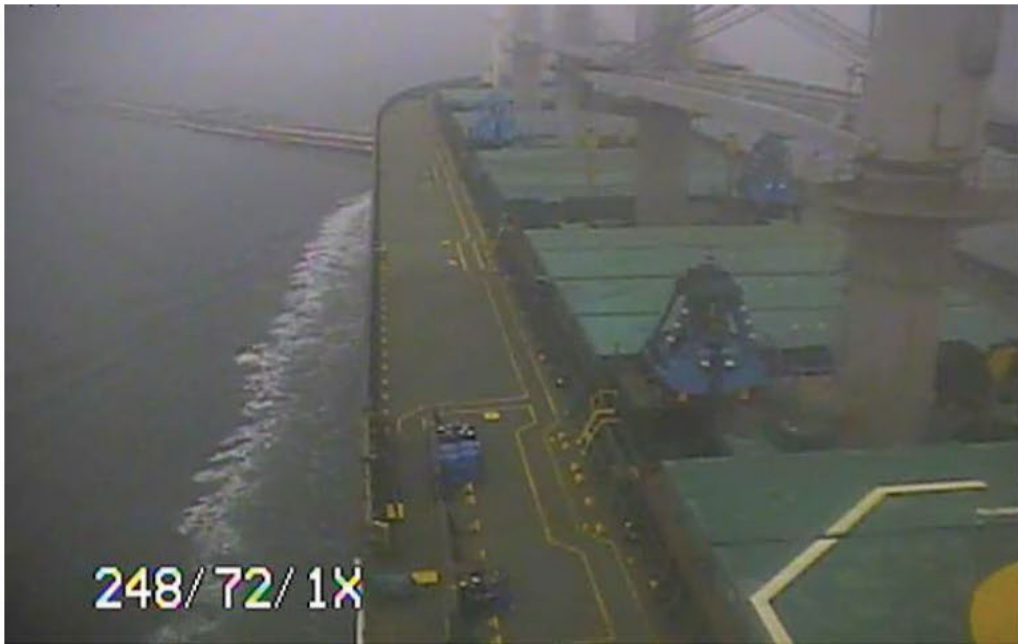
Figure 5: Video Capture from SUMMER WIND bridge camera showing visibility at time of incident

28. The visibility at the time and location of the incident was reported to be approximately 300 meters, or less than one quarter of a mile. See analysis section for further visibility discussion.

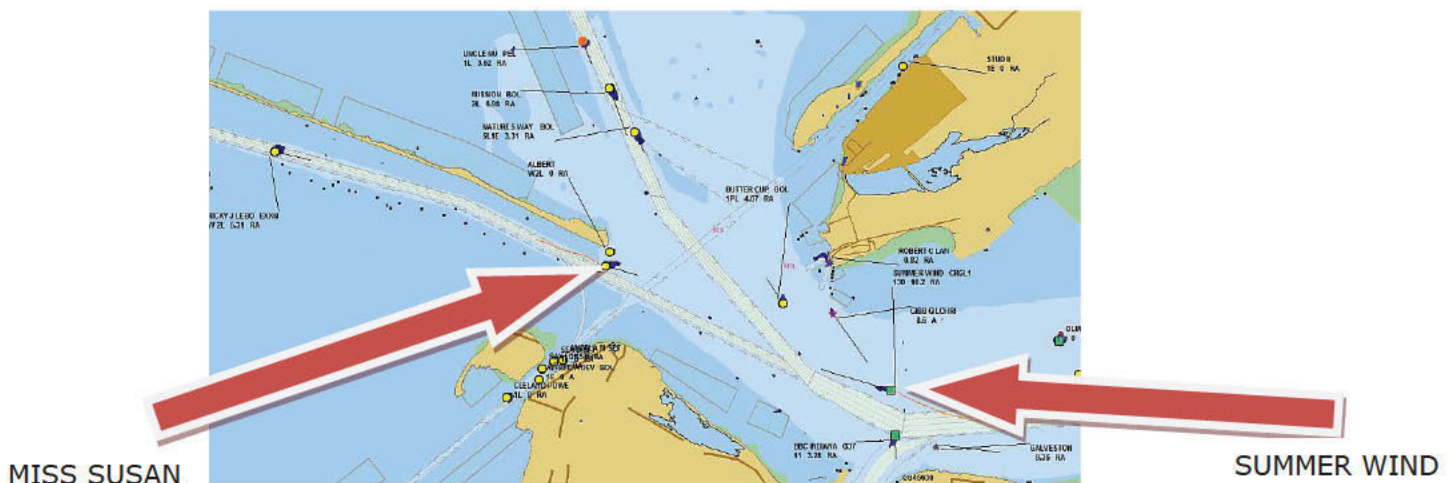
Figure 7: Video Capture showing MISS SUSAN executing turn at 12:25

55. Between 1225 and 1226, the UTV MISS SUSAN changes heading and begins to turn out of the Texas City Channel and into the Houston Ship Channel. When UTV MISS SUSAN and her barges left the Texas City Channel she began to rapidly lose speed, slowing from 6 to 4 knots, and maneuver erratically. When asked about this at the hearing, [REDACTED] stated that she was looking for the "sweet spot", meaning the speed and course that would be most effective in the prevailing conditions.

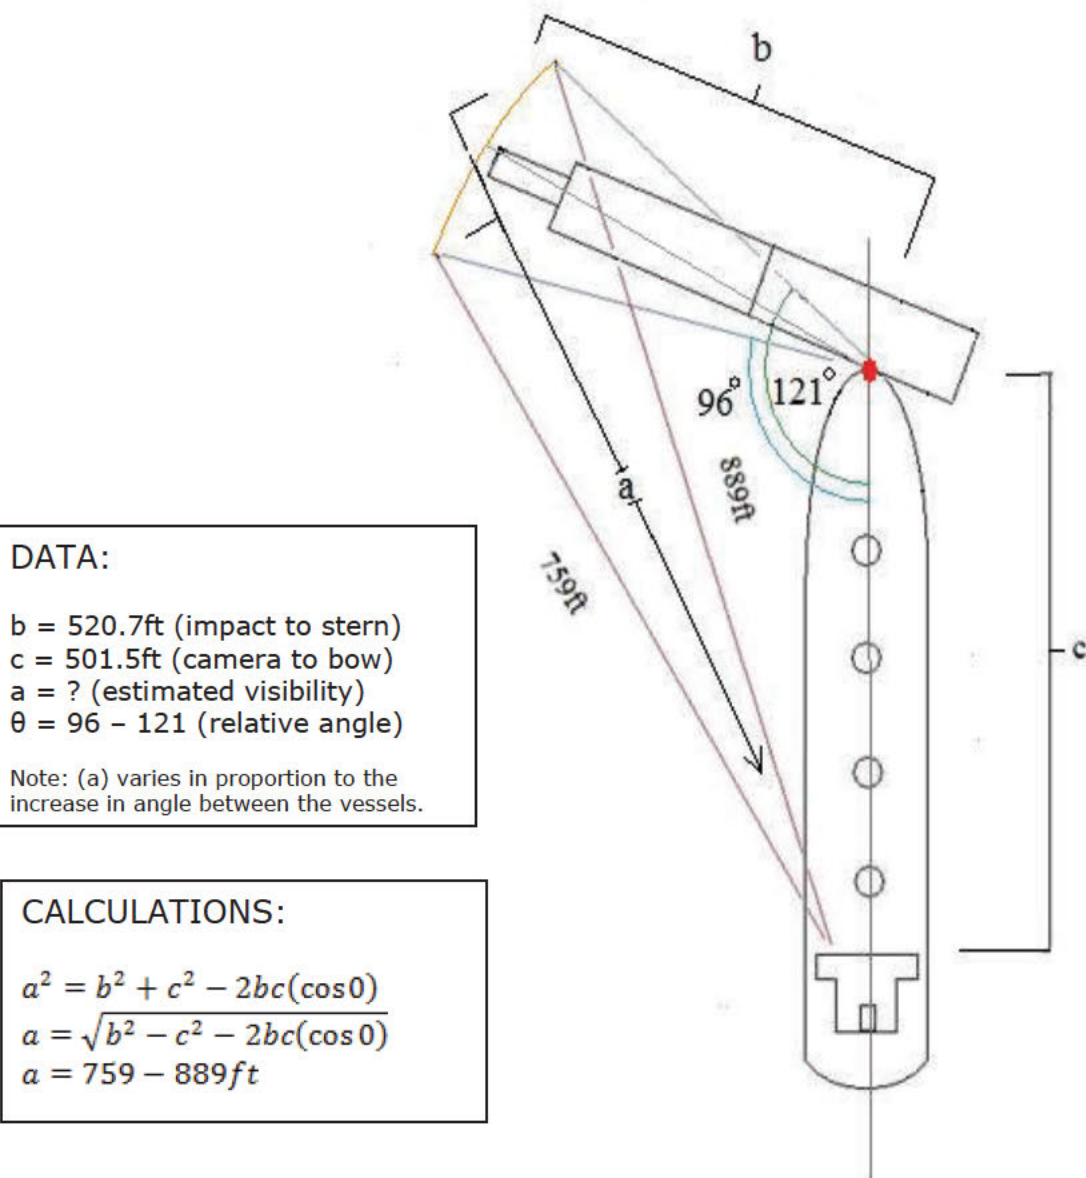
Figure 9: Visibility Calculations and Graphic

This estimate is based on:

- The known lengths of the vessels involved.
- The point of impact on the Barge KIRBY 27706.
- The ability to see the UTV MISS SUSAN (as indicated in the bridge video).
- The known location of the video camera aboard the M/V SUMMER WIND.
- Due to the camera only providing a single reference point of the collision angle between the vessels. The angle was estimated to be within a range of 96 to 121 degrees.

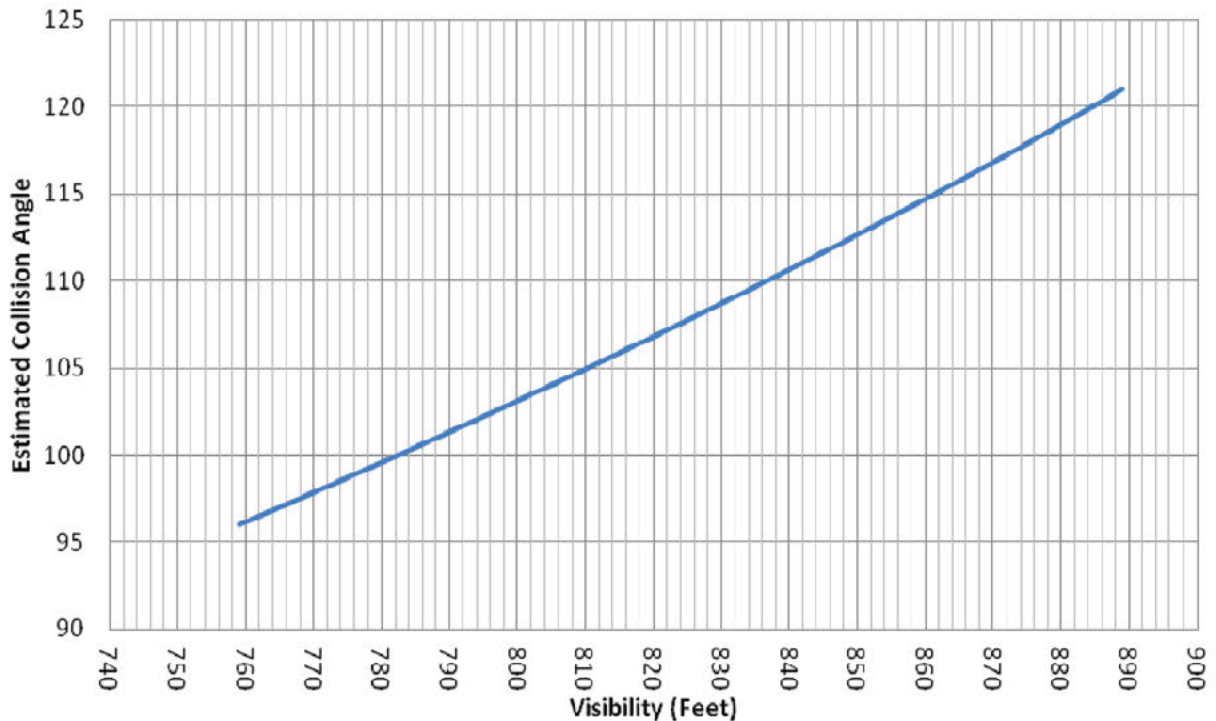
Figure 10: Visibility Graph and Results

Based on the available data the stern of the UTV MISS SUSAN can be seen at an estimated range of 824 ft. However the video shows the UTV MISS SUSAN only partially visible at that point. This is a result of the fog reducing the range of visibility from the bridge of the M/V SUMMER WIND.

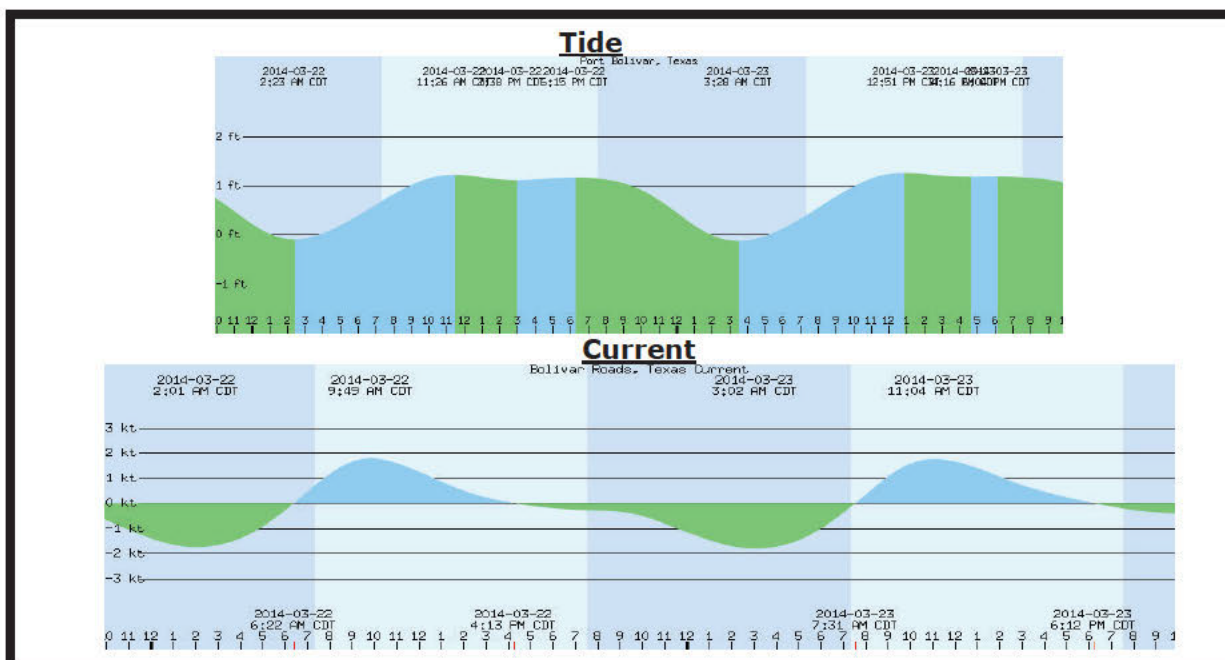
Figure 11: Tide and Current tables for the date of the incident (Source: GeoGraphics.com)

- f. ██████████ stated that based on his estimation of the conditions, the M/V SUMMER WIND was experiencing a 2 knot flood current, and because of that he needed to keep the M/V SUMMER WIND at Full Maneuvering speed in order to maintain steerage.

- g. Analysis of the PAWSS playback shows the M/V SUMMER WIND effectively maneuvering at speeds of 8.3 kts as she came around the wrong side of Buoy 16 to give another deep draft vessel room to make a turn.
