Report of Investigation into the  
circumstances surrounding the fire  
onboard the ROGER BLOUGH on  
February 1st, 2021

MISLE Activity Number: 7139261  
MISLE Case Number: 1249272

**THE FIRE ON THE U. S. CARGO VESSEL ROGER BLOUGH (O.N. 533062) WHILE  
MOORED AT THE FINCANTIERI BAY SHIPYARD IN STURGEON BAY, WI  
ON FEBRUARY 1, 2021**

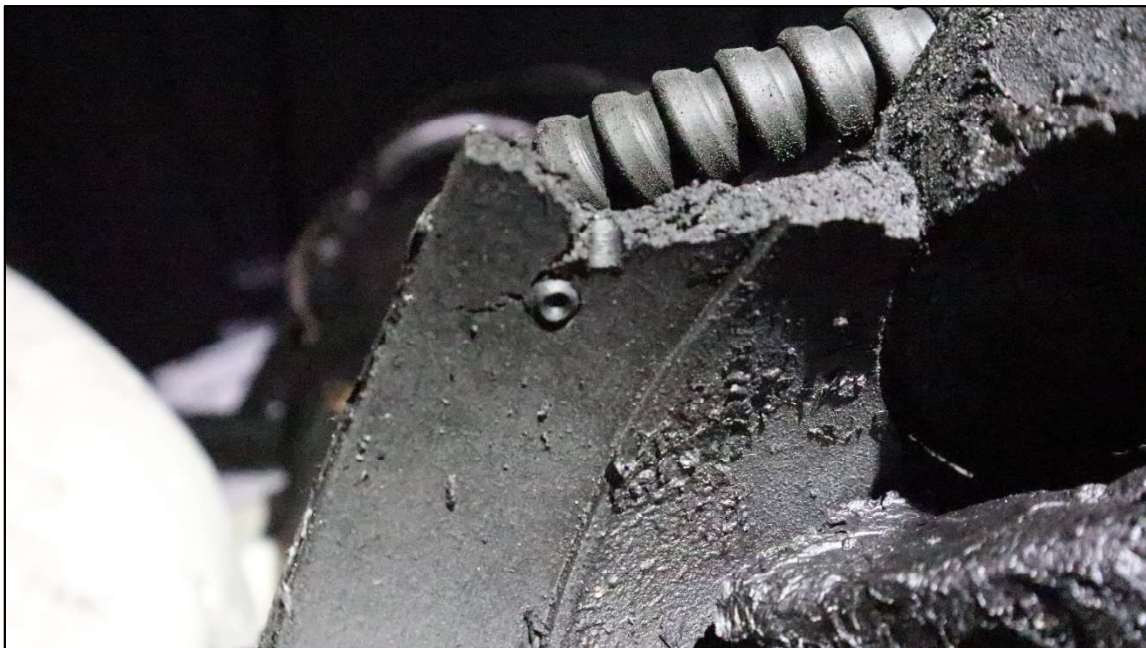
Figure 3, below, shows a post fire photo of the fractures.

4.5.5. Prior to around 0131 on February 1, 2021, the furnace burner assembly's cast retention ring, where the burner mates up with the flame tube, had a deficiency in the casting where the mounting set screws penetrated the retention ring to allow for tightening of the assembly to the flame tube. Fractures were present at both screw hole locations.

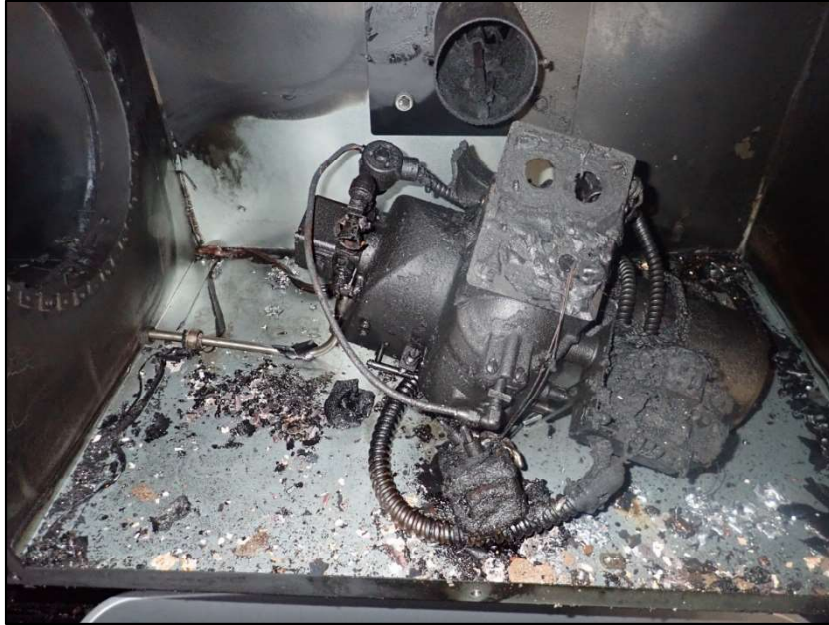
4.5.6. Prior to or around approximately 0131 on February 1, 2021 the burner assembly's mounting fractured at the retention screw holes on the retention ring. The burner fell to the bottom of the burner's enclosure box as shown in Figure 4

Figure 4: Burner Assembly in its Enclosure Box, Broken Free of the Flame Tube.

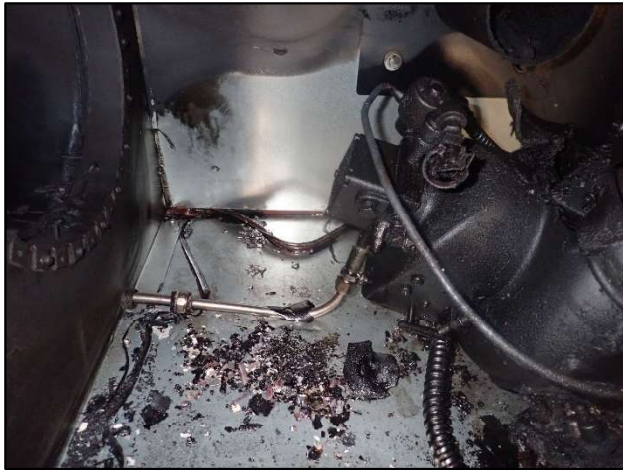
4.5.7. When the burner assembly fell, the rigid fuel piping connection to the burner assembly fractured, allowing #2 fuel to spray into the burner's enclosure box, shown in Figures 5 and 6. The broken fuel line allowed fuel to flow unrestricted through the broken connection into the burner's enclosure.

Figure 5: Fuel Supply to the Fuel Pump

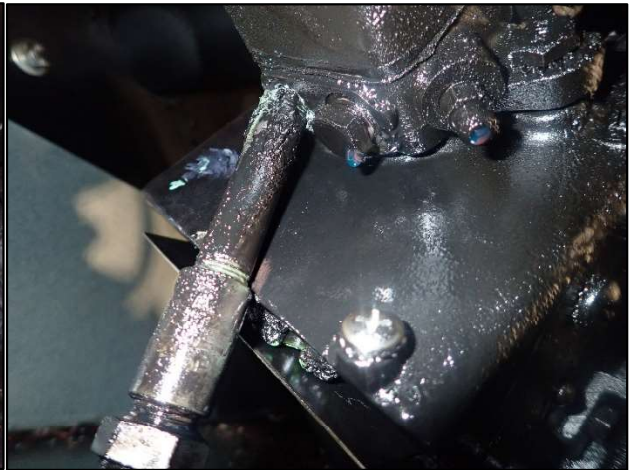
Figure 6: Broken Fuel line at the Fuel Pump

6.1.10. Causal Factor 1 – The fuel supply connection to the burner's fuel pump was rigid and provided no flexibility. The lack of flexibility resulted in the fuel connection breaking and allowed fuel to discharge into the burner's enclosure box.

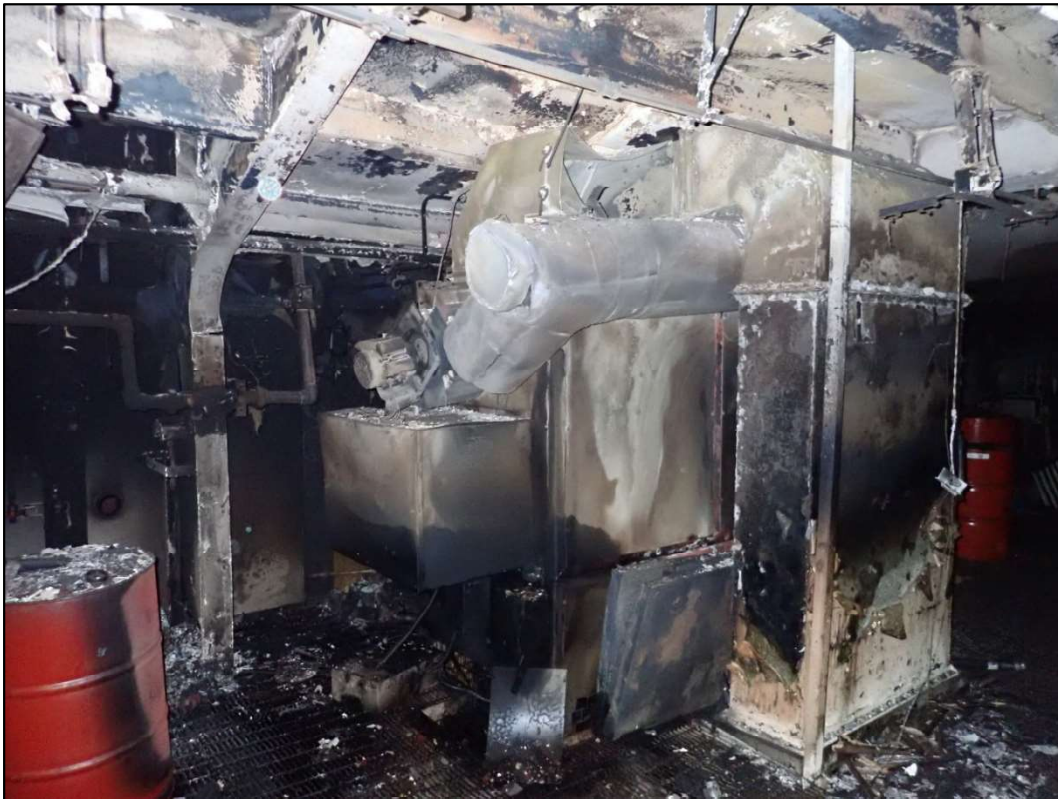
4.5.10. The fire within the burner's enclosure continued burning. Directly above the furnace, as shown in Figure 7, the steel overhead increased in temperature. The overhead formed the bottom boundary of the port side unloading conveyor trunk. The temperature reached a point at which the port side rubber cargo unloading belt laying upon the steel ignited. The fire migrated aft, up the port unloading belt, transferred to the vessel's unloading shuttle boom belt, and then transferred from the shuttle boom belt to the starboard side unloading belt where it progressed towards the unloading tunnel. The path of fire spread is shown in Figure 8. Areas damaged by the fire are indicated in Figure 9.

Figure 7: Winter Lay-up Furnace in the Lower Engine Room of the ROGER BLOUGH, Post Fire

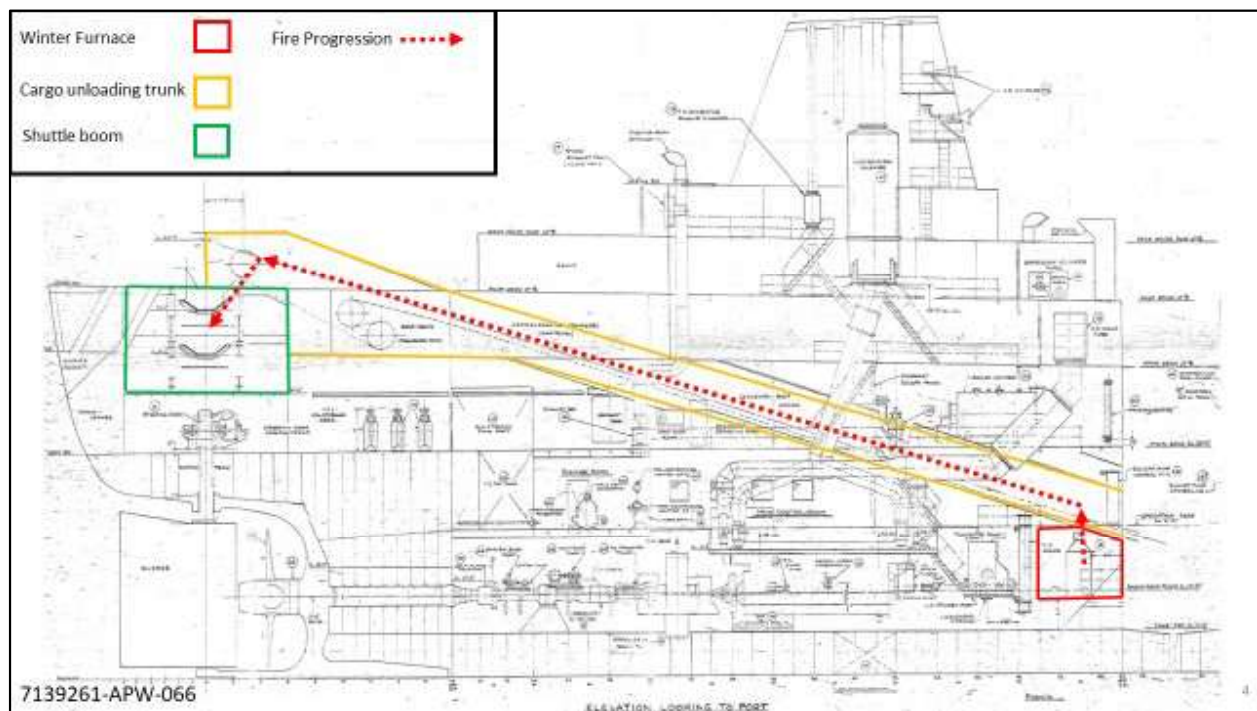
Figure 8: Arrangement Drawing Indicating Path of Fire Spread on the ROGER BLOUGH.

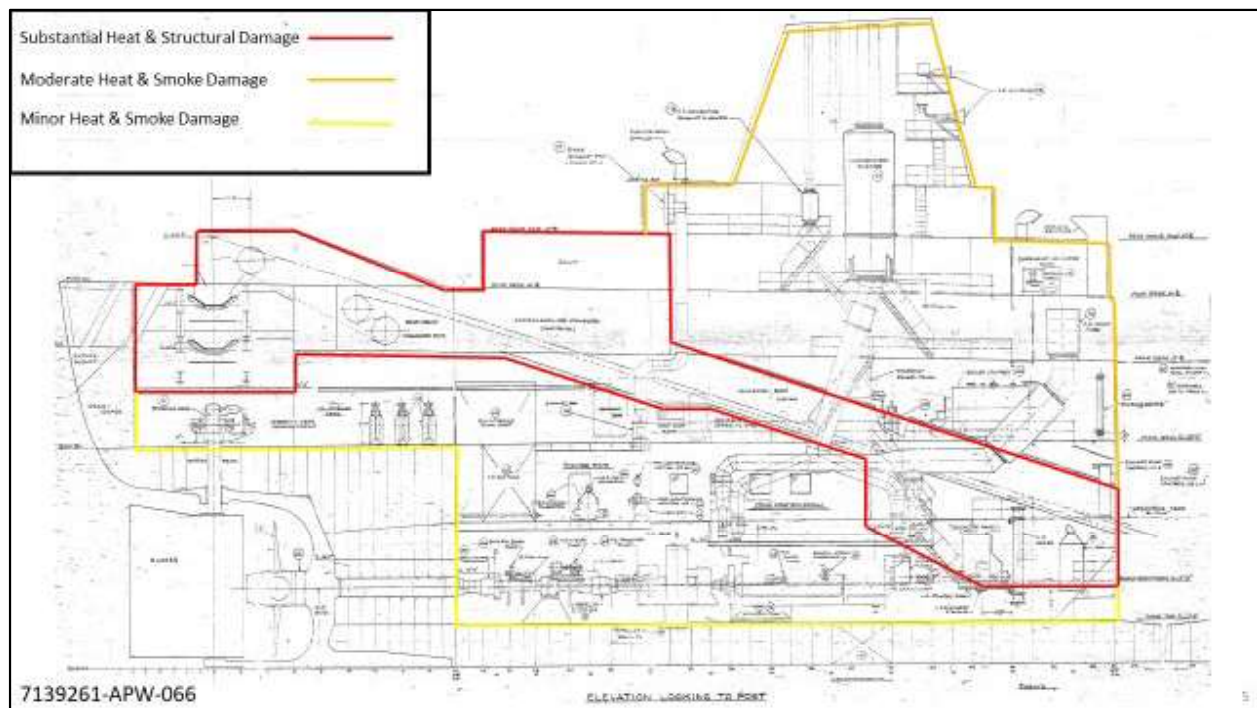
Figure 9: Arrangement Drawing Indicating the Fire Affected Areas on the ROGER BLOUGH.

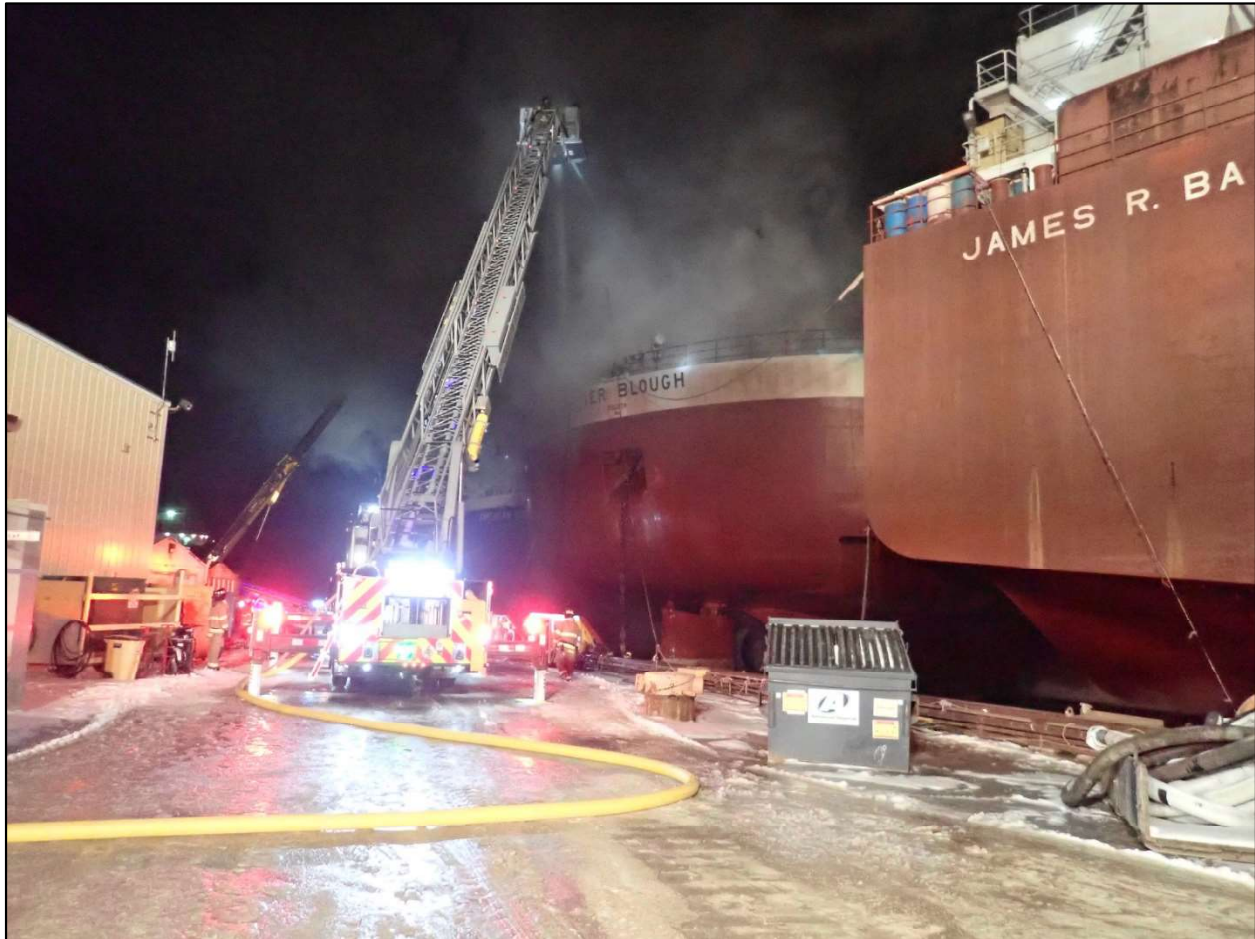
Figure 10: ROGER BLOUGH on Fire at Fincantieri Bay Ship Building in Sturgeon Bay, WI.

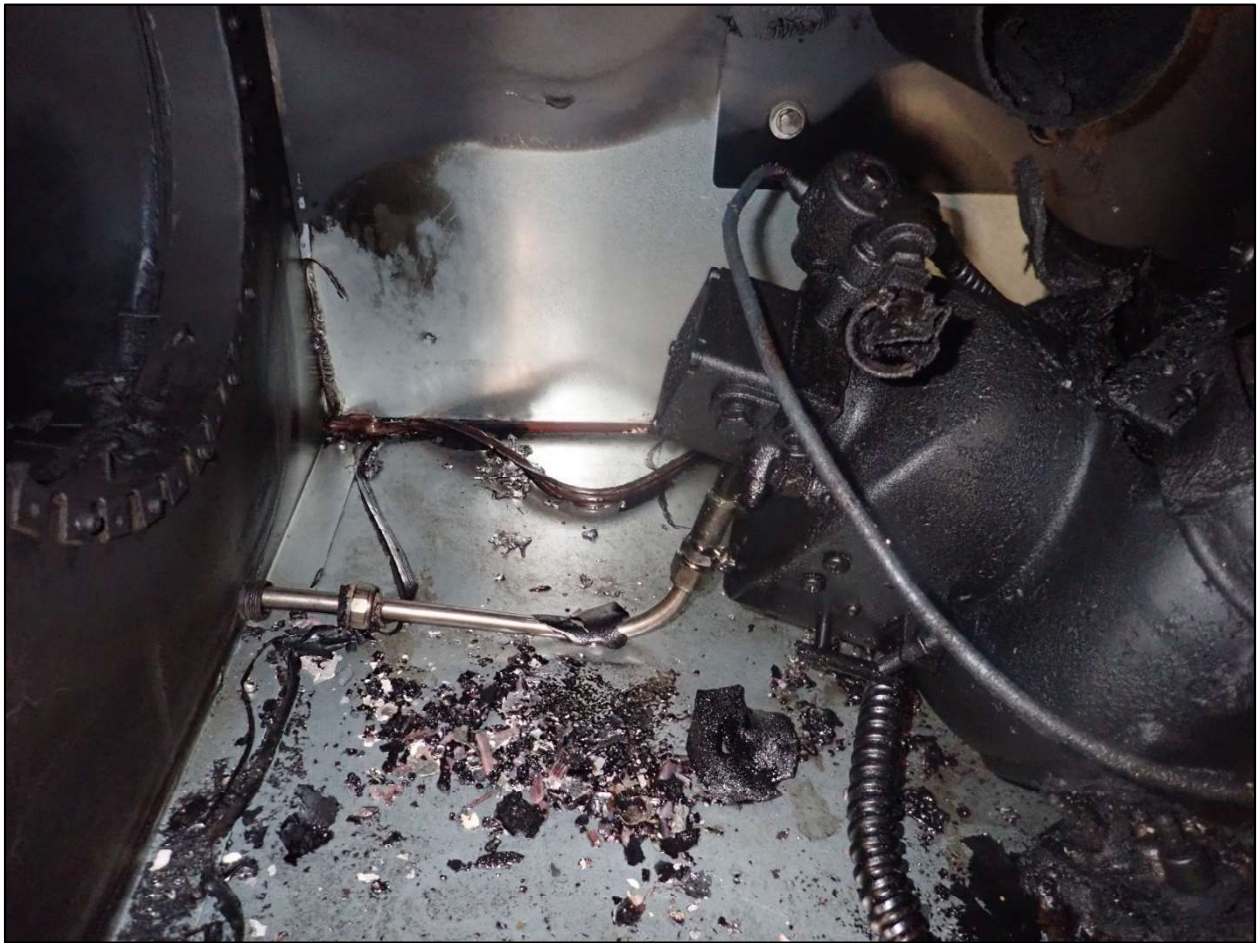
- 5.8 Violation of manufacturer’s installation requirements: The 601CRD burner and the SUNTEC fuel unit installation manuals both stated that NFPA 31 must be followed. NFPA 31 requires the use of “fusible link safety shutoff valves.” A fusible link shutoff valve was required by the manufacturer to be installed as close to the burner as practical. If the fusible link shutoff valve had been installed, when the heat increased in the burner’s enclosure, the missing valve would have actuated due to heat (as designed). Activation of such a valve would have automatically secured the fuel supply and could have prevented the spread of fire through the vessel via the elimination of the fuel source. As shown in Figure 12, the installation did not have a fusible link shutoff valve.

Figure 12. Fuel Supply Line to the Burner Assembly. A Fusible Link Safety Shutoff Valve is not Installed as Required by NFPA 31.
