MARINE SAFETY ALERT

Safety Alert 02-04

CONFINED SPACE ENTRY

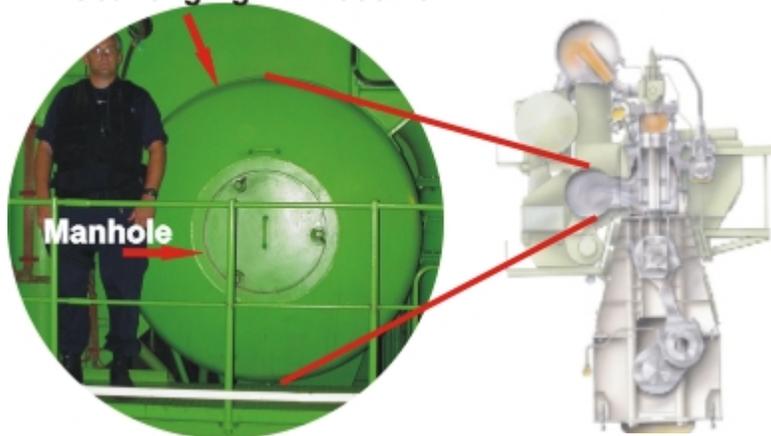
Scavenging Air Receiver

The vessel was powered by a Burmeister & Wain, 9 cylinder two stroke engine that develops over fifty-five thousand horsepower. The engine's scavenging air space can be accessed by two manholes located on both ends of the scavenging air receiver.

These circular manholes are secured by three L-shaped dogs having an outer edge that is tightened against an inner circumferential lip on the edge of the access hole. Tightening is achieved by the use a handled fastener.

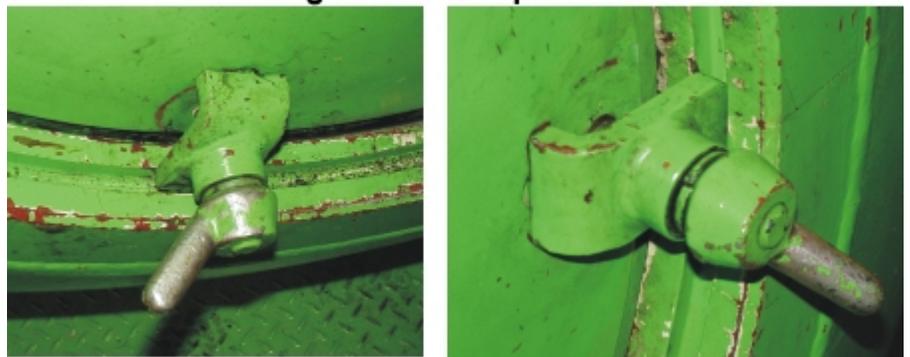
engine maintenance was performed in that space while at the first port and he may have returned to inspect the area for left behind tools and materials or to retrieve something. It appears that after his entry, the easily moved hinged / inward-opening door accidentally closed. Investigators believe that at that time, the upper left dog due to its weight and perhaps the vibration of the door as it closed, caused the dog to move allowing its edge to catch the circumferential lip at the opening. Once caught, even with the loosened fastener the door could no longer be opened from the inside of the receiver.

Dogs in latched position.

The Coast Guard **strongly recommends that:**

- All vessels complying with the International Safety Management Code (ISM) have a specific plan for entering confined spaces outlined within their Safety Management System.
- The confined space entry procedures include and identify various types of shipboard spaces such as those previously mentioned that could be encountered and which should be treated as confined spaces.
- Crew safety meetings address the identification of confined spaces and provide instruction on confined space entry procedures.
- Individual crewmembers that work in confined spaces review existing entry procedures and requirements regularly.
- All other vessels and maritime operations falling outside of ISM requirements develop and include in their marine safety programs similar confined space identification and entry procedures.
