MARINE SAFETY ALERT

Safety Alert 03-02

HANDHELD STEERING SWITCHES

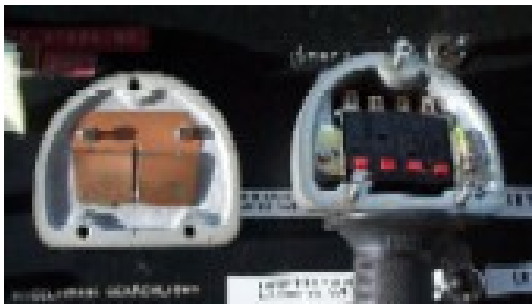
The loss of steerage was caused by the failure of a hand-held non-follow up remote steering switch. These devices are routinely used throughout the towing industry and consist of a two-button switch mounted at the end of a small handle attached to an extendable wire. The wire is connected to the vessel's rudder control circuitry. By depressing either of the two buttons, the towing vessel operator is able to position the rudders and maintain desired steerage. This control is not the only steerage device available to the operator. However when used, it permits movement of the operator within the pilothouse area enabling him or her to ascertain side clearances while transiting narrow channels or during other periods of close maneuvering.

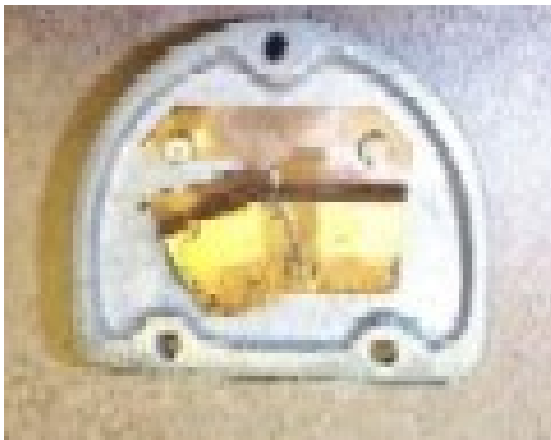
The steering switch is a Robertson Model F ½. The assembly contains four micro switches and consists of two pushbuttons which when depressed come in contact with a two sectioned plate. The depressed button causes one section of the plate to shift against the actuating tabs of two side-by-side micro switches. When this occurs, the steerage circuitry is activated and the rudders shift in the selected direction. As the button is released, the inherent resilience of the contact plate causes it to move off the actuating tabs of the micro switches thereby allowing the circuitry to return to normal.

During the casualty, the vessel operator was unable to change to another means of steering prior to the tug and tow running aground. Afterwards, an inspection of the steering switch revealed that one section of the plate fractured and lodged itself between the other section and the actuating tabs of the micro switches. Although the buttons were released, the broken section of the plate depressed the actuating tabs resulting in the continued hard right rudder positioning. The failure of the plate is most probably related to metal fatigue caused by long-term cyclic operation.

vessels of its fleet. Four vessels were discovered to have similar fractures in various stages on the plate. The manufacturer's equipment manuals were void of any preventative maintenance requirements and the vessel's operators did not have any routine scheduled maintenance plan to inspect or replace worn components of the switch.

- Inspect the internal components of existing controls for signs of fatigue or fracturing.
- Establish a preventative maintenance procedure that complies with the manufacturer's recommendations.
- Ensure that equipment operators are knowledgeable in its usage, capable of inspecting its components and completely understand what immediate actions may be required when failure occurs.
- Consider the use of an electrical disconnect switch located at or near the cable's connection to the vessel's primary steerage circuitry. The use of a disconnect switch will permit isolation of the cable and hand held unit in the event either item fails. Disconnecting would enable operation of another steering method.
