# United States Coast Guard

## Marine Safety Alert

Alert 5-06

#### Structural Integrity of Propulsion Boiler Casings

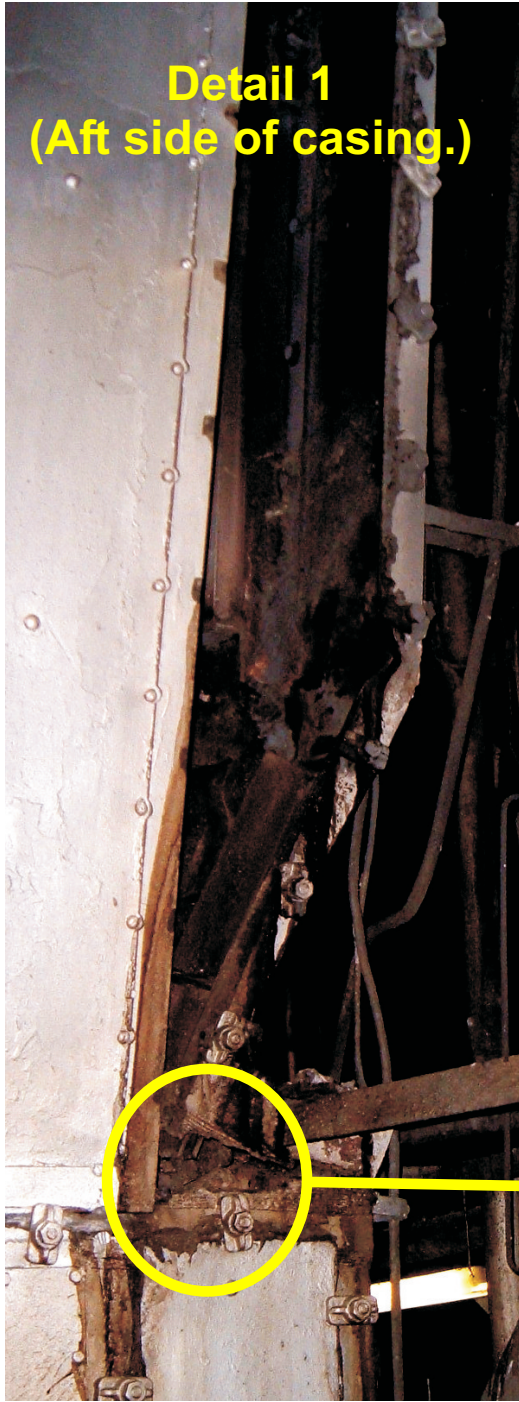
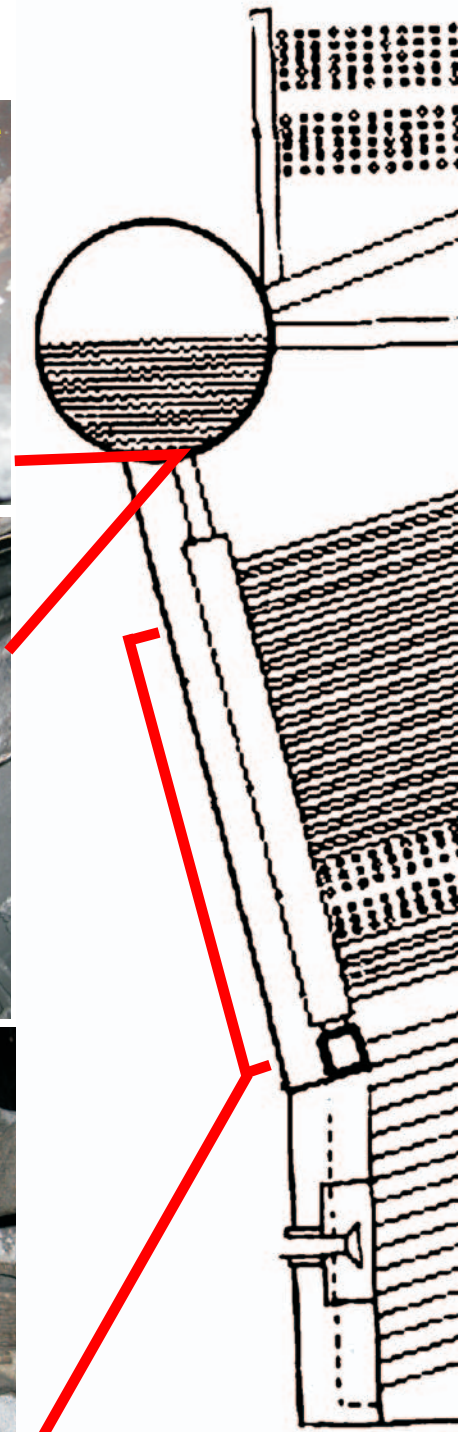
**Area of Detail 1.**

An investigation revealed that the structural integrity of the inboard boiler casing was compromised and the increase in internal casing pressure caused by the flashing of water into steam and its expansion caused a portion of the casing to separate, allowing the steam and a mixture of soot, refractory and other debris to be released in the vicinity of the operating station. (Attachment detail 1) Investigators discovered a number of areas where the strength of the inboard casing was compromised.

To prevent a similar casualty, the U.S. Coast Guard strongly recommends that owner operators of steam propelled vessels have their engineering staffs assess the structural integrity of their boiler casings; paying particular attention to support structure interfaces at the steam drum, front to side casing attachments and upper to lower casing transitions. It is also recommended that a thorough review of previous casing repairs be conducted to identify signs of diminished structural integrity. For U.S. flag vessels, any repairs necessitated by this assessment should be coordinated with the cognizant Officer in Charge Marine Inspection and Classification Society representatives to ensure that the equipment is reconstructed as originally designed and in accordance with good marine practice.
