MARINE SAFETY ALERT

Safety Alert 5-15

SECURED FOR SEA OR NOT

Anchor Equipment – Attention to details.

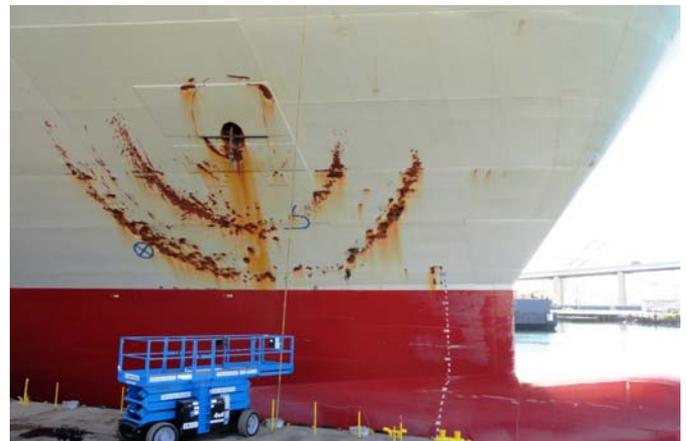
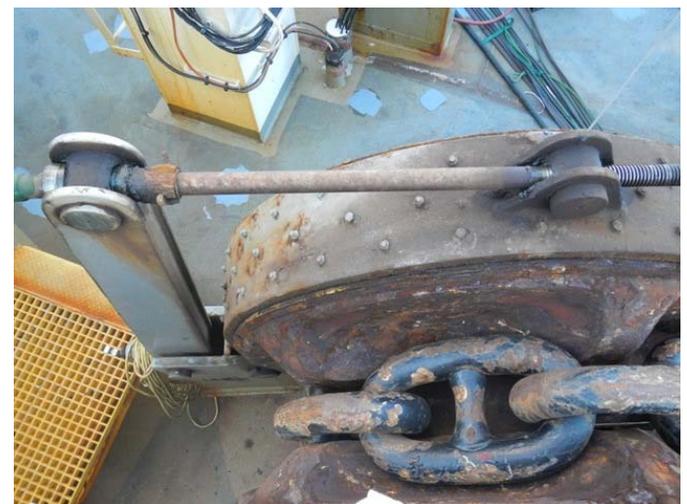
Recently, a freight ship was underway in 15 foot seas when the forepeak flood alarms activated. The crew investigated and discovered the starboard anchor had slipped 10-15 links, causing it to strike and puncture the hull. As a result, seawater flooded the bow thruster and emergency fire pump compartment. The casualty resulted in excess of \$1 million in vessel damage and a month's lost revenues while the vessel was out of service affecting repairs.

During the repair period, it was discovered that the anchor windlass brake pad had worn down to 2-3mm thickness. With only this amount of pad the fully applied brake could not achieve its designed holding power. The crew should have recognized the excessive wear to the brake pads and required replacement.

It was also discovered that the involved anchor had dissimilar specifications to the original anchor it had replaced. As a result, the replacement anchor's relative position in the hawse pipe was not the same because of its different shank length and connecting linkages. The size difference prevented the riding pawl from properly engaging the anchor chain.

- All preventative maintenance programs are up to date and include specific language on anchor windlass equipment, particularly emphasizing when brake assemblies must be renewed or adjusted;
- When key vessel components, such as anchors, are to be replaced, that a proper company plan review occurs, taking into account all possible variables; and
- Persons involved with vessel maintenance and repair have technical resources available to assist in determining serviceability or replacement of shipboard equipment.

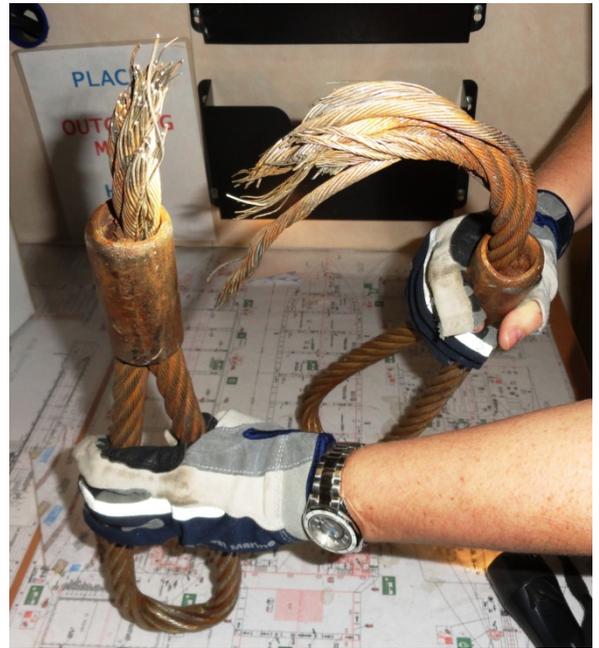
As an added safety device, a wire sling had been used to secure the anchor. The wire sling was threaded through a chain link and secured to the vessel with a pelican hook. When the sling broke and the brake failed, the anchor's weight and ship's movement then caused it to drop before the riding pawl could properly engaged.

The sling failure was likely caused by the corrosion of the inner wire strands. The inner wire strands were exposed to the elements because of the sharp bend in the wire created by being fed through the chain link and secured by a pelican hook. The wire sling was inspected regularly; however, those performing the inspections were not instructed on how to examine and determine its serviceability.
