MARINE SAFETY ALERT

Safety Alert 05-17

Got Gas? In the Wrong Place?

Don't allow corrective actions to create additional hazardous conditions!

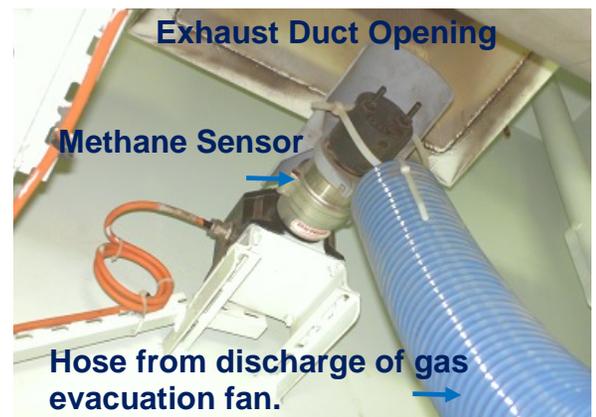
Engineers traced the methane leakage to the recently removed bellows and replaced the damaged O-ring. To prevent future accumulation of gases they rigged a hose from the outlet of the gas evacuation fan, across the GVU room to the sensor at the entrance exhaust duct. This unauthorized arrangement, which was identified during a Coast Guard examination, could have likely disabled the sensor's ability to detect methane leakages from other components within the GVU room. (See image at right.)

- an inadequate fix of a component leading to the dislodging of an O-ring;
- gas leakage captured and returned back to the GVU room but not removed from the room;
- an accidental exposure / personnel casualty caused by a lack of oxygen and excessive gas accumulation; and
- a second potentially hazardous condition due to the unapproved installation of the exhaust hose, which would likely disable the methane sensor's effectiveness in monitoring other components for leaks within the GVU room.

Coast Guard examiners also noted that a second exhaust hose was similarly installed in the vessel's second GVU room. These hoses were in place for about eight years. It is also important to note the engine manufacturer's manual highlights the need for caution when replacing the bellows and to use care when installing the O-rings. The manufacturer also emphasizes the need to check for gas leaks after repairs or maintenance are performed.

- Emphasize to their organization's technical shore side and vessel personnel the importance of following:
 - Manufacture guidance;
 - Recommendations in terms of maintenance and repair procedures;

- Methods to validate successful repairs involving critical systems, including leakage detection; and
 - Procedures to evaluate corrective modifications (e.g., the use of the exhaust hose), even if intended to be temporary, to ensure they do not create additional safety hazards.

- Urge their vessel personnel to request additional expertise such as classification societies and manufacturer representatives when technical issues arise (e.g., the failure of the GVU room sensor to detect gas leakage or potential inadequate diffusion and circulation of air exchanges within the GVU room) to ensure the most effective corrective actions and system alterations take place as needed.

- Make notifications to the proper Flag State authorities and classification societies regarding potentially hazardous conditions before making any modifications to existing approved installations, arrangements, or procedures.
