MARINE SAFETY ALERT

Safety Alert 07-02

FUEL AND EXHAUST SYSTEM MAINTENANCE

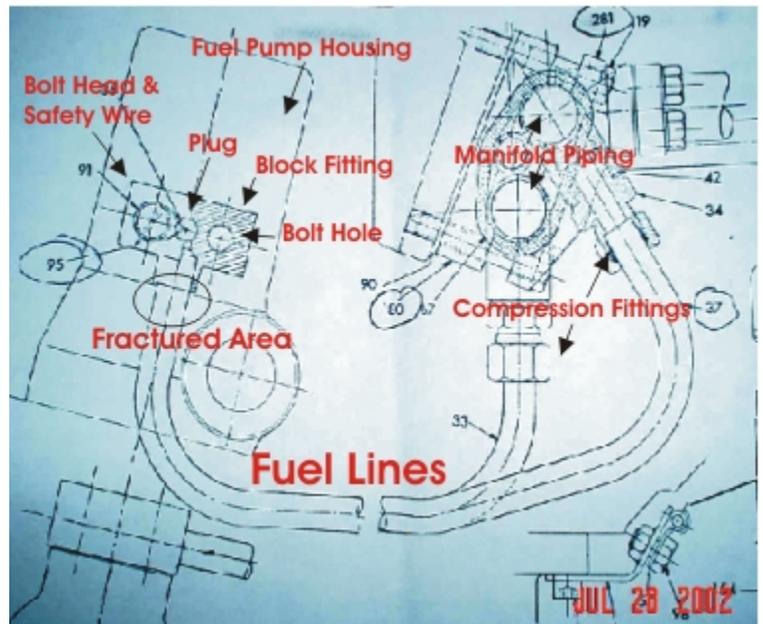
On the fuel pump ends, each pipe consists of a rectangular shaped block containing two bolt holes. Both blocks connect directly opposite one another on the fuel pump housing. Two metric bolts are used with spacers for each fitting. The heads of the bolts are drilled to receive safety wiring which when properly used prevents loosening. Also located on each block fitting directly between the two bolt holes is a viewing plug that is removed whenever necessary to time the fuel pump to the engine.

Investigators discovered that the supply line to the starboard engine number three cylinder fuel pump had fractured just below its connection into the rectangular block fitting. Additionally, shipyard personnel discovered the inboard bolt on the supply line fitting loose. Of 112 bolts securing the fuel pump fittings on the vessel's two engines, none were safety wired despite the availability of drilled bolt heads and indications of such wiring in engine schematics and diagrams.

Just under the block fitting of each connection, hose clamped around the tube joint is a rubber boot about four inches long. This boot is designed to deflect oil sprays downward should a break occur in this area. The boot on number three cylinder was destroyed in the fire.

The insulation of potential fuel oil ignition sources and the use of specialized fasteners and other devices to reduce the loosening of critical engine and systems components is essential for long term safe operations.
