MARINE SAFETY ALERT

Safety Alert 09-02

TANK EXPLOSION

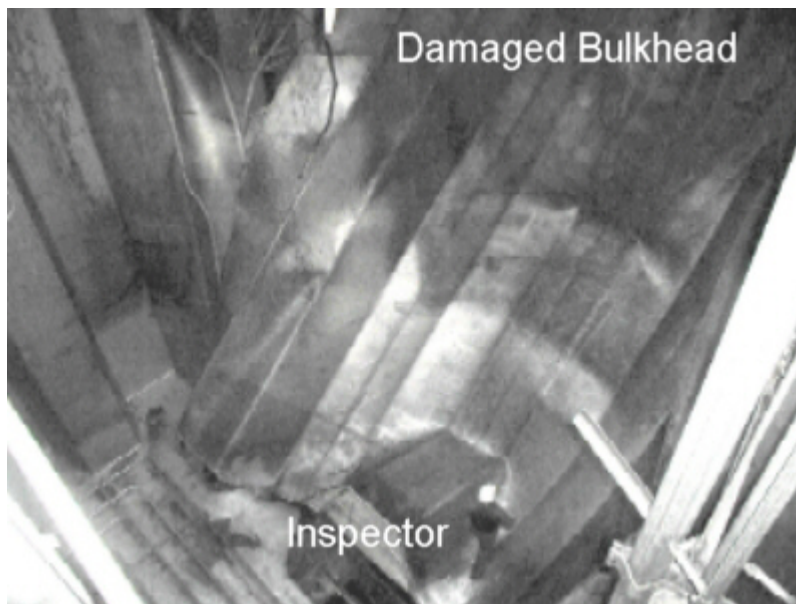
Upon nearing completion of tank washing while stripping the tank, the vessel's pumpman opened the tank top cover. Air immediately rushed in and an explosion occurred. The centerline bulkhead between the ignition space and the adjacent cargo tank ruptured. A fire also developed and was extinguished in twenty minutes by the ship's crew using a water/foam mixture.

The pumpman was severely burned and required an evacuation to a medical facility. The cargo hold was severely damaged and resultant structural and machinery repair costs are expected to be significant.

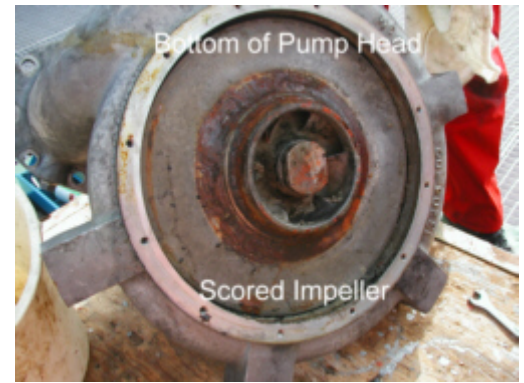
Pump and Motor Assembly

A preliminary investigation reveals that the upper bearing of the cargo pump located deep within the tank had failed. The shaft and impeller shifted axially one half an inch causing the impeller to contact and spin against the end plate of the pump casing. The resultant friction caused extreme heat and possibly sparks which ignited the atmosphere in the tank.

When the tank top cover was opened, enough fresh air was introduced to allow the benzene vapor content to fall below the upper explosive limit and into the explosive range. The vapor in the presence of the operating but severely overheating cargo pump components ignited and caused the explosion.

- Ensure that the proper maintenance and repair as recommended by the manufacturer is accomplished for all pump, motor and drive components.
