**MARINE SAFETY ALERT**  
**Inspections and Compliance Directorate**

Safety Alert 12-14

**DESIGNED FOR A REASON – FUEL SYSTEM MODIFICATIONS LEAD TO FIRE**

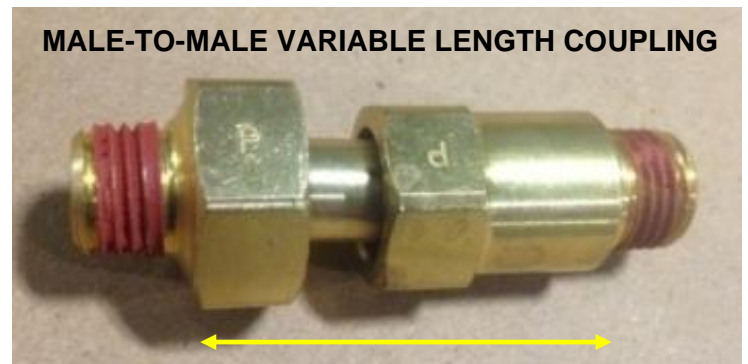
The vessel was equipped with four Detroit Diesel sixteen cylinder high speed engines - model 16V92. The engines were constructed by coupling two V-8 cylinder engines together. There are also other similarly coupled engine models and in widespread use including the Detroit Diesel 12V92, 12V71, and 16V71. Fuel and coolant flow from head-to-head and within passages on each side of the engine. The fuel supply passage delivers fuel to the injection equipment of each cylinder. A return passage handles excess fuel. To connect the heads on each side of the engine, a male-to-male threaded variable length coupling is used by design. There are four couplings per engine that handle fuel supply and returns from the injection components. These couplings are unique in that they facilitate installation by their capability to lengthen when their ends are threaded into the heads.

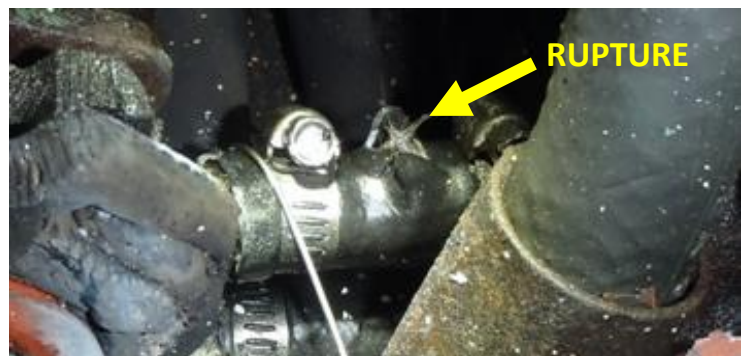
On the passenger vessel that experienced the engine room fire, couplings on three of the four engines were replaced with threaded hose barb fittings and rubber hose. One of those fuel hoses subsequently failed and sprayed fuel directly onto the main engine exhaust lagging and blankets. The seam in the insulation blanket was facing towards the engine rather than away and likely provided the ignition source.

As a result of this casualty the Coast Guard **strongly encourages** owners, operators, and marine engine rebuilders with the types of engines listed above, either as propulsion or prime movers for generators to:

- Always use proper replacement parts,
- Consider seam placement of exhaust insulation blankets and lagging during installation,
- Follow good marine practice by always maintaining the tightness and correct fit of the insulation blankets over the entire exhaust system, and
- For those who repair or own and operate vessels with these Detroit Diesel engines either as propulsion or electrical generation equipment of design configuration 16V92 ,12V92, 12V71 and 16V71, inspect and verify that the proper head to head couplings are used for the fuel supply and return passages. If incorrect, contact an authorized manufacturer technician for specific guidance.
