# U.S. COAST GUARD

**SAFETY ALERTS  
1996-2014**

**PREVENTION**

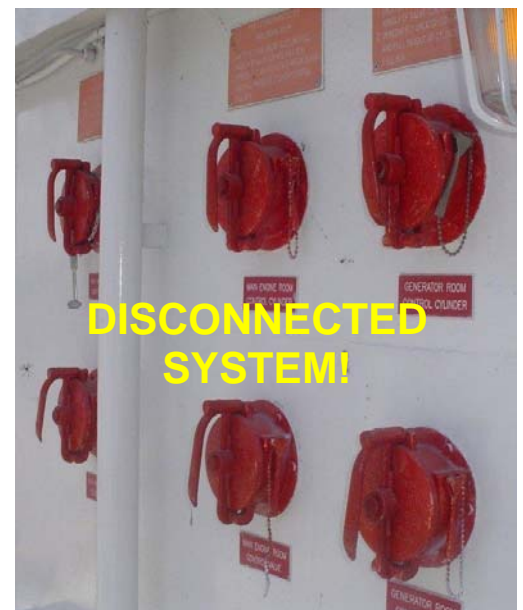
In a separate recent UTV examination, an inspector found two sets of remote emergency shutdowns with only one set operational. The original station (see image on the right) appears to be fully operational, but was not connected. The operational shutdowns were at a separate location.

The Coast Guard **recommends** conducting a comprehensive pre-test meeting and simulated step-by-step “walk-through” between involved parties prior to actual testing of complex or potentially confusing systems. Operational controls should be implemented to maximize safety and reduce risk.

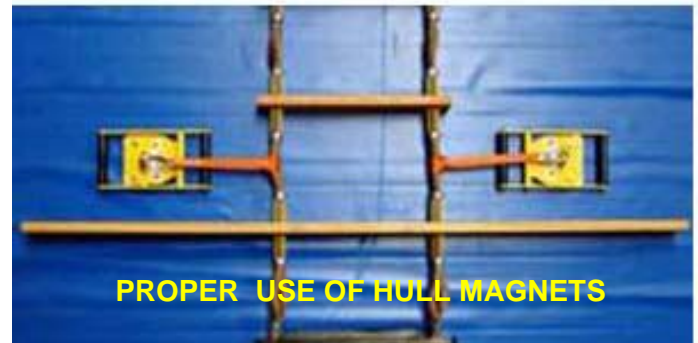
This alert raises awareness as to the importance of not modifying equipment or components from their intended design or operation. Recently, a State Pilot suffered a concussion as he was boarding a vessel via its pilot ladder. The primary cause of the accident was an improperly modified embarkation ladder hull magnet that disconnected from the ship's hull and struck the Pilot on the head.

Hull magnets are easy to operate devices and when positioned correctly, provide substantial holding force. The handle of the magnet is also a lever and enables easy release from the hull of the vessel. The intended proper use of the magnets is shown in the above image. In the incidents where the magnets unexpectedly detached from the hull, only one securing magnet was used between the rails of the ladder along with equipment alterations that deviated from the manufacturer's design (see image below).

The Coast Guard **strongly recommends** that vessel owners/operators refrain from modifying embarkation equipment. In addition, operators should regularly inspect existing vessel boarding equipment and return improper modifications back to the manufacturer's original design. Pilots are encouraged to consult with their appropriate associations to determine if any additional precautions should be taken as part of their normal boarding practices and this identified risk.

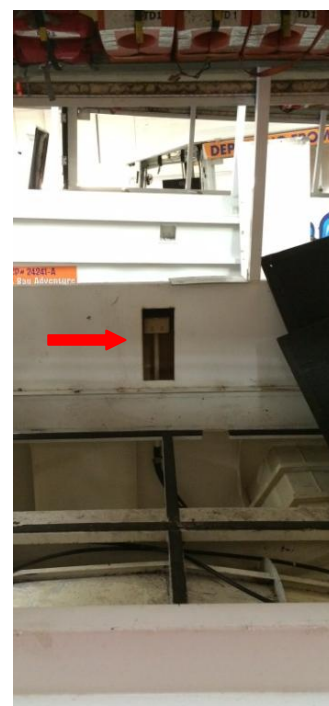
**WHAT YOU CAN'T SEE - CAN HURT YOU!**  
**Corrosion of "Duck" Boat Bilge Pump Discharge Piping**

The failure of this piping creates an extremely unsafe condition by rendering the vessel's bilge pumping system ineffective. Because the wasted section of piping is hidden behind inner sidewalls within the passenger seating section, the problem can persist and evade detection by the vessel owner or operator.

- Immediately trace out and inspect the entire bilge piping system for wastage or deterioration of metal bilge piping, check the condition of all hoses, hose clamps, supports and make repairs as needed.
- Make the inspections of these concealed components part of the vessel's overall routine inspection process.
- Consider installing an access plate on the inner panel at the area of the discharge piping so that the piping is easily accessible for inspection and maintenance. (See image at right)
- Inform the appropriate Coast Guard personnel if the system piping has changed significantly or in any way that may require regulatory notification, oversight or guidance for permanent repair solutions.

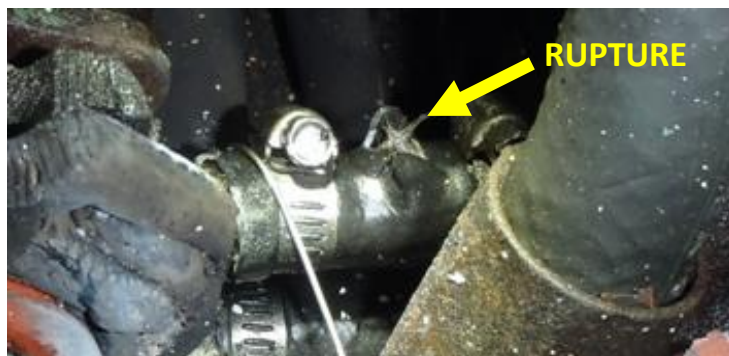
On the passenger vessel that experienced the engine room fire, couplings on three of the four engines were replaced with threaded hose barb fittings and rubber hose. One of those fuel hoses subsequently failed and sprayed fuel directly onto the main engine exhaust lagging and blankets. The seam in the insulation blanket was facing towards the engine rather than away and likely provided the ignition source.

As a result of this casualty the Coast Guard **strongly encourages** owners, operators, and marine engine rebuilders with the types of engines listed above, either as propulsion or prime movers for generators to:

- Always use proper replacement parts,
- Consider seam placement of exhaust insulation blankets and lagging during installation,
- Follow good marine practice by always maintaining the tightness and correct fit of the insulation blankets over the entire exhaust system, and
- For those who repair or own and operate vessels with these Detroit Diesel engines either as propulsion or electrical generation equipment of design configuration 16V92 ,12V92, 12V71 and 16V71, inspect and verify that the proper head to head couplings are used for the fuel supply and return passages. If incorrect, contact an authorized manufacturer technician for specific guidance.

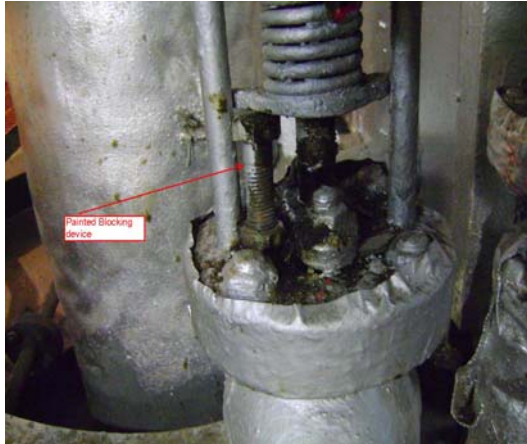
QCV blocked utilizing a bolt to hold in the open position. (Note: the painted portion on the bolt indicating possible long term condition.)

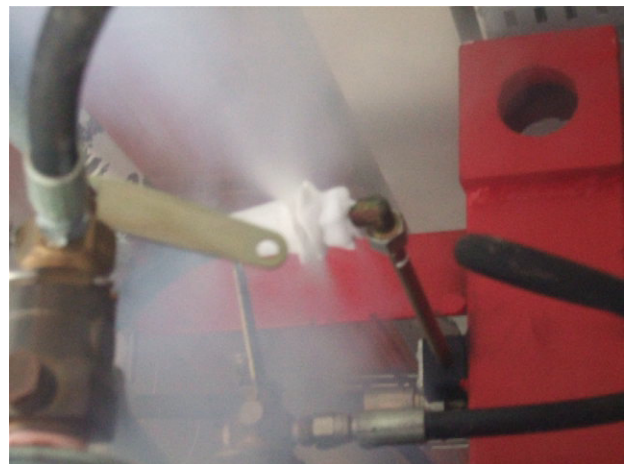
- The zone valve for the aft machinery space which admits CO2 from the bottle bank manifold to the space failed. Specifically, the ball valve's opening actuating arm fell off the valve when the gas powered piston actuator attempted to move it. The ball valve actuating arm was held in place by a very small machine screw and washer. When firefighters attempted to open the valve manually using the provided hardware it could not be moved. The valve was only able to be moved after the gas pressure was relieved from the inlet side of the valve. (Photograph at right.)

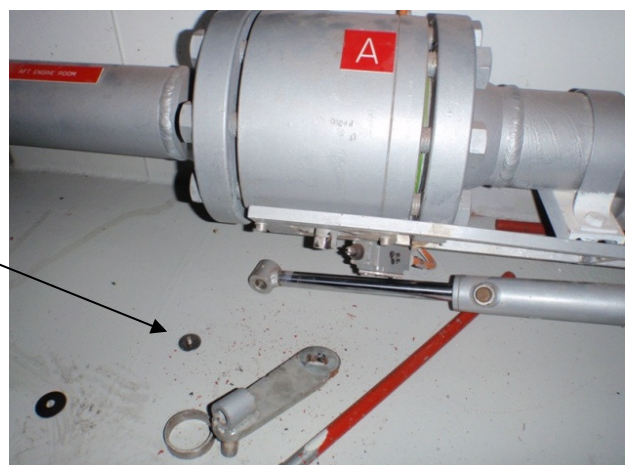
- Actuating arms to five of the six other zone valves were found loose. They were also attached by small machine screws. (Photograph at right.)

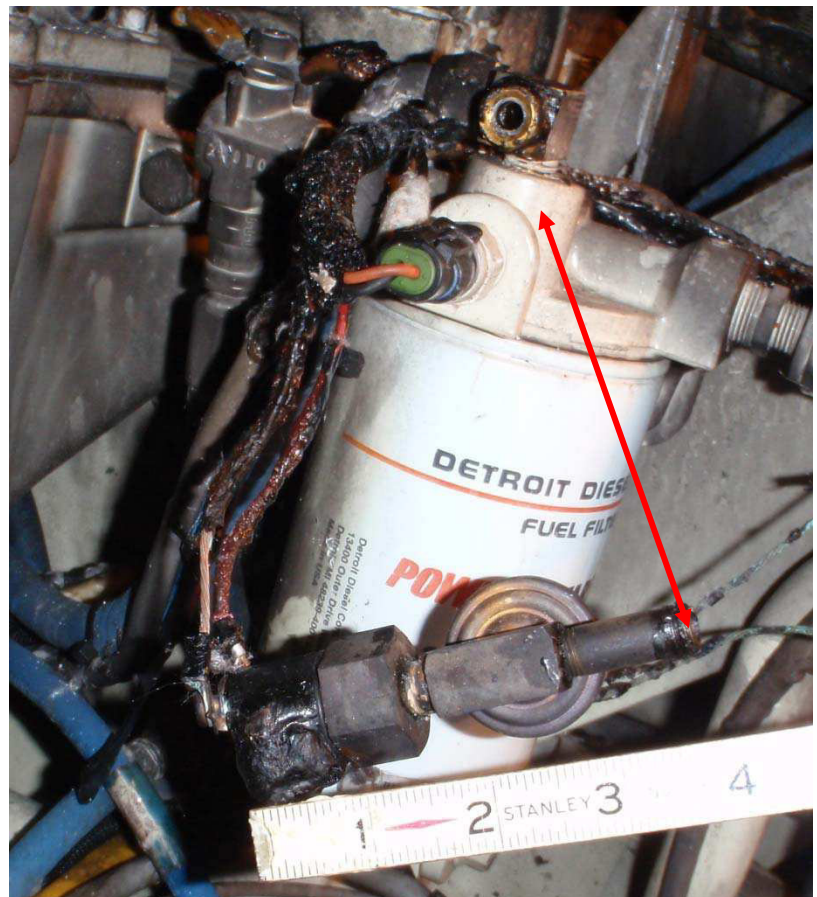
suspected that the fitting leaked first and did not immediately shear as shown in the photo at the right.

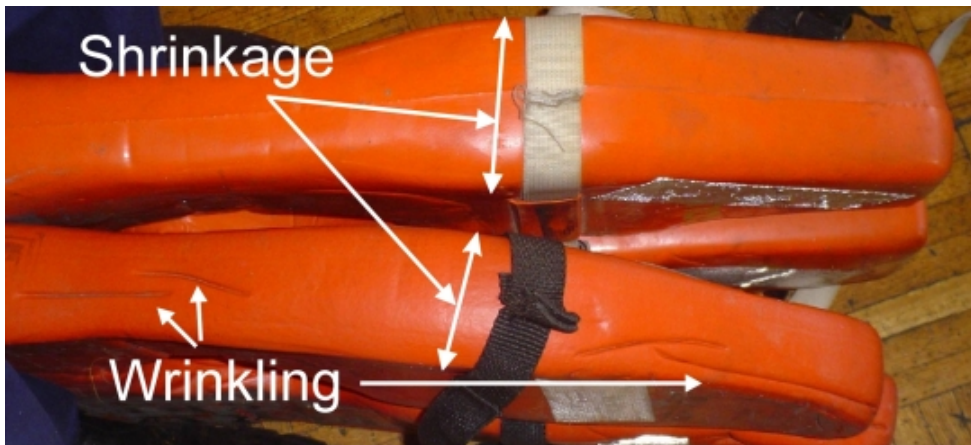
Left image shows an example of a vinyl dipped PFD with compressed or hardened foam. Right image illustrates a fabric covered PFD with brittle foam.
