MARINE SAFETY LESSONS LEARNED

Lessons Learned 01-17

Lingering Lye Leads to Costly Deck Replacement

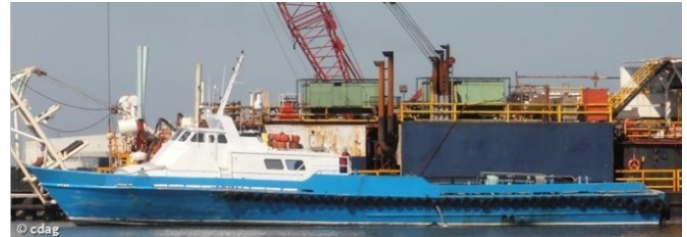
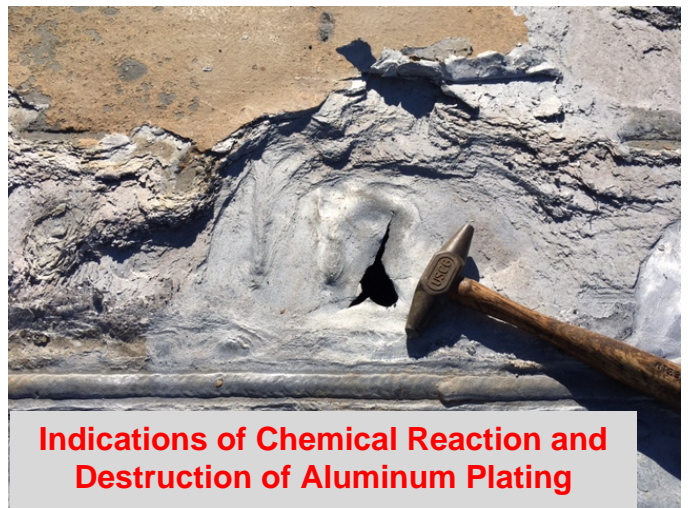
Earlier this year several Coast Guard marine inspectors were performing a deficiency check on a crew boat that operates in the Gulf of Mexico. It happened to be raining that day and while the inspectors were in the engine room, they noted water dripping from the overhead at various locations. They also spotted several cracks and parted seams in the aluminum braces of the structure that was the underside of the vessel's cargo deck. The extent of damage and exact sources of the leakage was difficult to determine, so the inspectors requested the boards covering the surface of the cargo deck be removed. Upon returning to the vessel the following day, the team found significant wastage covering a large area of the now exposed aluminum surface. Furthermore, they identified areas where the corroded aluminum had softened and appeared spongy. It was clear that a chemical reaction had taken place.

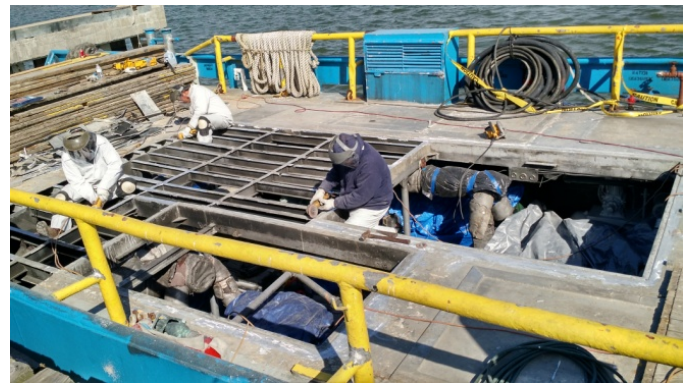
In their investigation into the circumstances surrounding this situation, the inspectors learned that there had been a caustic soda spill on the deck. While it was washed off the vessel with water, a diluted caustic soda and water mix seeped into and settled underneath the wood planking. A chemical reaction then occurred, causing damage and the need for extensive repairs.

Caustic soda is highly reactive with aluminum causing it to oxidize and corrode quickly. Additionally, when caustic soda is exposed to aluminum under some conditions it can also produce highly flammable hydrogen gas.

As a result of this incident, the Coast Guard reminds vessel owners and operators to consider all hazards related to chemical spills. In addition to potential health risks to personal involved with routine handling and clean up of spills, there is also the potential for adverse chemical reactions with vessel components, construction materials, and other items onboard.
