MARINE SAFETY ALERT

Safety Alert 07-22

UNEXPECTED DANGERS: LIFEBOAT REMOTE CONTROL WIRES

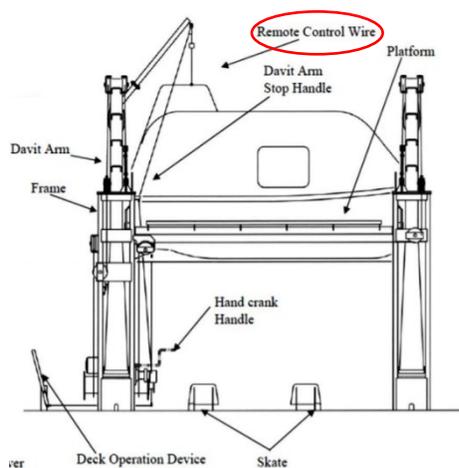
Figure 1 - Davit Launched Lifeboat Arrangement.

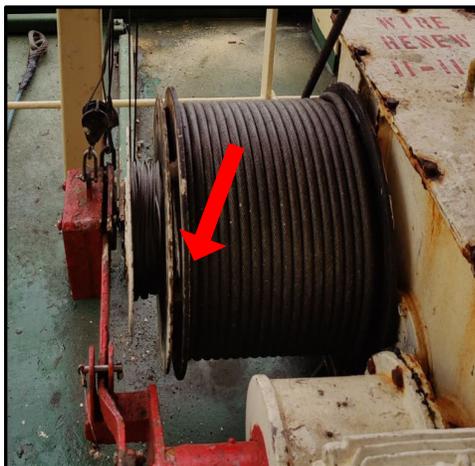
Figure 2 - Poorly-spoiled Remote Control Wire.

- (1) The first occurred when the remote control wire parted as the lifeboat was being lowered to the waterline with crew on board. Causal factors included poor winch spooling potentially hidden under the outer spools, which led to a wire kink and winding on itself, creating enough force to part the wire.

- Verify the proper spooling of the remote control wire, expand inspection as necessary.
- Verify the proper position of the remote control wire weight. If the weight is very close to the top of the lifeboat, this may indicate the remote control wire is too long.
- Verify material condition of the shackle that connects the pull cable to the remote control wire within the lifeboat. These steel shackles can corrode in the elements and may be overlooked during weekly/monthly/annual inspections.

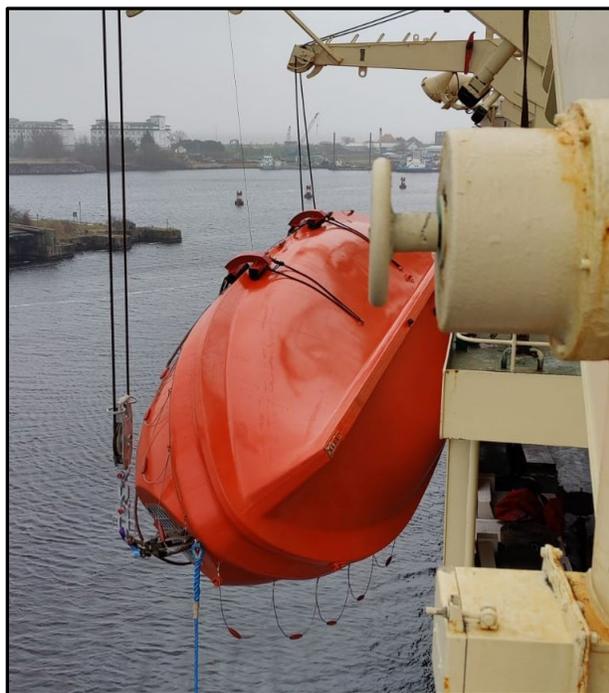
- (2) The second occurred a day later after the replacement remote control wire was hand spooled from extra wire found on board. While testing with crew on board using the remote control wire to lift the brake, an unexpected pay out of wire led to the winch brake prematurely engaging, which made the lifeboat stop lowering and swing erratically above the embarkation deck. Seconds later, the movement caused the wire to regain tension, which lifted the winch brake arm and caused the lifeboat to lower again. While lowering in a swinging motion, the skeg of the lifeboat caught on the knife-edge of the ship's deck, causing the lifeboat to list more than 90 degrees. Without the quick action of a crewmember who activated the winch brake lever from the deck, the lifeboat could have inverted further and led to catastrophic outcomes.

Figure 3 - Lifeboat listing more than 90 degrees w/ crew inside.

The Coast Guard **strongly recommends** that ship's crew conduct a thorough visual inspection of lifeboat launching systems and test lowering prior to operation with crew on board, paying special attention to the following inspection points:

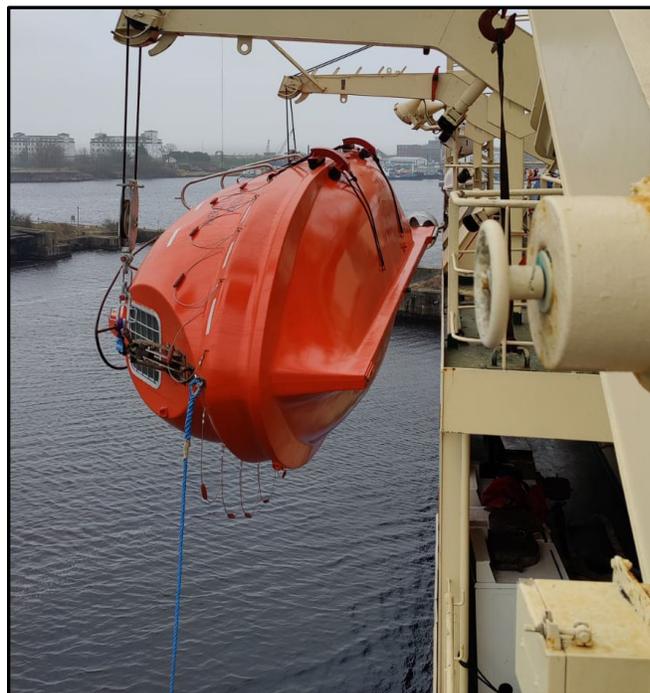
Figure 4 - Lifeboat skeg caught on deck edge.
