SS EDGAR M. QUEENY - S/T CORINTHOS; COLLISION
AT MARCUS HOOK, PENNSYLVANIA ON 31 JANUARY 1975
WITH LOSS OF LIFE

U.S. COAST GUARD
MARINE BOARD OF INVESTIGATION REPORT
AND COMMANDANT'S ACTION

REPORT NO. USCG/NTSB MAR-77-2
RELEASED

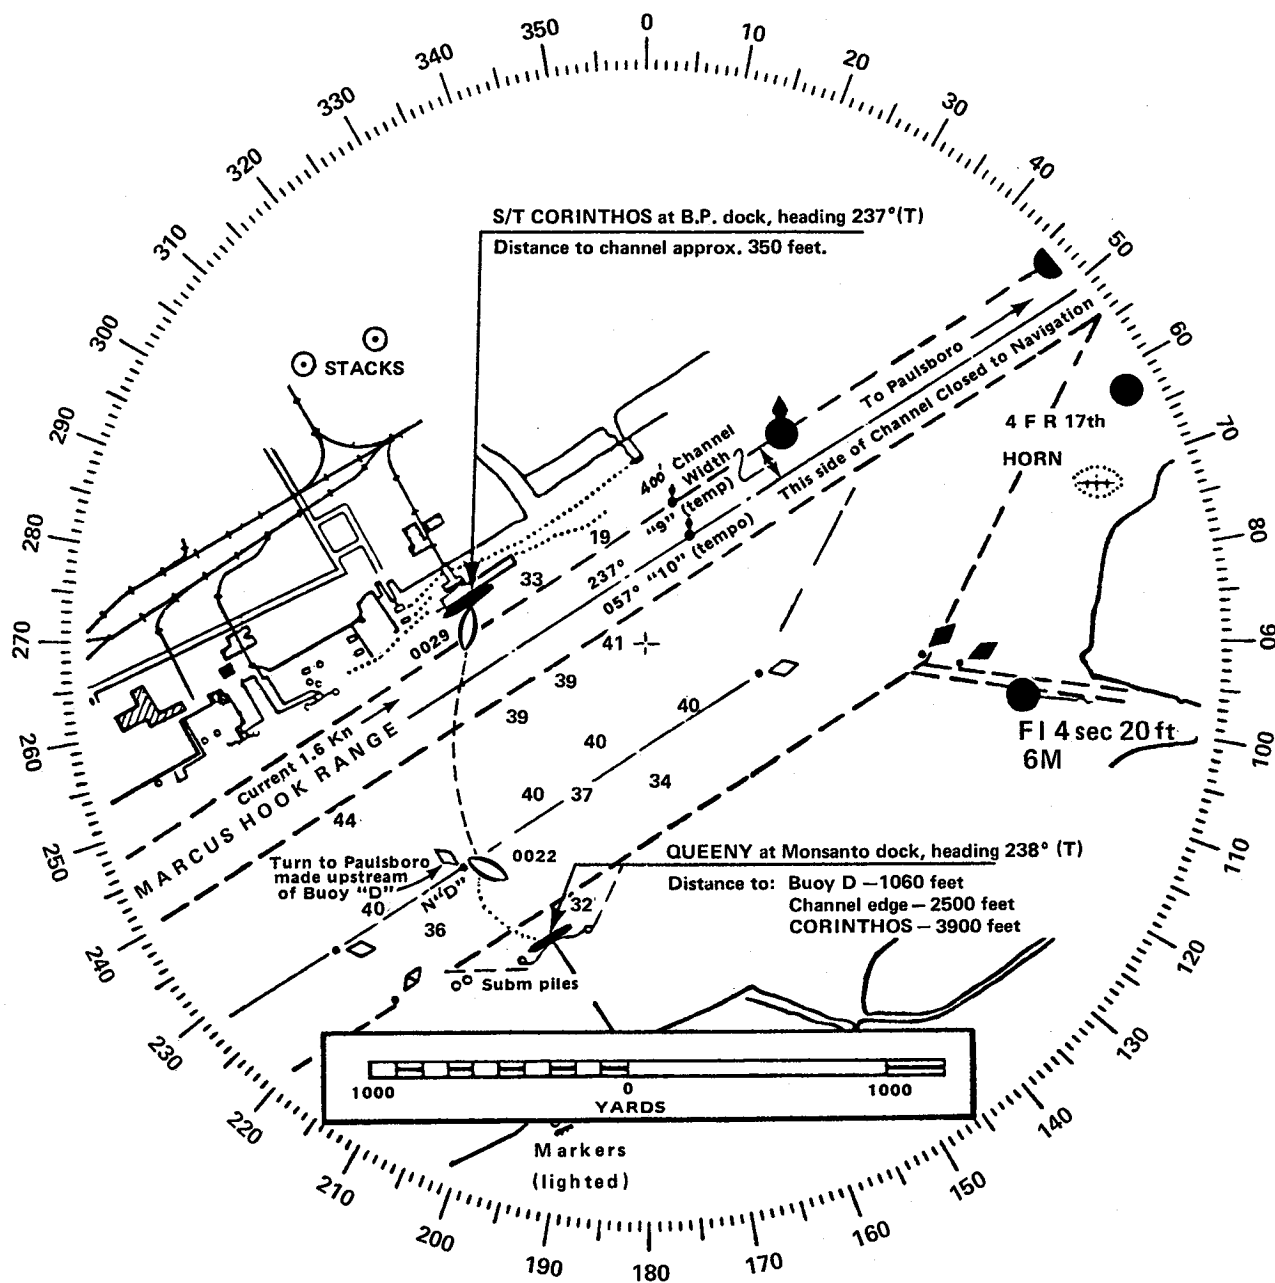
FIGURE 1

Plan of accident site

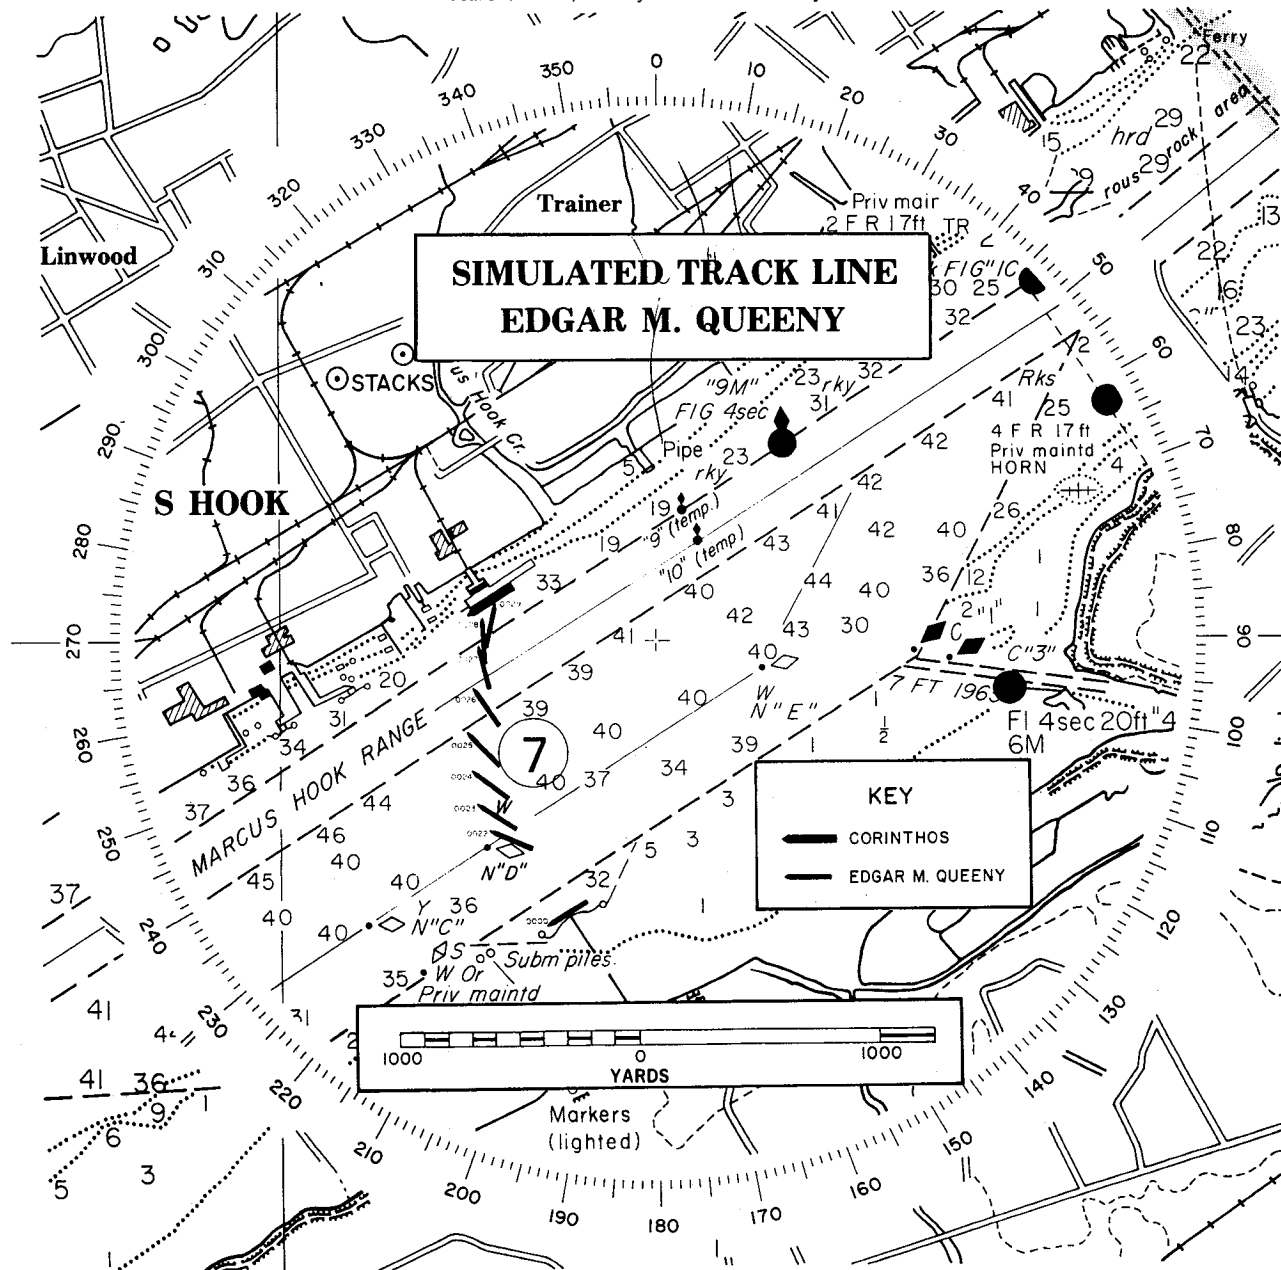
FIGURE 1

37. During the preparation of Figure 1 appended hereto, the Board determined that the EDGAR M. QUEENY rudder was hard right at the time that the vessel struck the CORINTHOS. The Board recognizes that this presumption conflicts to some degree with the testimony of the Helmsman Mr. [REDACTED]. One part of Mr. [REDACTED] testimony alternately indicates that he observed the rudder amidships at or before the time of collision. Comparing the description of one of his observations with other events it is obvious that he was describing a condition that existed for several minutes before the collision. Repeated questioning by Board members, and others participating in the hearings, also elicited from Mr. [REDACTED] an acknowledgement that the observation could have been made after the collision. The Board chose to discount his testimony regarding this point since it could not be corroborated and because of his tentative and contradictory accounts.
