MARINE CASUALTY REPORT

**SS FROSTA (NORWEGIAN), M/V GEORGE PRINCE;
COLLISION IN THE MISSISSIPPI RIVER
ON 20 OCTOBER 1976 WITH LOSS OF LIFE**

**U.S. COAST GUARD
MARINE BOARD OF INVESTIGATION REPORT**

REPORT NO. USCG 16732/73429

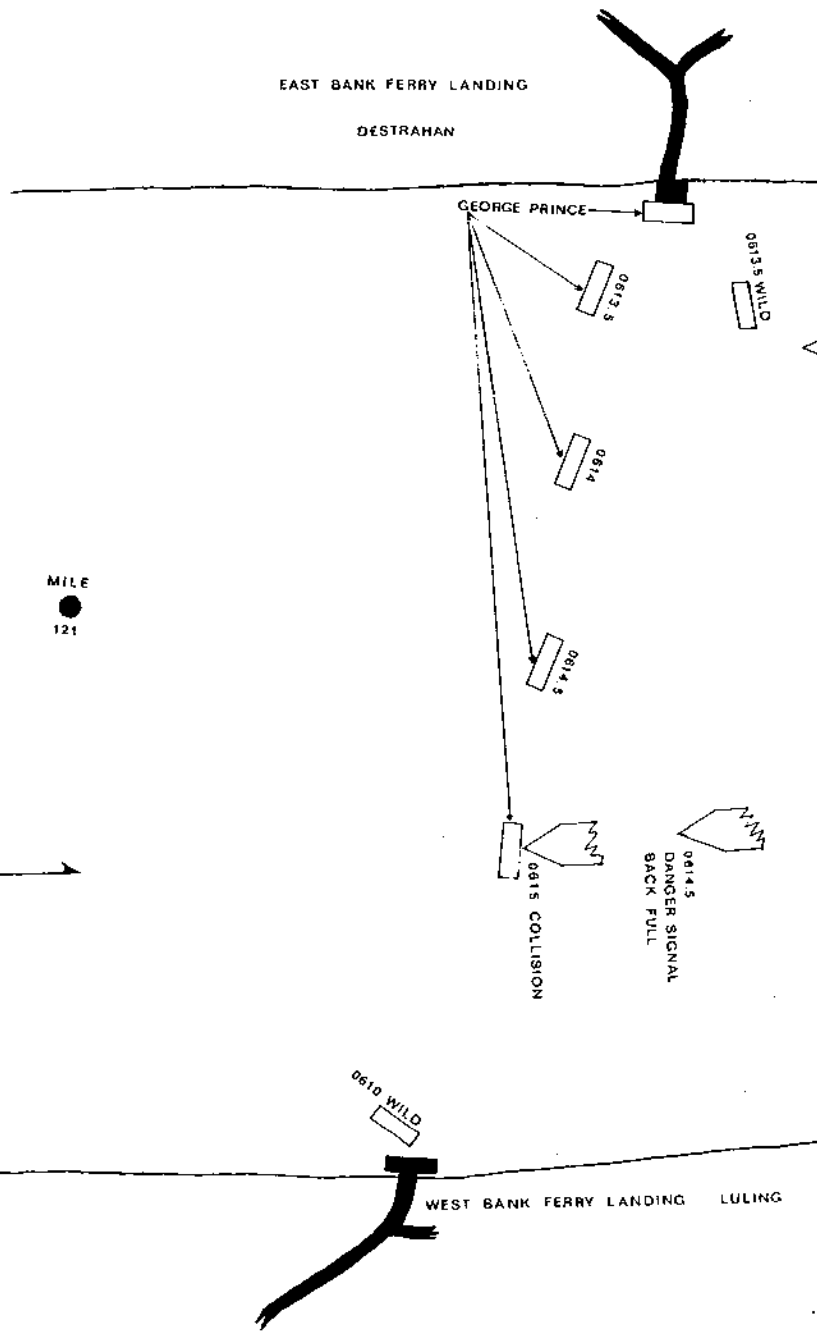
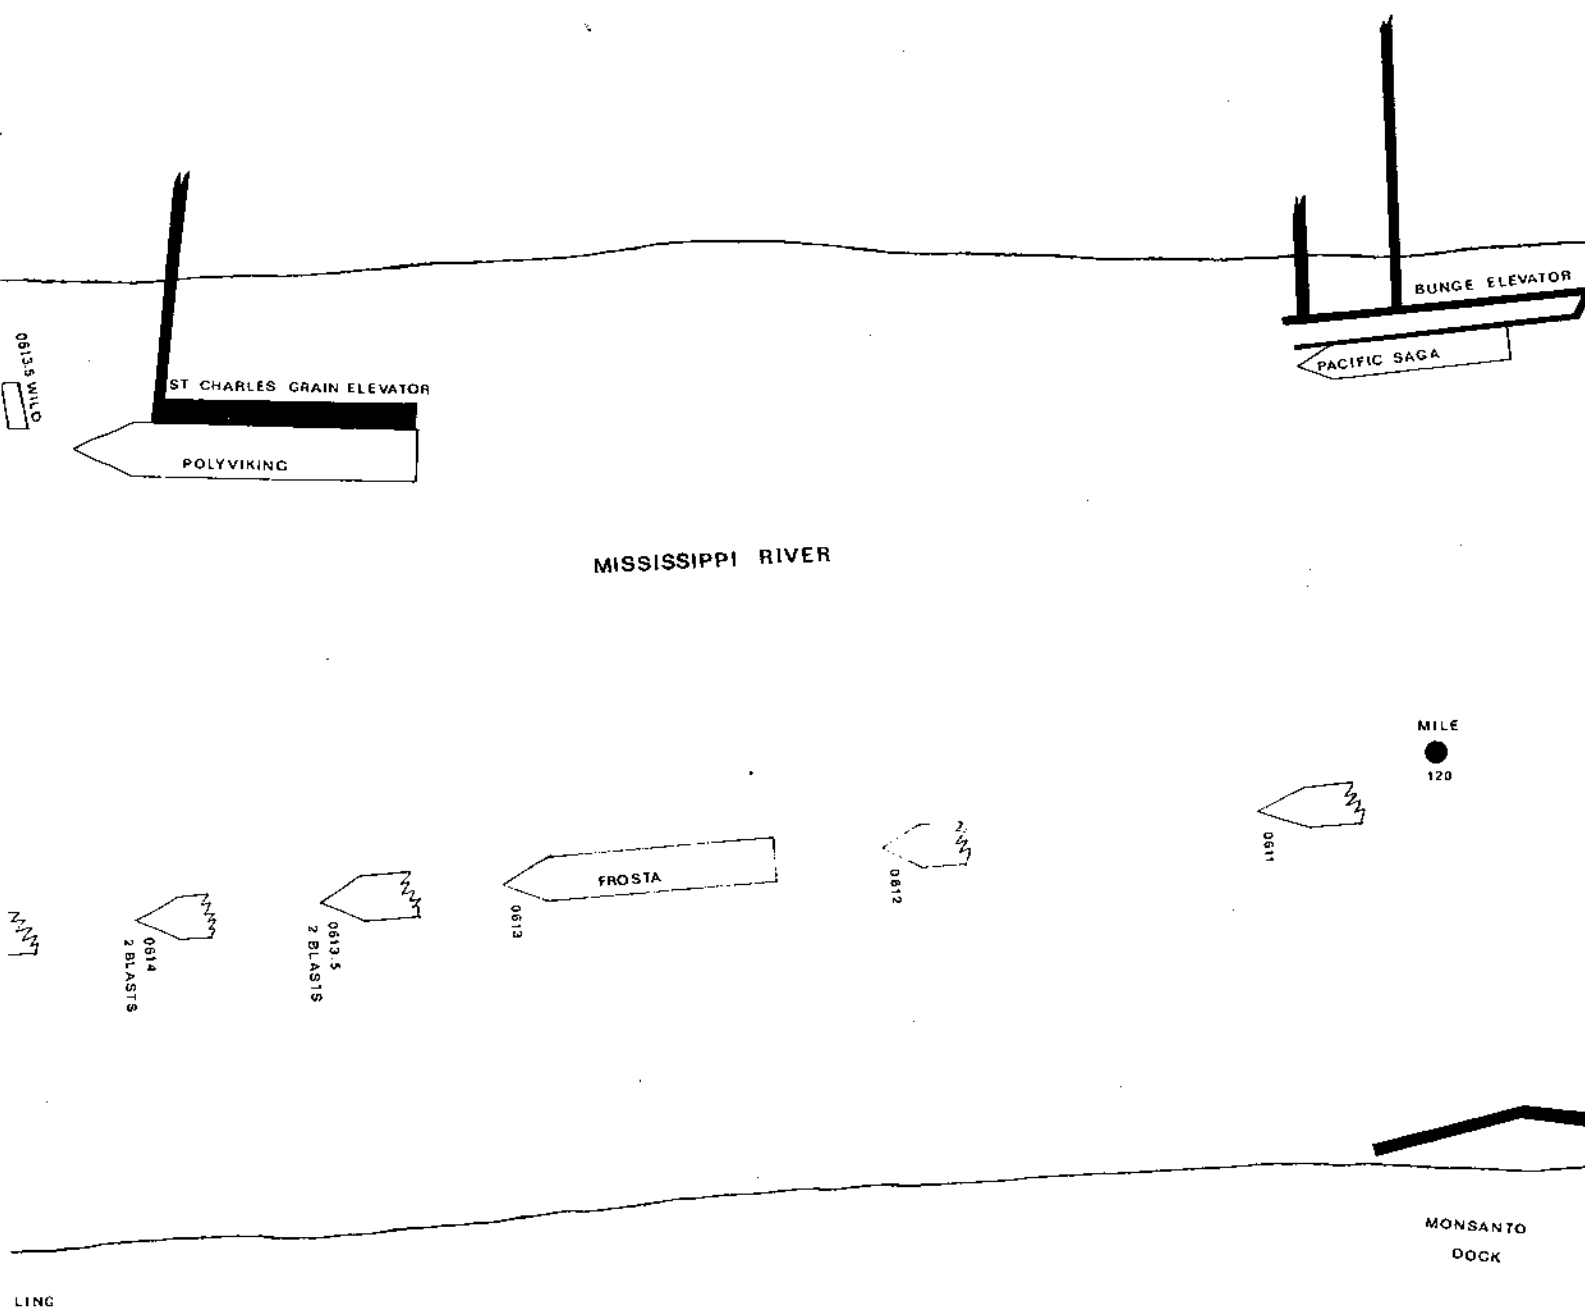
MILE
121

AVERAGE CURRENT
VELOCITY 1.2 MPH
