UNITED STATES COAST GUARD

**INVESTIGATION INTO THE CIRCUMSTANCES
SURROUNDING THE EXPLOSION AND FIRE
ABOARD THE TANKSHIP**

OMI CHARGER

**ON OCTOBER 9, 1993, AT BOLIVER ROADS
INNER ANCHORAGE NEAR GALVESTON,
TEXAS, WITH INJURIES AND MULTIPLE LOSS
OF LIFE**

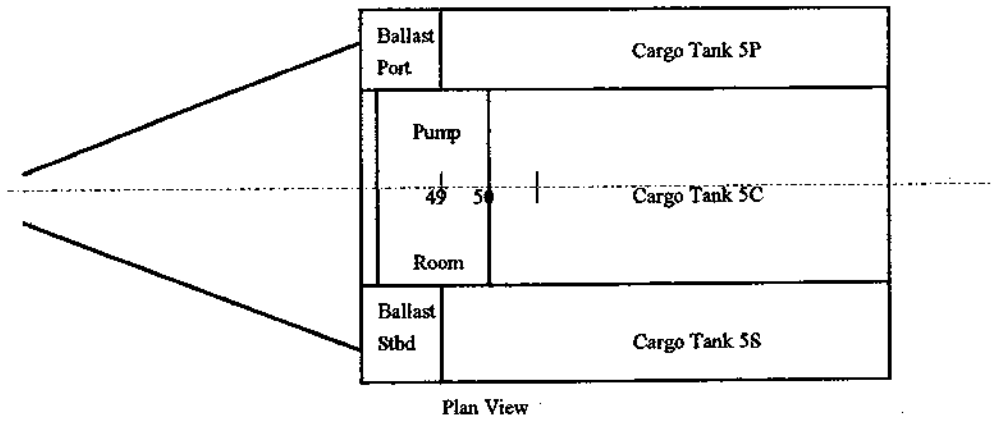
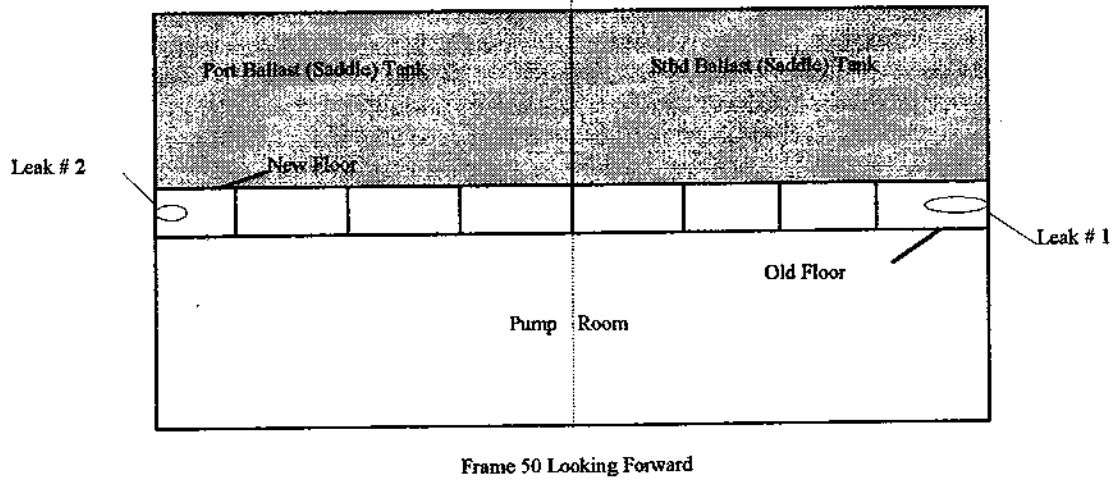
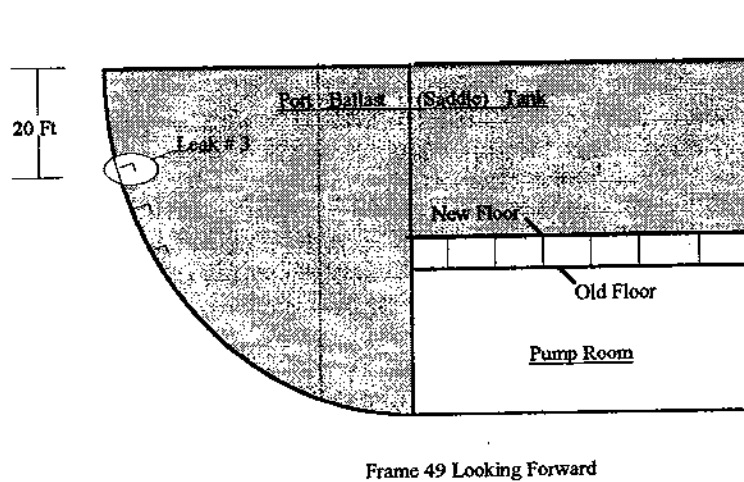
Figure 2, Location of Leaks (not to scale)

18. Three different blends of gasoline were loaded. At about 0330 on October 1st, the third mate, Tara Ziegler, making rounds in the pumproom, discovered a leak coming from the forward bulkhead between the pumproom and the 5 Center (5C) cargo tank. The leak was located on the starboard side, upper portion of the bulkhead, in between two horizontal plates that formed the overhead of the pumproom. This small space was created in the shipyard, as a result of modifications to the pumproom overhead, in an effort to correct problems in the saddle tanks (ballast) directly above the pumproom.

20. Sometime that afternoon, a second leak was discovered in the same bulkhead, in a similar location as the first, but on the port side of the pumproom. The rate of this leak was "just a drip" and the master was so notified.

See Figure 2, LOCATIONS OF LEAKS

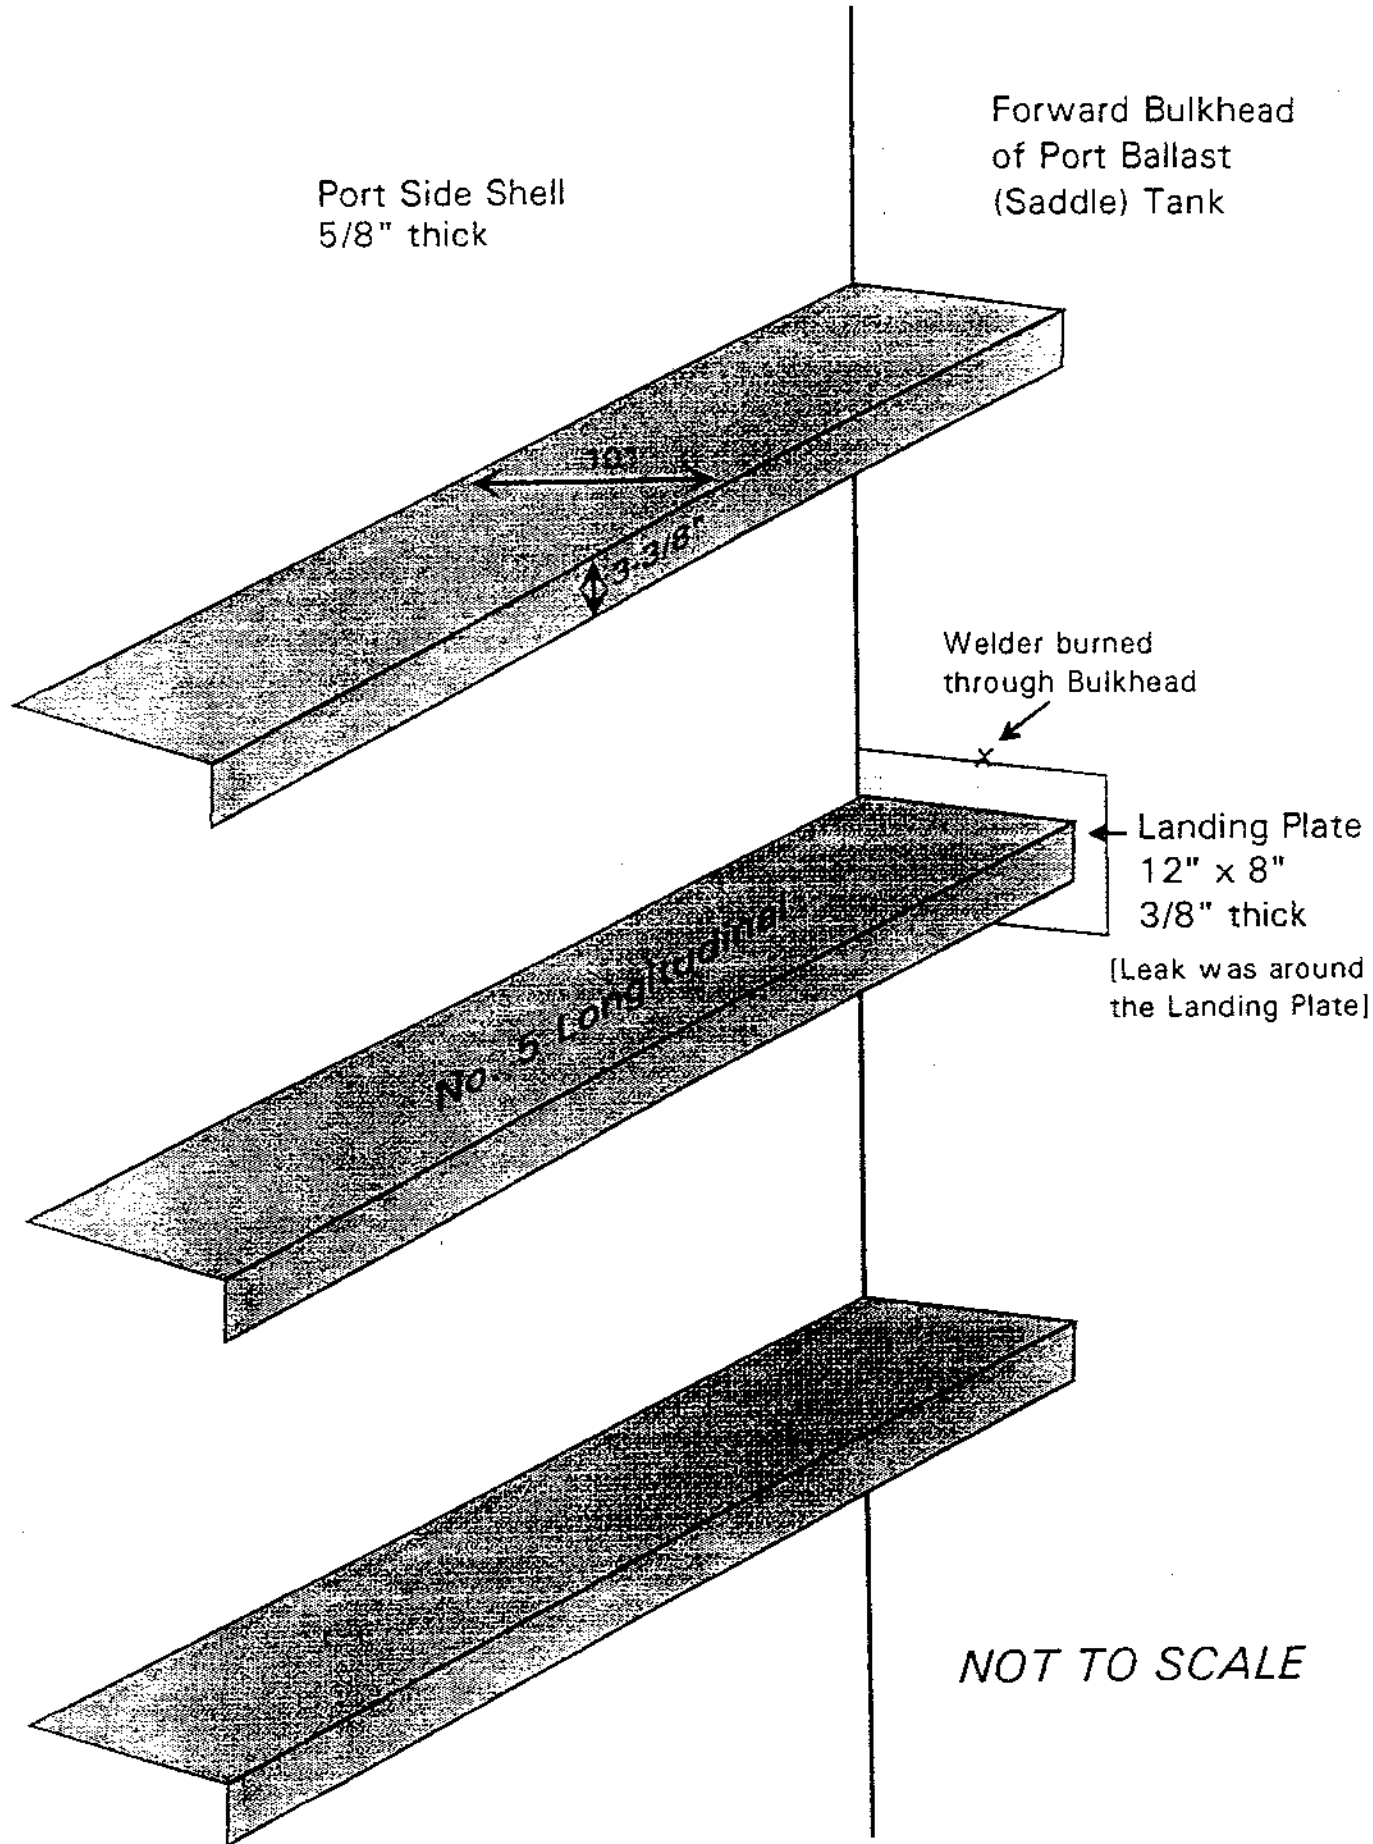
Figure 3, Location of Leak #3

24. At about 0800 October 2, the chief mate talked with the C. M. foreman, then entered the port saddle tank to further investigate the complaints. Using a gas detection meter he tested various locations in the tank without indication until reaching the outboard side of the tank, at the bottom, where the meter detected a rise in the percent lower explosive limit (%LEL). At this point the mate knew there was a problem, but still did not see any visual indication. Upon further investigation he noted a "weep" on the bulkhead adjacent to No. 5 port cargo tank, in an area around a 8 inch by 12 inch "landing plate," abutting one of the upper sideshell longitudinal stiffeners, which had recently been repaired in the shipyard. The chief mate informed the master, notified the C. M. gang to take their equipment out of the tank, and had a blower put over the manhole to ventilate the space. Meanwhile, the master called Mr. [REDACTED] on the cellular phone to discuss the latest development with respect to the leak discovered in the No. 5 port cargo tank "weeping" into the port saddle tank. Mr. [REDACTED] proposed to meet the ship in Tampa, because there was nothing they could do until the vessel discharged cargo. The morning of October 3, the chief mate checked the "weep" in the port saddle tank and determined it was not worsening, but the dampness had increased to about 3 feet below the weld, where the source seemed to be. No standing gasoline was found. Ventilation of the space continued with a copus blower over the manhole in the steward's storage locker and the butterworth opening on deck, port side, open.

See Figure 3, LOCATION OF LEAK #3

27. The "weep" in the saddle tank (leak #3) was also thought to be a bad weld from the shipyard, and the proposal was to simply reweld it.

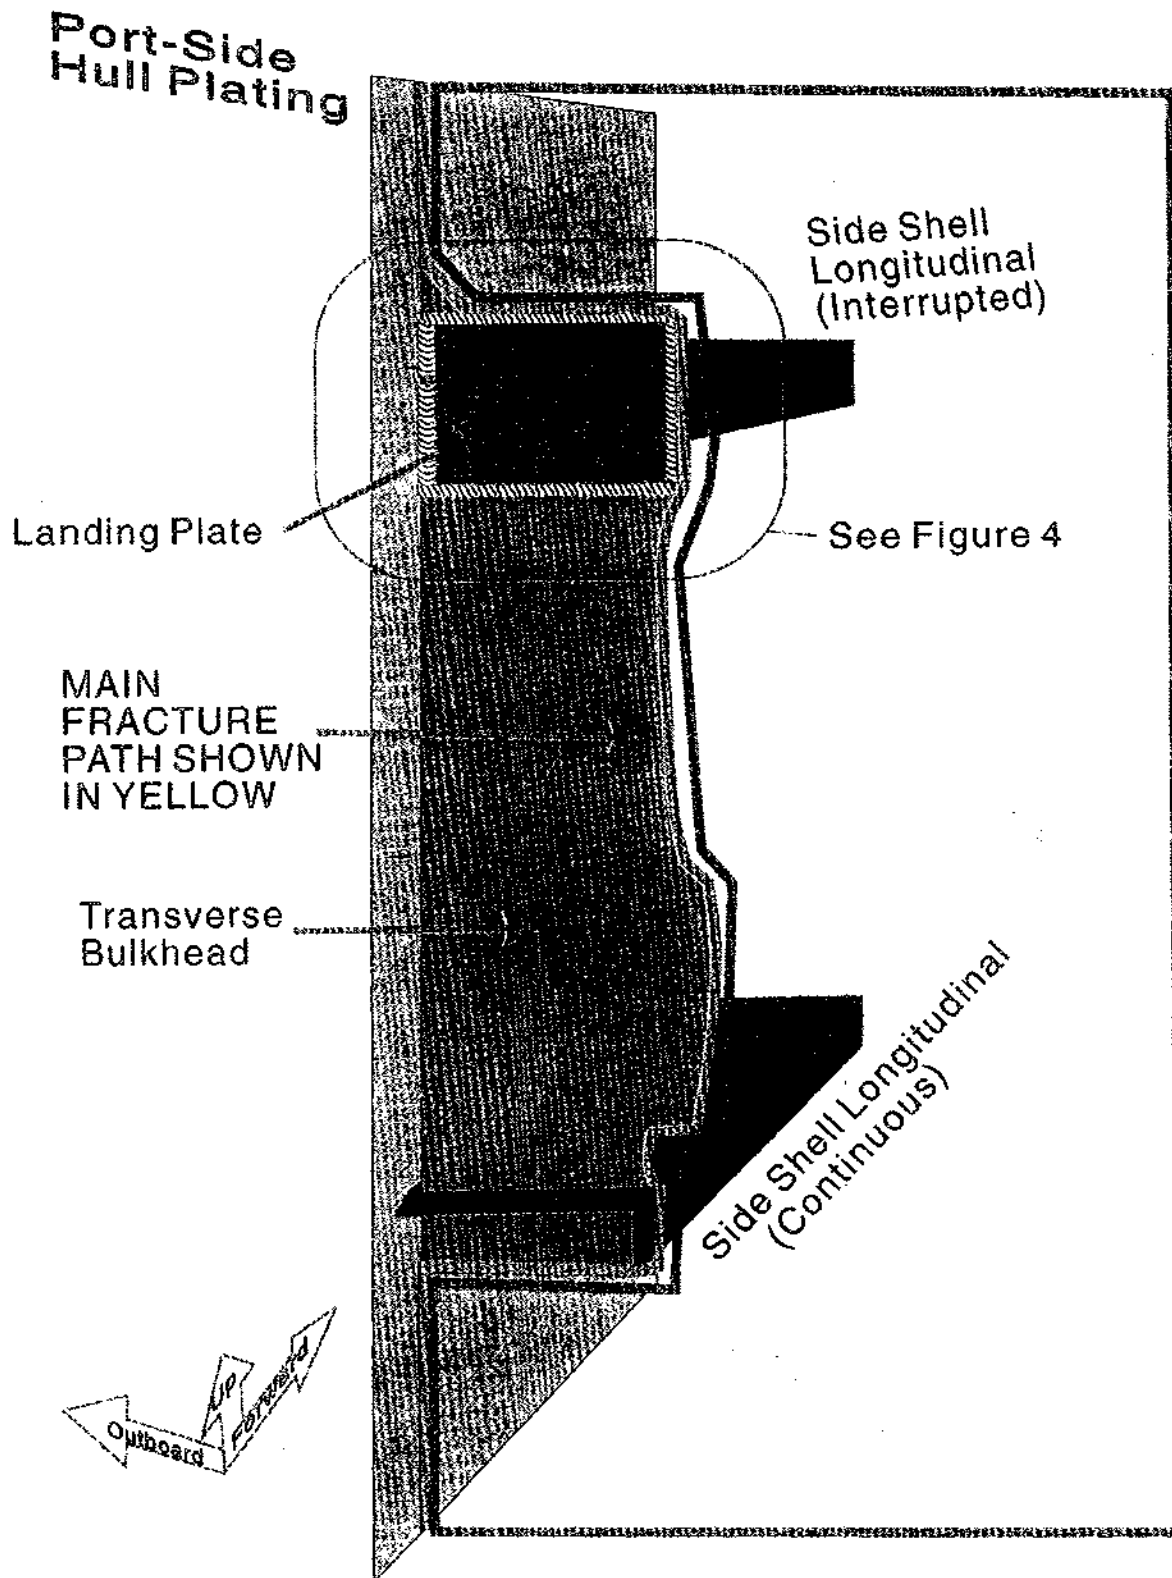
Figure 3 A drawing illustrating the arrangement of components. The main fracture path through the transverse bulkhead is denoted by the yellow line. The larger inboard piece of the bulkhead is shown as an outline for clarity. View is not to scale and shown without deformation.

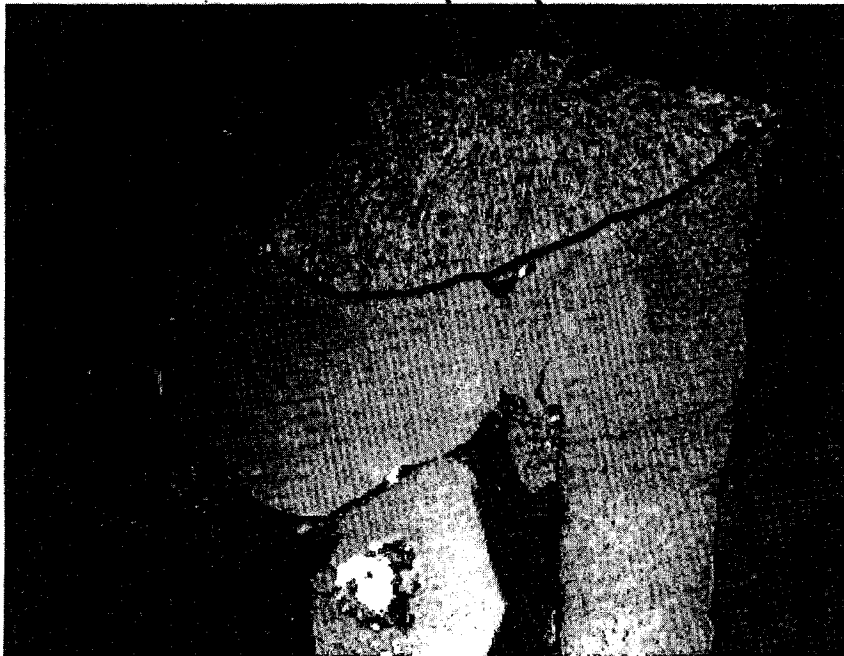
Figure 9 A 4X macrograph of a section through the top landing plate weld near the thin region showing the fissuring in the last weld bead. Also note that the fusion zone of the last weld bead, defined by the blue line penetrated through to the forward face of the bulkhead.
