### MARINE CASUALTY REPORT

SS SANSINENA (LIBERIAN) EXPLOSION AND FIRE  
IN LOS ANGELES HARBOR, CALIFORNIA ON  
17 DECEMBER 1976 WITH LOSS OF LIFE

U.S. COAST GUARD  
MARINE BOARD OF INVESTIGATION REPORT

REPORT NO. USCG 16732 / 71895

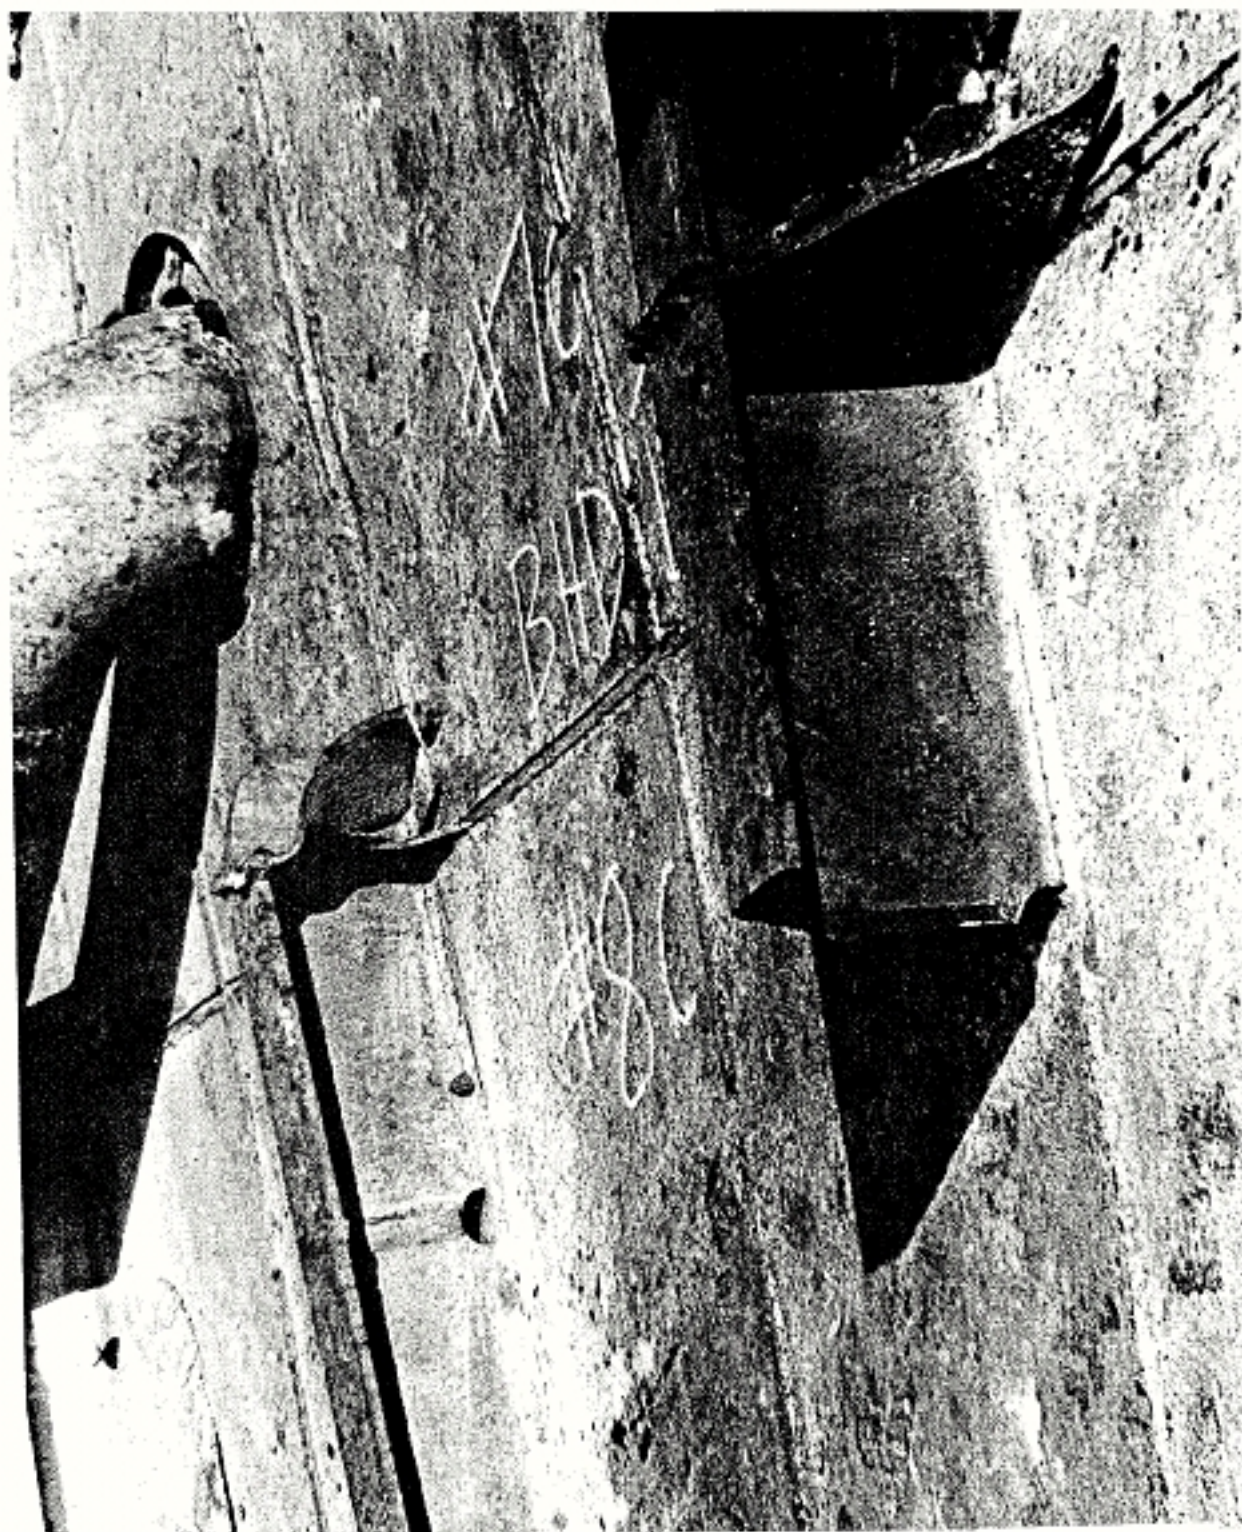
tank were bent forward, all abaft #10 tank were bent aft. (Figure 5.) There were no bits of the #10 longitudinal bulkheads left attached. However, a close examination of the broken continuous fillet welds along those bulkhead lines revealed that on the outboard sides the remaining welds were lower on average and were beveled outward from the bulkhead's former position, while the opposite broken fillets were higher and were slightly "hooked" toward where the bulkhead had been. (Figure 6 typical.) The bulkhead fragments indicated clearly the direction of bulkhead displacement. There were consistent findings that the beveled fillets were on the side toward which the bulkhead fragments were bent, with the slightly "hooked" edge higher on the opposite fillets.

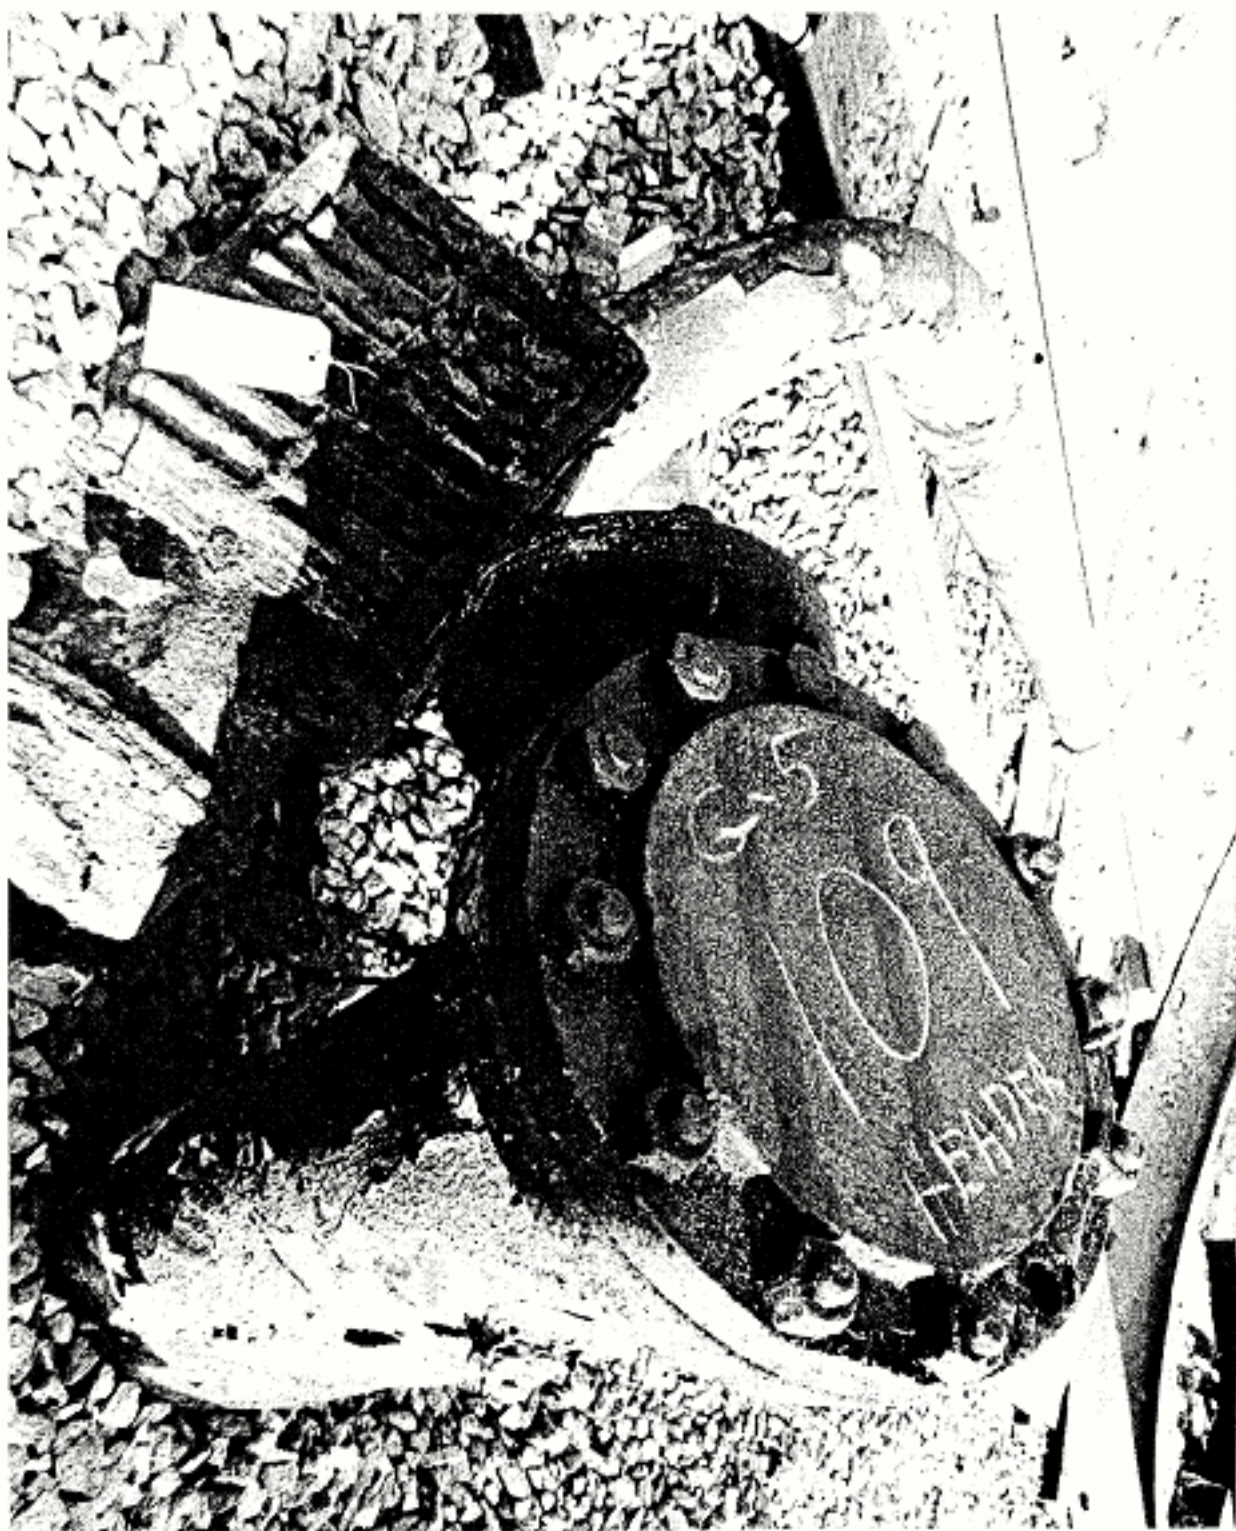
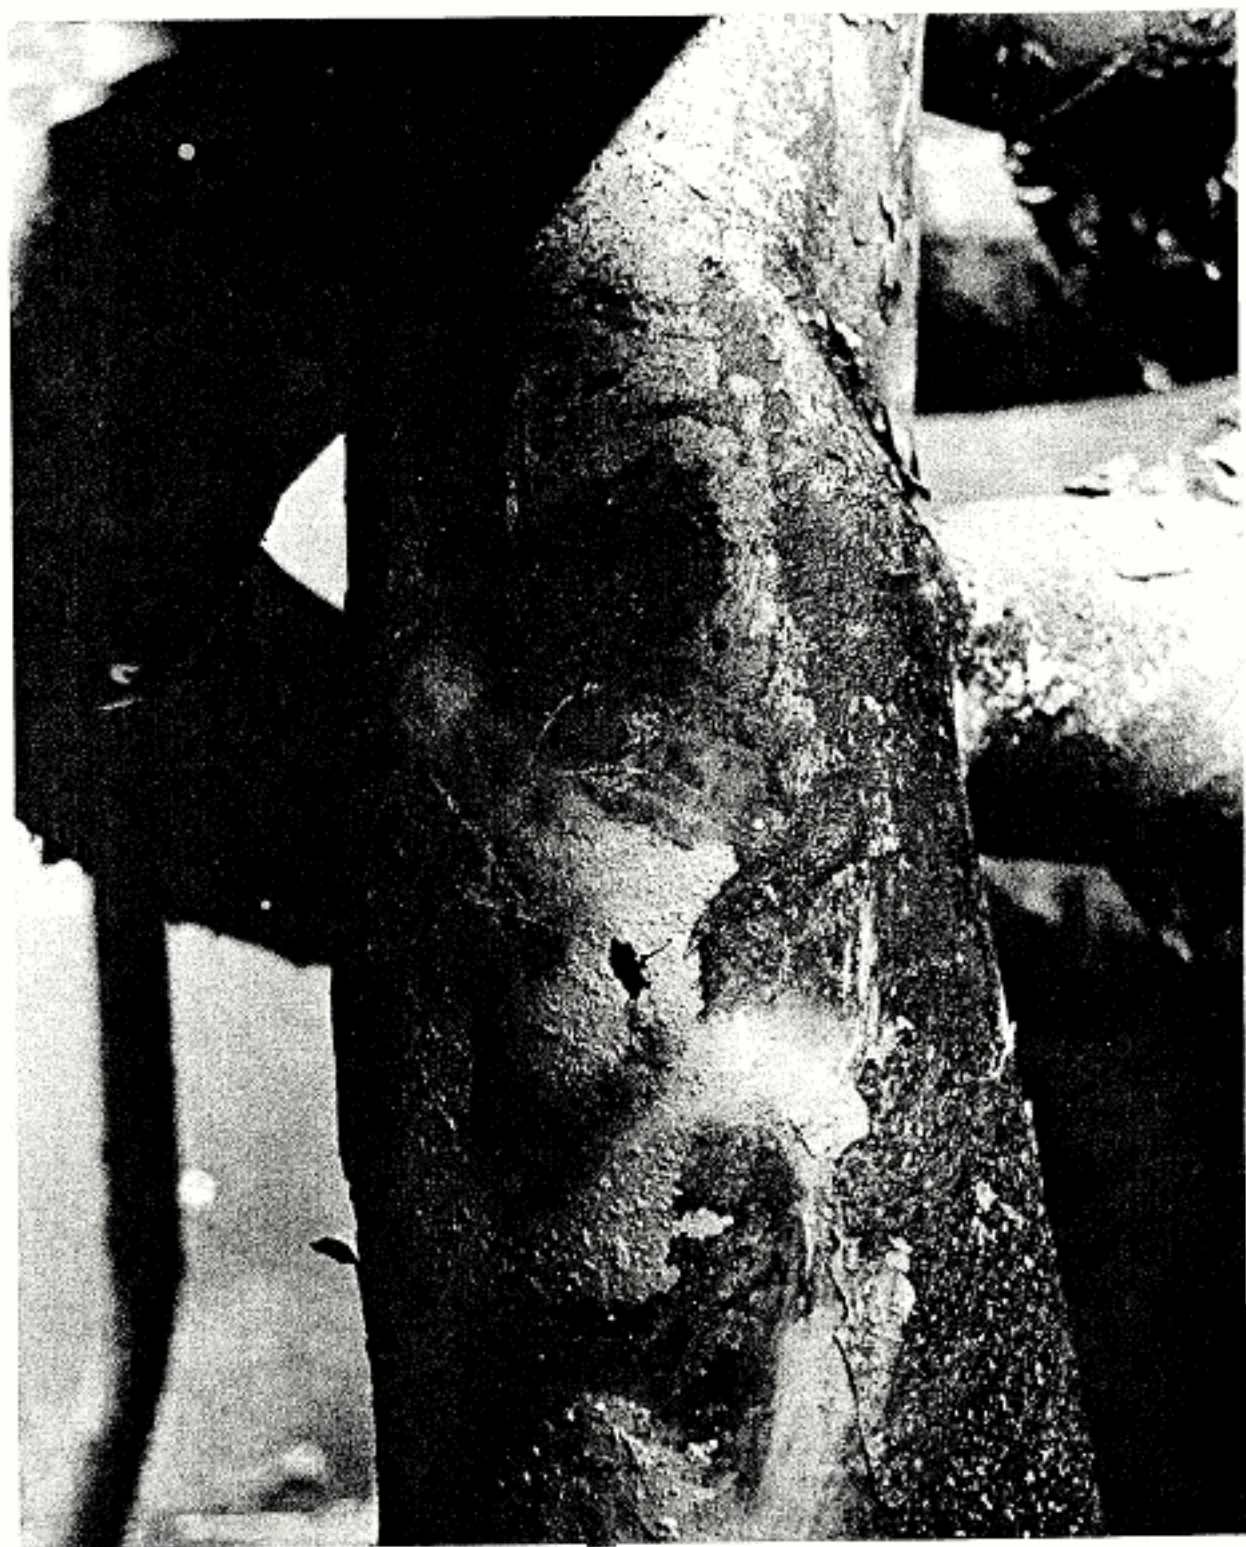
The integrity of the cargo vent system was compromised by numerous wastage holes on the underside of the cargo vent piping, a missing washout nipple cap, and a missing drain plug. The lack of integrity in the cargo vent piping further negated the dissipating effect of the weather head vent stacks at the top of the kingposts and contributed to the accumulation of hydrocarbon vapors on deck in the cargo tank area. The inspection procedures of the cargo vent system by the shipboard personnel, classification society inspectors, inspectors for the Government of Liberia, and company inspectors were inadequate to detect the relatively extensive deterioration that existed on the underside sections of the cargo vent piping. Furthermore, this lack of integrity allowed the vent piping to serve as a path of transmission for a flame to enter the cargo tanks.

d. Examination of pieces of the cargo tank vent piping, including the branch lines and the common header revealed numerous areas of localized wastage. Several pieces were found with holes wasted through on their undersides. (See figures 7 through 8 for examples.) Examination of the area surrounding these holes revealed that the holes were primarily the result of internal corrosion. Much of this piping had a very heavy buildup of exterior paint, as much as 1/8-inch thickness in places. Various samples of the cargo vent piping and a typical P/V valve were analyzed by the Aerospace Corporation in an effort to characterize the corrosion behavior. Generally, uniform corrosion of the bottom portion of the vent piping was noted to be at least twice and at some places up to four times the normally expected corrosion rate for galvanized steel in a marine environment. Further, localized deeper pits and holes in the vent header pipes in the vicinity of P/V valve connections were attributed to either galvanic action between the steel pipes and copper products from the P/V valves or action of a hydrochloric acid solution in areas of initial breakdown of the protective zinc coating. The analysis also concluded that the corrosion holes studied were covered by a thick external paint coating prior to the explosion.

6. The recommendation that every cargo venting system at an age of 10 years be surveyed to determine its material condition, including the removal of all P/V valves and audiogauging of the underside of the piping directly under the P/V valves is concurred with in part. The Merchant Marine Technical Division will conduct a detailed physical and metallurgical examination on a representative number of tank vessels in various trades over the next 5 years to determine needed inspection intervals. In the interim the program of examining tanker venting systems, which was initiated as a result of this casualty, will be continued. Also, the scope and interval of examinations to be conducted aboard tankers is being thoroughly discussed at IMCO and a proposal will be presented at the Plenipotentiary Conference
