16732/MC96000914

**FIRE AND GROUNDING OF THE TUGBOAT SCANDIA, O.N. D517785, AND
GROUNDING OF THE TANK BARGE NORTH CAPE, O.N. D591040, OFF POINT
JUDITH, RHODE ISLAND ON JANUARY 19, 1996, WITH MAJOR POLLUTION AND
NO PERSONAL INJURIES OR LOSS OF LIFE**

Subj: INVESTIGATION INTO THE CIRCUMSTANCES SURROUNDING THE FIRE
AND GROUNDING OF THE TUGBOAT SCANDIA, O.N. D517785, AND
GROUNDING OF THE TANK BARGE NORTH CAPE, O.N. D591040, OFF
POINT JUDITH, RHODE ISLAND, ON JANUARY 19, 1996, WITH
MAJOR POLLUTION AND NO PERSONNEL INJURIES OR LOSS OF LIFE

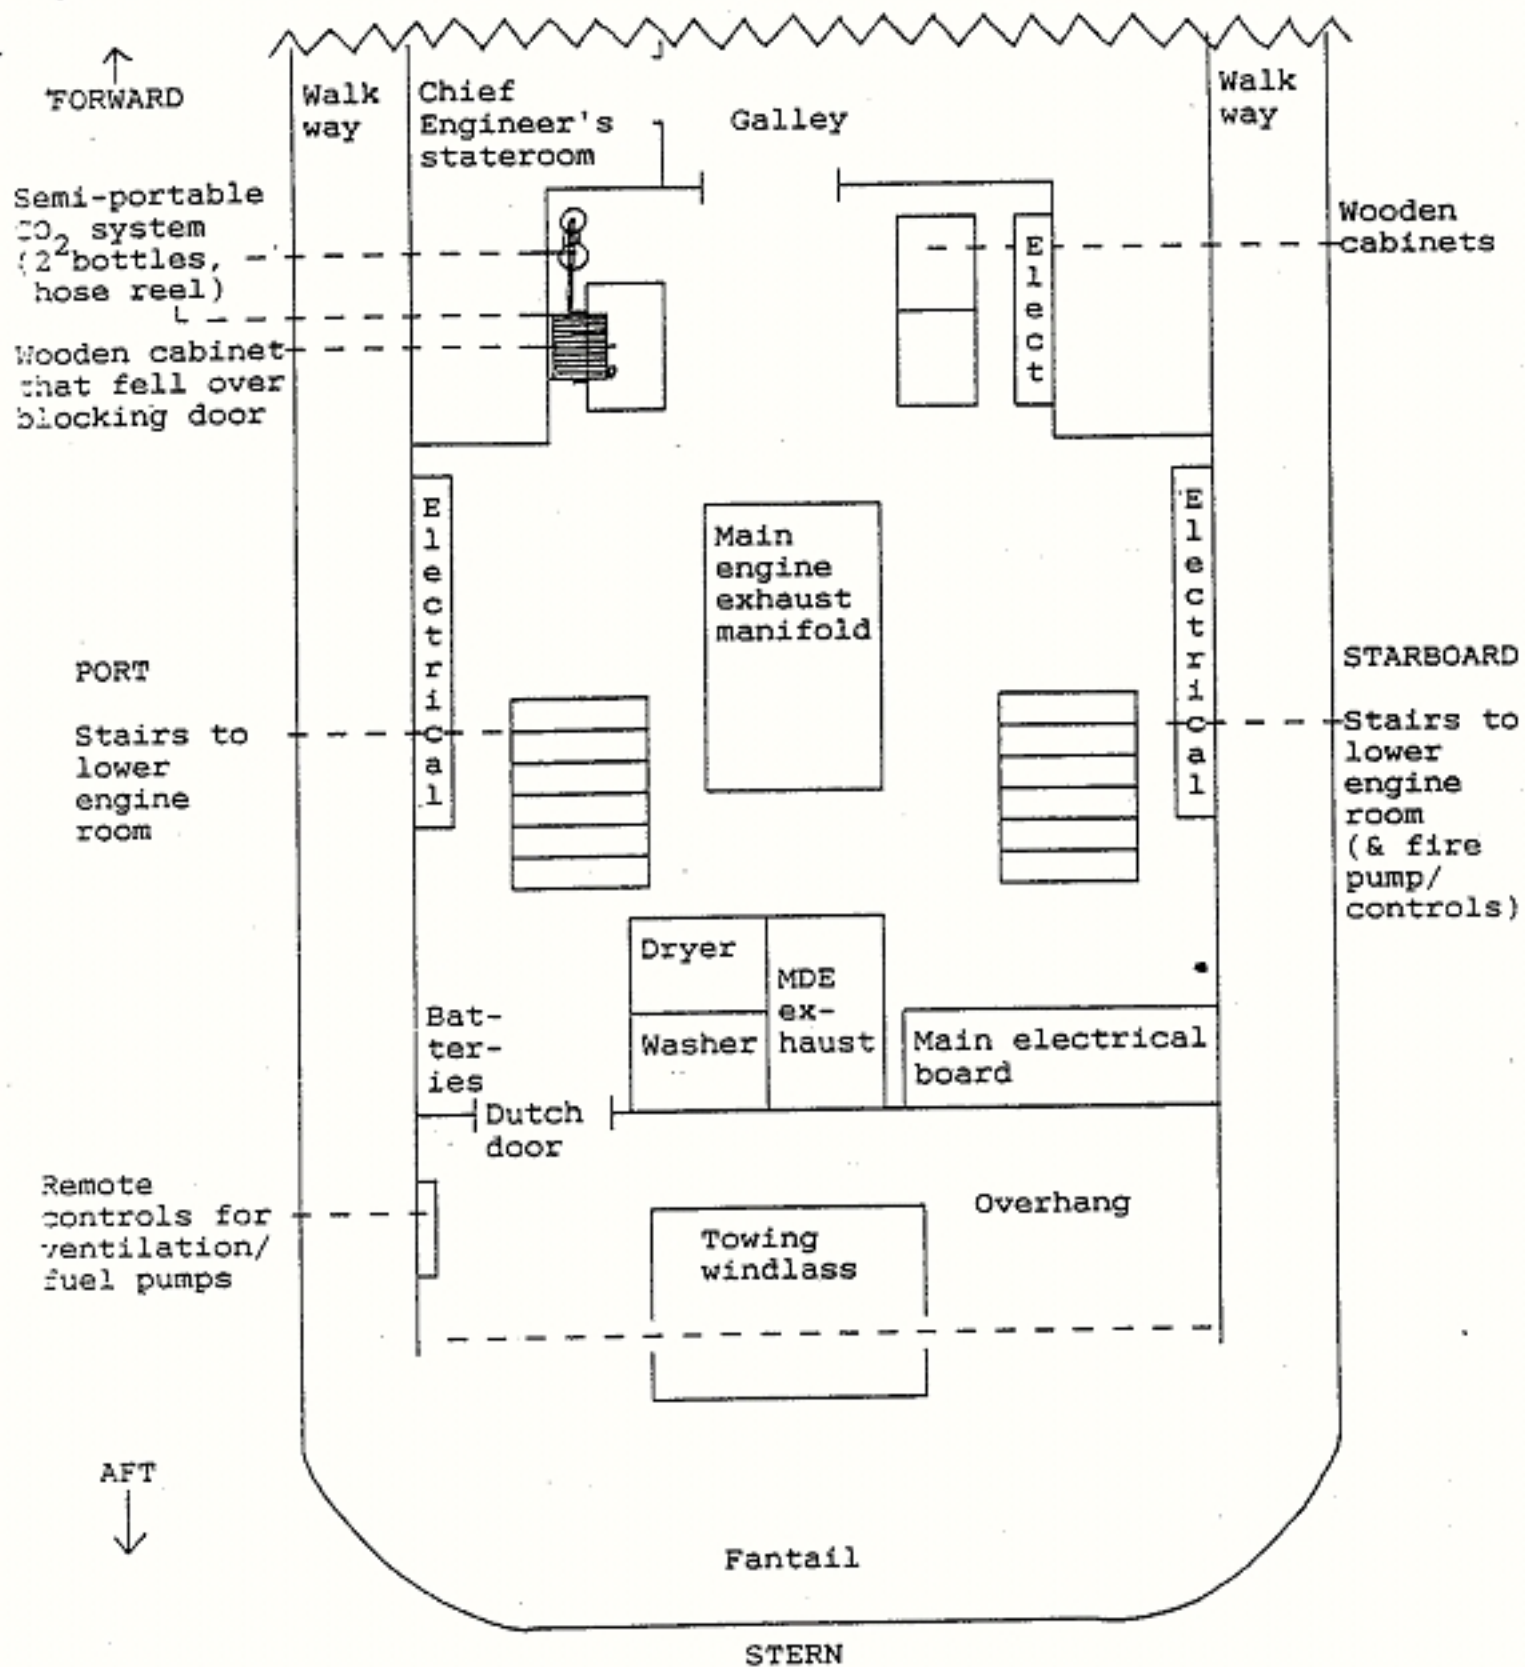
DIAGRAM OF THE UPPER ENGINE ROOM OR "FIDLEY" (not to scale)

The fidley space above the lower engine room was approximately 20 feet long (see following page for diagram of this space). The after 12 foot length was approximately 19 feet wide and the forward 8 foot length was 7 feet wide. The overhead was approximately 9 feet above the grating except immediately below

the stack opening. Two watertight dutch doors led to the main deck, one aft and one to port. A third non-watertight door led forward to the mess deck and galley. Flammable 1/4 inch sound proofing fiberboard covered the fidley bulkheads and overhead. Fiberglass insulation filled the 3 inch deep, 18 inch wide spaces between the bulkhead frames behind the fiberboard. Two open metal stairways, one port and one starboard, led down to the lower engineroom. Two 16 inch portholes were located, one each in the port and starboard fidley bulkheads. Combustion air to the main engine was through an 18 inch diameter steel pipe descending from the air-intake space aft in the exhaust stack casing through the fidley to the turbo charger in the lower engineroom. All other diesel engines used ambient air for combustion air. Ventilation for the engine room and fidley included electric exhaust and supply fans in the stack. Other openings to the fidley included gaps above and below the fidley/mess deck door (through which the smoke was first seen coming out of the fidly) as well as numerous non-tight pipe and electrical runs through this same bulkhead. Four foot square louvered exhaust ventilation ducts were on each side of the stack. Each was fitted with a dogged steel door damper. Ventilation supply steel trunks were located at the outboard aft corners of the stack deck. The air intake louvers installed inboard in these trunks had no closing apparatus. The deck grating and stair openings allowed free flow of air between the lower engine room and the fidley above.

All combustible materials in the fidley (as well as all other compartments on the main deck, stack deck and bridge deck) were completely consumed by the fire. The fidley/mess deck door was off its hinges, laying inside the fidley. Three expended portable fire extinguishers were also on the deck grating just inside the doorway. Spare diesel engine parts that had reportedly been stored in the three wooden cabinets were scattered over the deck grating throughout the fidley, several inches deep in places. All above showed considerable fire damage. The soundproofing fiberboard bulkhead and overhead covering had been completely consumed. Glass globes around light fixtures on the centerline were found melted and deformed. The

13. The presence of combustible, inadequately secured wooden cabinets in the fidley contributed to the crew's difficulty in fighting the fire.
14. Combustible materials used in construction of the vessel contributed fuel to the fire.

23. The master's failure to adhere to the provisions of the vessel's stability letter, specifically allowing the aft fidley dutch door to remain open, likely contributed to the escalation of the fire.
