**INVESTIGATION INTO THE CIRCUMSTANCES  
SURROUNDING THE FIRE ABOARD THE  
TANKSHIP**

**SEAL ISLAND**

**ON OCTOBER 8, 1994, IN ST. CROIX, U.S.  
VIRGIN ISLANDS, WITH INJURIES AND  
MULTIPLE LOSS OF LIFE**

**SS SEAL ISLAND, L7326130, ENGINE ROOM FIRE AT THE HESS OIL REFINERY,  
ST. CROIX, U. S. VIRGIN ISLANDS, CARIBBEAN OCEAN ON 8 OCTOBER 1994 WITH  
LOSS OF THREE LIVES AND SIX INJURIES**

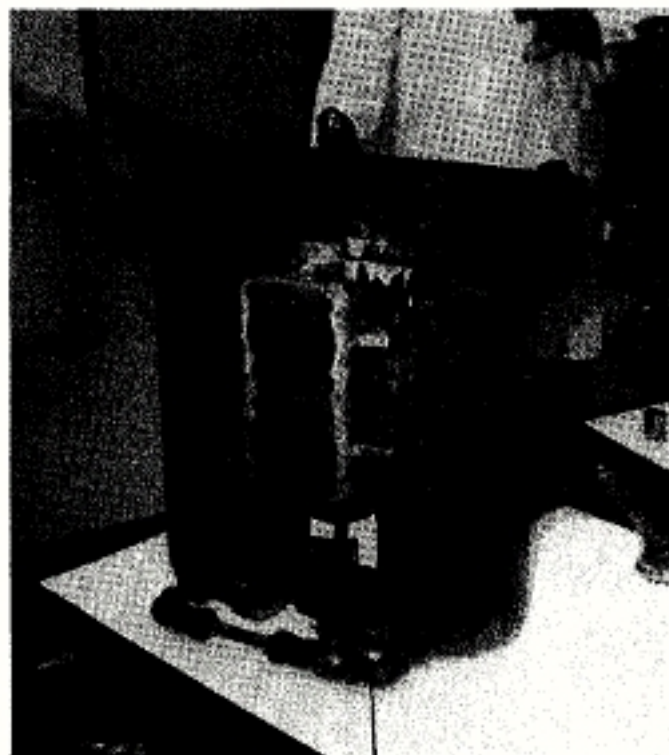
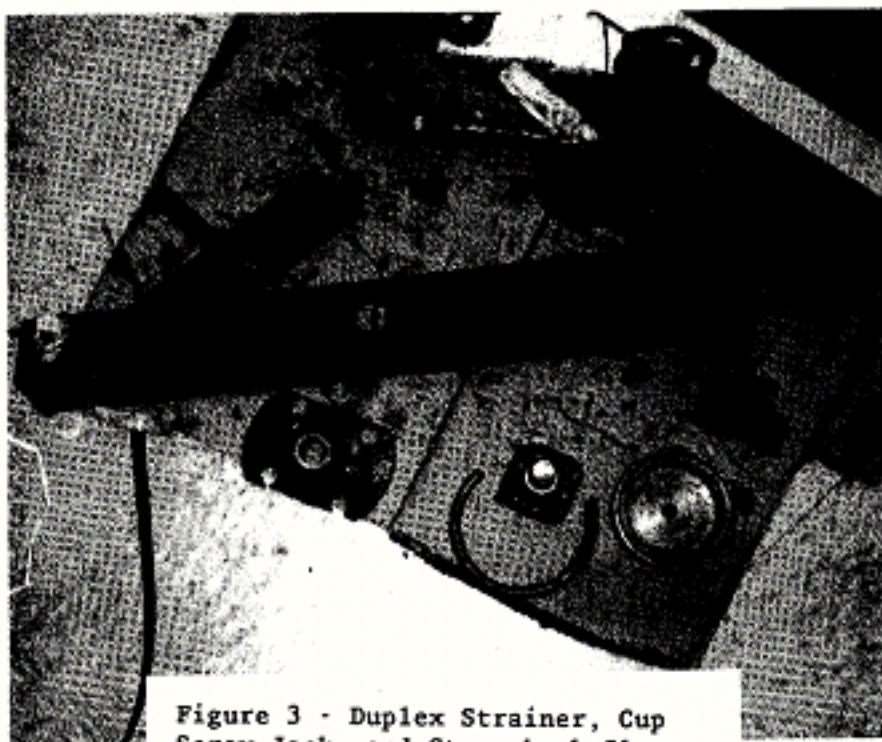
Figure 3 - Duplex Strainer, Cup  
Screw Jack, and Strongback Clamp

Under the first assistant engineer's direction, three of the crewmembers fabricated a cup with a gasket for placement underneath the bottom of the duplex strainer, where the directional control spindle valve exited the casing, to stop the leak. The crew also fabricated a screw jack made from a small steel plate which they welded to one end of a threaded stud. The free end of the stud (with nut installed) was placed into a pipe flange which held it upright. The cup was fabricated from teflon stock and was machine grooved around the circumference to accommodate the installation of an "O" ring. The center of the stock was machined out to accommodate the installation of the lower end of the directional control valve as it exited and extended over one inch below the casing. When the cup was in position, the nut was turned which raised the threaded stud and the small steel support with the cup, attempting to squeeze the "O" ring between the bottom of the strainer casing and the cup. The cup would not seat properly since the lower securing pin for the spindle valve on the duplex strainer was extending out.

On 12 June 1994, the crew made another cup out of brass stock. They placed the cup on the jack and raised it up until it seated tightly against the duplex strainer casing which effectively stopped the lube oil leak. At this time, the strongback clamp was still in place from the day before. The chief engineer also instructed the crew to make a third cup with a hole drilled out of the bottom so that a relief valve could be fitted. The cup was fabricated by the crew and stored in the lower control room but it was never used. (See Figures no. 3 and 4 which are photographs of the duplex strainer, cup, screw jack, and strongback clamp.)

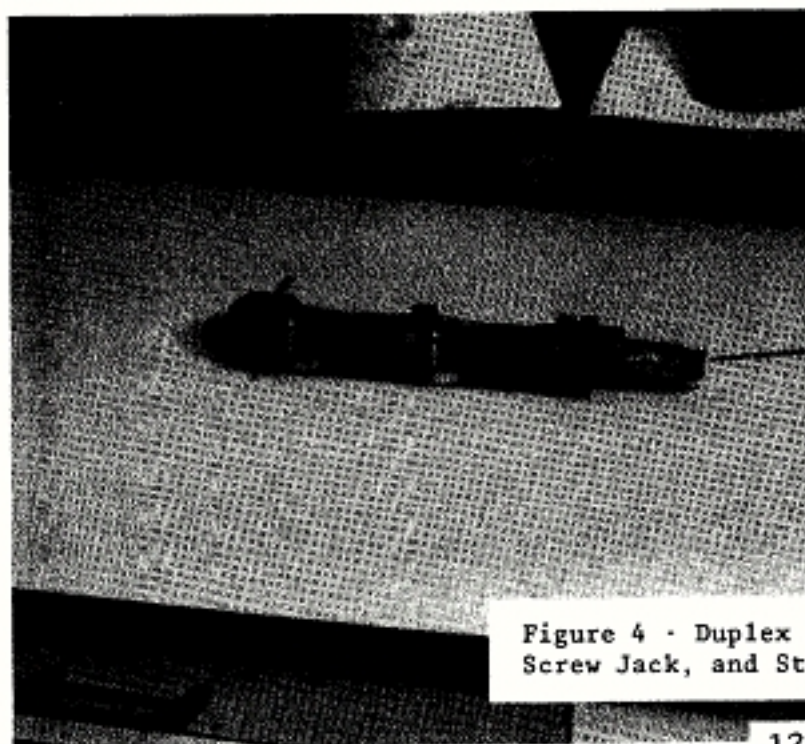
12

Spindle Valve Removed From Casing

\* Note 'O' ring on bottom and missing 'O' ring on top
