MARINE CASUALTY REPORT

SS WILLIAM T. STEELE; DEATH OF THREE SHIPS OFFICERS
AT GUAYANILLA, PUERTO RICO ON 18 NOVEMBER 1972

U.S. COAST GUARD
MARINE BOARD OF INVESTIGATION REPORT
AND COMMANDANT'S ACTION

REPORT NO. USCG/NTSB - MAR-74-6
RELEASED 26 SEP 1974

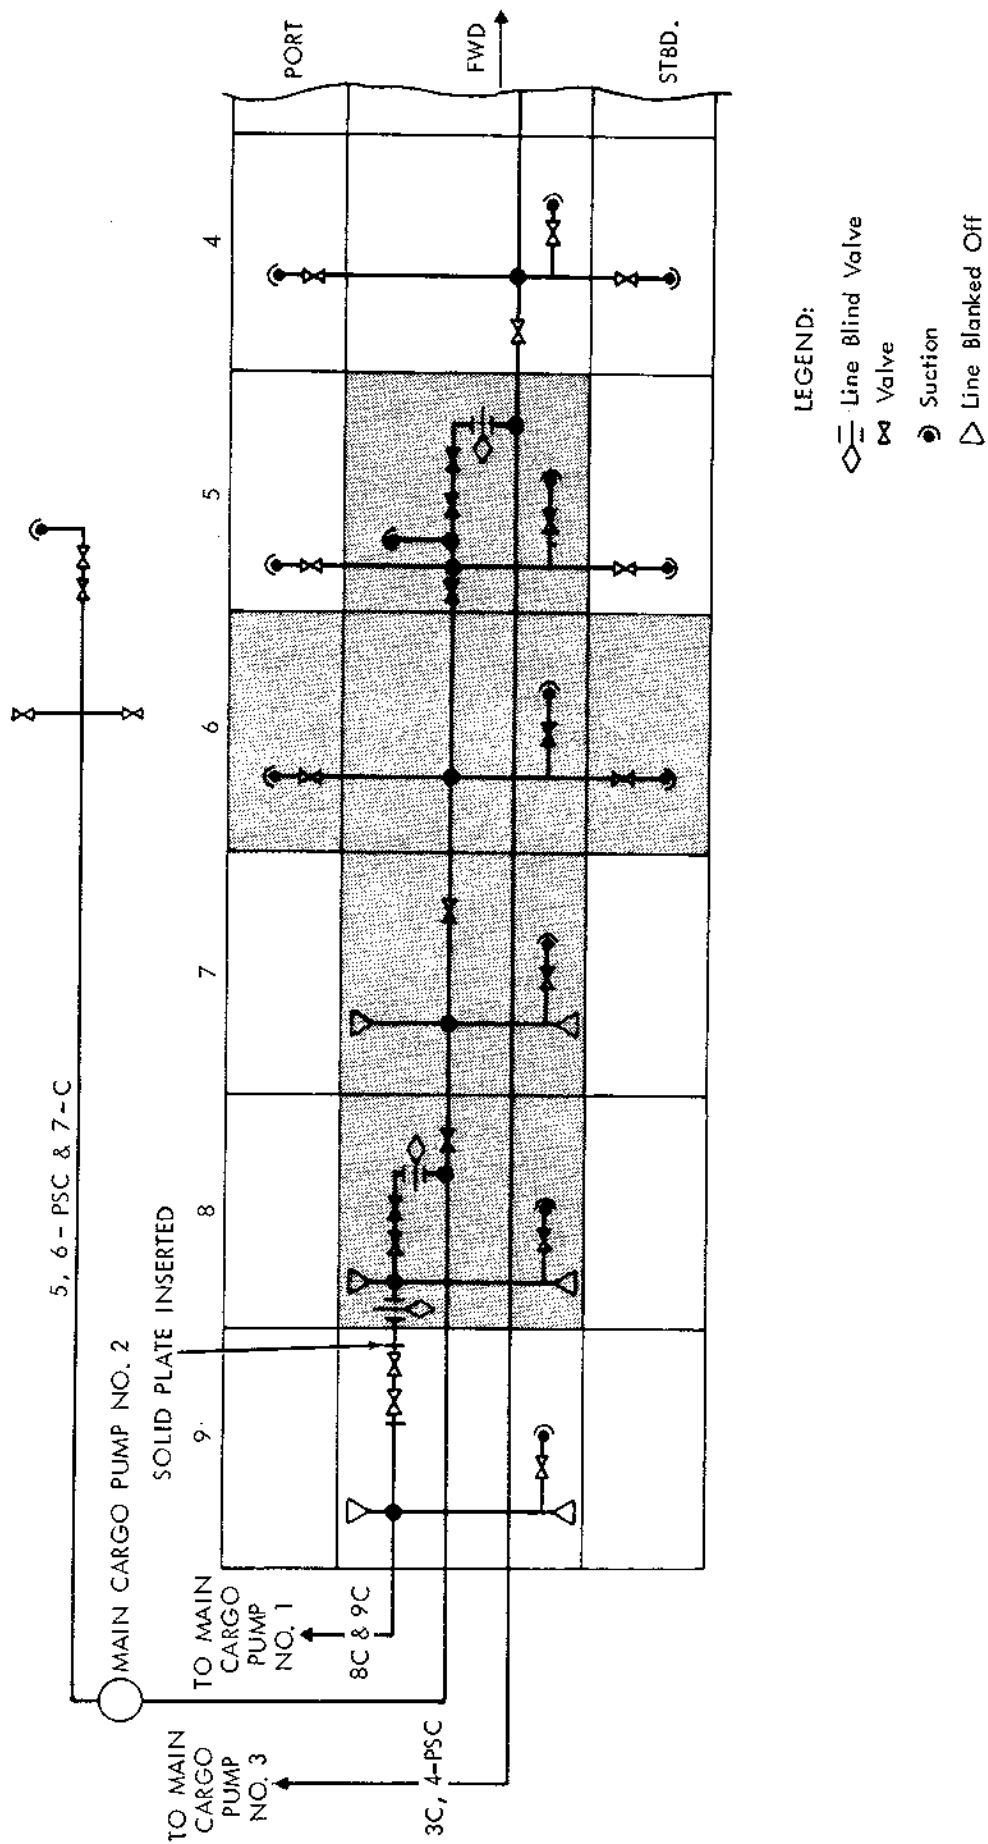
Figure 1. DIAGRAM OF CARGO PIPING SYSTEM
FOR TANKS 4-PSC, 5-PSC, 6-PSC, 7-C, 8-C & 9-C

Improper loading of cargo. Instead of distributing a cargo-loading plan to the crew or providing a checklist to assure that all valves and blinds were configured as planned, the chief mate issued verbal orders to the pumpman which specified only the setting of certain conventional and line blind valves. Because of his limited experience on the STEELE, the heavy workload, and the insufficient information regarding the desired lineup of cargo tanks to receive benzene, it is unlikely that the pumpman would have realized any omission in the chief mate's orders. The chief mate, on the other hand, without a checklist and probably fatigued from working more than 24 hours immediately before his death and from supervision of numerous tasks, was not prepared to supervise cargo loading adequately. These problems led to the oversight in not closing the line blind valve in the No. 8 center tank. (A diagram of the pertinent section of the cargo piping system, with shaded areas indicating the tanks originally intended to receive benzene is shown in Figure 1.)

Blinding the cargo line involved opening a flange to insert a plate in the pipeline carrying benzene. (An arrow points to this flange in Figure 1.) The two block valves in the No. 8 center tank, just forward of this flange, were closed. The Marine Board did not determine what precautions were taken to purge benzene from that section of pipeline. There could have been a considerable amount of benzene in the 12-inch-diameter pipe which would have leaked out once the flange was separated. Further, the two block valves were relied on to sustain without leakage the pressure head of benzene in the No. 8 center tank, which was partially loaded.

The chief mate decided to insert a plate between the flanges forward of the double block valves in the No. 9 center tank. In part, this decision was probably based on his prior success in similar blanking operations; insertion of plates between flanges was standard practice on the STEELE before the line blind valves were installed. In fact, the third mate testified that an experienced crewman using the proper shaped wedges could split the flanges, insert a blank, and secure the line without leaking more than 2 or 3 gallons of benzene. Thus, it appeared to be an accepted practice to allow benzene to leak into enclosed spaces where men were working.

Although benzene was leaking from the opened flanges, there were other possible sources of benzene vapor. The residual tank washings in the aft end of the tank may have contained benzene. The two block valves in the No. 8 center tank were not sufficiently tight to
