# PROCEEDINGS OF THE MERCHANT MARINE COUNCIL UNITED STATES COAST GUARD

### LESSONS FROM CASUALTIES

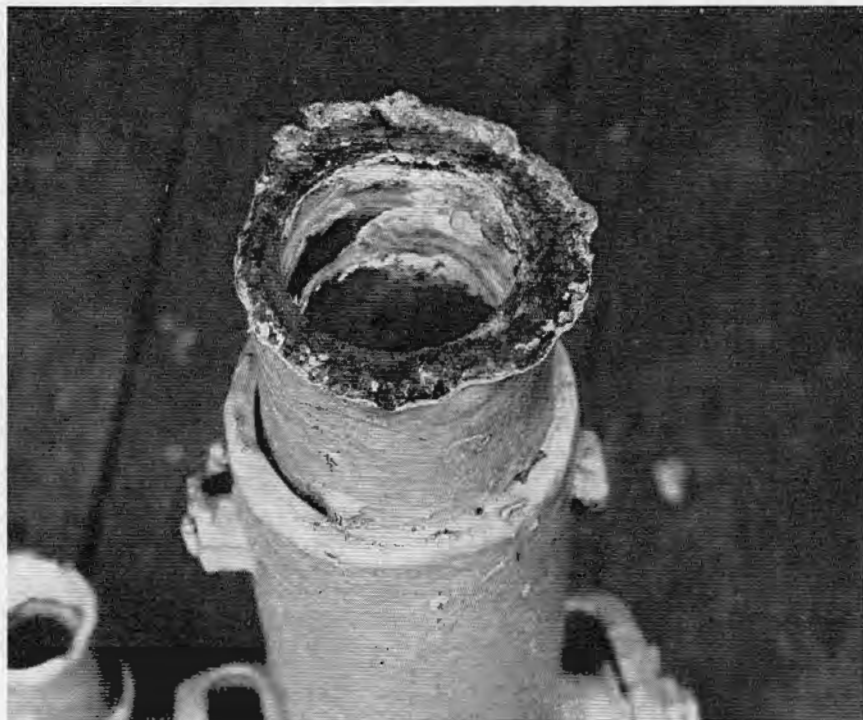
Figure 1.

Sudden death came to an electrician sent aloft to repair a light on a mast when part of the mast fell off, and the workman plummeted to the deck over 40 feet below. It was a very special type of light and mounted in a very special way. The light was an aircraft warning light installed on a piece of 2-inch steel pipe. This pipe, as a standard for the light, was arc welded to the top of a brass dome which served as the cap on the aftermast. The cap itself was a half round brass casting.

The electrician, a man with approximately 20 years' experience in shipboard work, ascended the aftermast in order to disassemble the light. Upon passing the height of the cap, he fastened his safety belt around the steel pipe standard and leaned back against the belt to start the disassembling job. Immediately, the weld between the brass dome and the steel pipe failed completely, and the electrician and steel pipe fell to the deck. The man died almost instantaneously of multiple internal injuries.

While no data is available as to the type of welding rod used in attempting to weld the steel pipe to the brass dome, it is certain that the proper type of rod was not used and that the surfaces to be joined were not adequately or properly prepared. Examination of the ruptured surfaces indicated (see figure 1) the pipe was

In the above fabrication which failed, if the brass dome had been counter bored to provide a socket for the pipe, if the pipe had been chamfered to obtain proper weld penetration, and if the proper electrode had been used, the weld would not have failed as it did. Indeed, a proper silver or bronze brazing job on the above pipe and dome would have been a satisfactory means of joining the two members.

Welding dissimilar metals is a specialized job requiring specialized procedures. Don't guess on a job like the broken standard. It may be fatal.

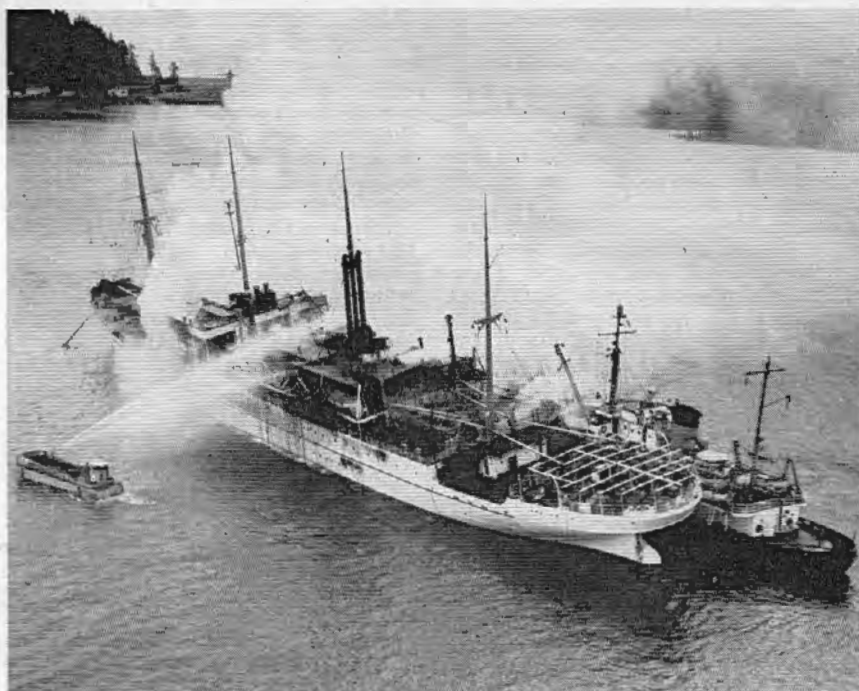
Figure 2.

A grim reminder of the terrible consequences of failing to have a crew trained to cope with emergencies occurred a few months ago when a foreign combination passenger-freight vessel burned at night in an American port. See figure-2. The deaths of 8 passengers and 3 crew members were directly attributable to the breakdown of the smooth functioning of the crew when it was presented with a disastrous situation for which it had been poorly trained.

With the ship at anchor in an open harbor, the fire apparently started in a maze of wiring, distribution panels, and ventilating and heating ducts installed in a 14' void space between the ceiling and the deck above it in the midship passenger and crew berthing area. Smoke was detected issuing from the paneling; the master was notified; but, no general fire alarm was rung or any positive action taken for several minutes. Consequently, dense smoke and darkness caused by the failure of several lighting circuits hampered subsequent fire-fighting efforts. Streams of water from the burning ship's fire hoses were played at the general overhead area. Passengers were aroused and directed to assemble at the smoking lounge on the upper deck. When all the passengers had gathered in the lounge, and were accounted for, the Master returned to the scene of the fire. By this time dense clouds of smoke had engulfed the entire midships area. Realizing that conditions were beyond control, the Master ordered abandon ship.

Investigation of this tragic casualty pointed up the deficiencies in the training of the vessel's crew to meet emergencies. Effective organization, instruction, and drilling of the crew had not been established or carried out. Many of the crew had not been thoroughly acquainted with their duties for emergencies. There was no clear cut indication by whistle signal or other means when the emergency organization should change from fire fighting to abandoning ship. There was no effective plan for the warning and safeguarding of all passengers. Abandon ship was a fiasco. Such organization as had existed seemed to vanish in the overwhelming holocaust of flame and smoke.

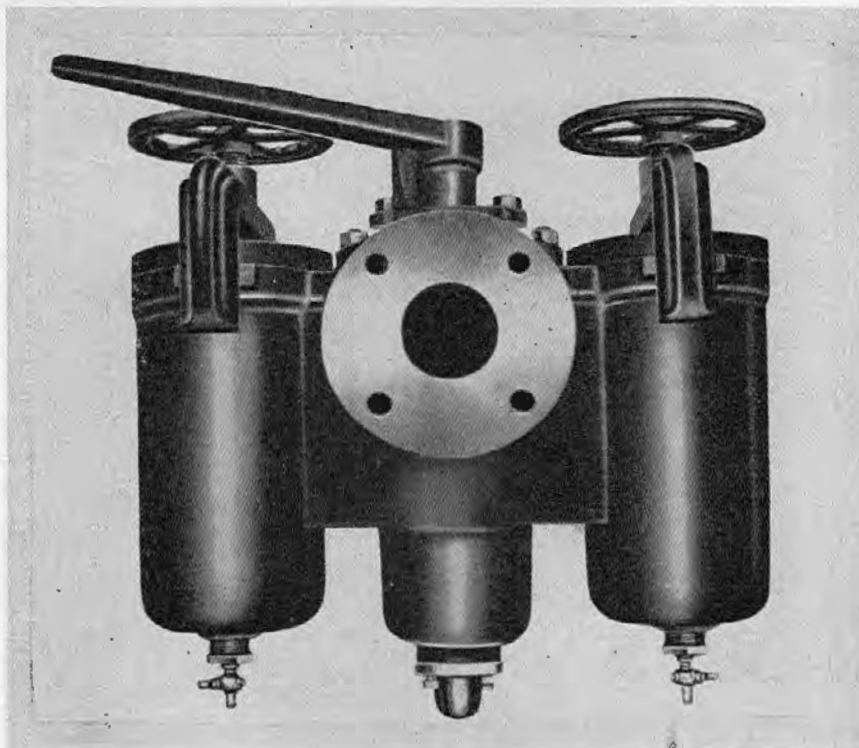
Figure 3.

The oiler and the third assistant engineer were performing a routine task of shifting lube oil pressure from one side of a duplex pressure strainer to the other, in order to clean the strainer which had been in use. This duplex strainer (see figure 3) was located in the lube oil system, just before the inlet to the starboard side of the engine, at the maneuvering platform level. Changing pressure from one side to the other was a simple process, consisting of using a box wrench, normally kept close at hand, on the 2-inch square plug at the top of the valve mechanism and making a 90° turn.

Originally the wrench referred to was fitted with an integrally cast tab or extension on one side, approximately under the shank, which, in turning, moved within a 90° arc cut into the neck of the valve body. By coming up against the limits of this 90° arc, this tab prevented the valve body from turning past the two points where the internal ports lined up to send oil into one strainer or the other. Otherwise, if the valve body were turned more than the 90° arc, and

over into the other 270°, the result would be a blockage of flow into either strainer.

Some enterprising soul, noting that the box wrench would fit nicely into a convenient slot in the floor plates if the tab was removed, had performed the operation, removed the tab, and set the stage for a nice big repair bill. And, so it happened at the time of the above casualty that the oiler on watch took hold of the wrench and threw it over through approximately a 90° arc. While it cannot be proved, the most logical conclusion is that he assumed he was moving from one strainer to the other, while he was actually moving from one strainer to the 270° arc, where lube oil was blocked.

bearings and Rotor thrust shoes were badly wiped; the H. P. Rotor bearings and thrust shoes were moderately wiped; the astern blading had rubbed, scoring the nozzle block and damaging astern blading and shrouding; the H. P. forward high speed pinion bearing was badly wiped; and there was other lesser damage. . . . All because someone had removed the tab from the wrench.

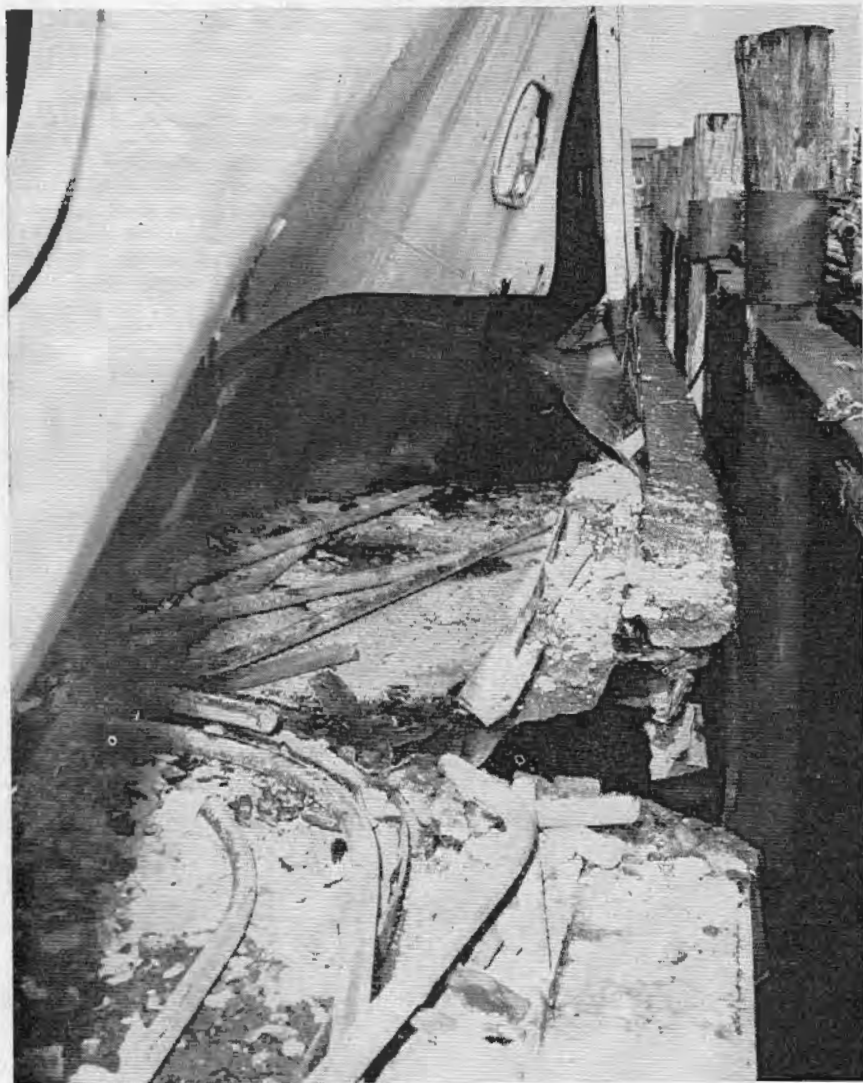
Figure 4.

Fortunately, in the collision which ensued nobody was injured, though one of the ferries (see figure 4) came out much the worse for wear.

Both ferries were engaged in their regular routine, traversing their regular run. Both had radar sets working competently; each had noted the other on the radar screen well in advance of the collision; each correctly assumed the identity of the other; and, each took some evasive action to avoid the other. Visibility was about 300 feet. Radar sets on both vessels were set on the 1½ mile scale.

Ferry No. 1 detected No. 2 dead ahead a few minutes after leaving its dock. No. 1 changed its course ½ point to the right. The relative bearing of No. 2 did not change, so No. 1 changed course one more point to the right. The bearing still did not change, so No. 1, which had been making standard cruising speed,

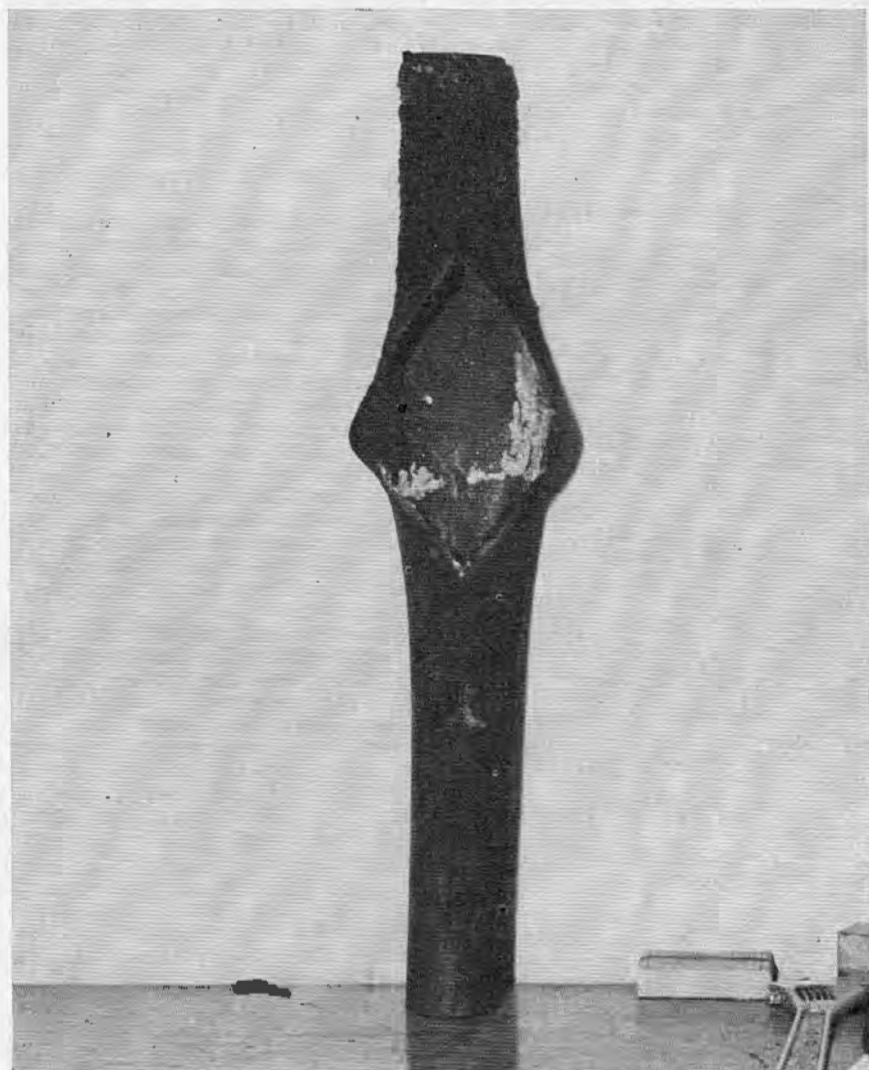
Figure 5.

The rapidity with which a boiler can be damaged when its water is low was clearly illustrated on the Eastern Seaboard recently as a Victory ship steamed slowly out to sea. See figure 5.

was discovered that the fifth water-wall tube in the front row of that boiler had burst. This tube apparently ruptured, due to low water and overheating of the metal, at about the time the Chief Engineer arrived in the engine room—whereupon the port boiler lost all its remaining water through the rupture—because before the furnace could be cooled, 22 other tubes were badly distorted due to overheating.

It is believed that a small leak developed in the fifth waterwall tube before it ruptured, causing the initial difficulty in maintaining sufficient water in the boilers. However, with proper surveillance by engineering personnel, a leak of this type is usually readily detectable. Operating on a normal working pressure of 525 p. s. i., a leaky water tube can set up quite an

The main propulsion should have been immediately slowed or stopped to cut steam consumption and the fires in the port boiler secured. Had this been done the power plant of this vessel probably would not have been lost. As is happened, the leaking port boiler required so much feed water that the water level was also low in the starboard boiler, and when the port boiler let go, the starboard had to be secured also, resulting in a most embarrassing and expensive blackout and a repair bill over \$5,000.
