PROCEEDINGS OF THE MERCHANT MARINE COUNCIL UNITED STATES COAST GUARD

March 1954

LESSONS FROM CASUALTIES

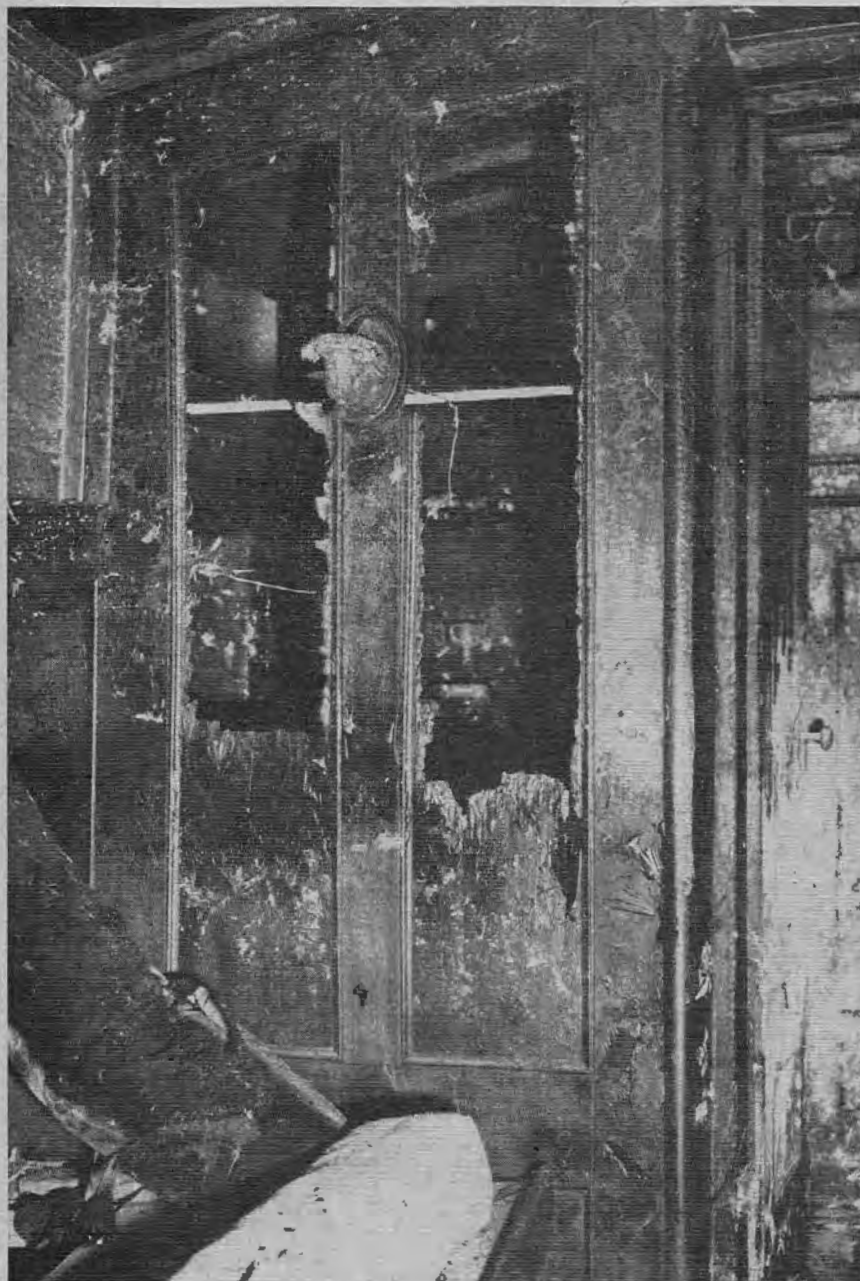
Figure 1.

It was certain that the spark for original ignition was supplied by the battery test circuit switch, and the fumes which exploded were undoubtedly from gasoline which had leaked from the generator fuel system. Subsequent melting of the plastic gasoline fuel line allowed a small stream of gasoline to run steadily from the gravity flow tank and feed the roaring flames. The lack of ventilation for the enclosed lower portions of the hull was probably the strongest contributory factor in the circumstances leading to this fiasco. Regardless of date of build, any owner of a motorboat using fuel with a flash point below 110° F., such as gasoline, should insure that the fuel tanks and decked-off portions of his hull are adequately vented to the atmosphere to remove any inflammable or explosive gases. Fuel piping should be of seamless drawn annealed copper tubing or the equivalent, never plastic hose or any other type of hose.

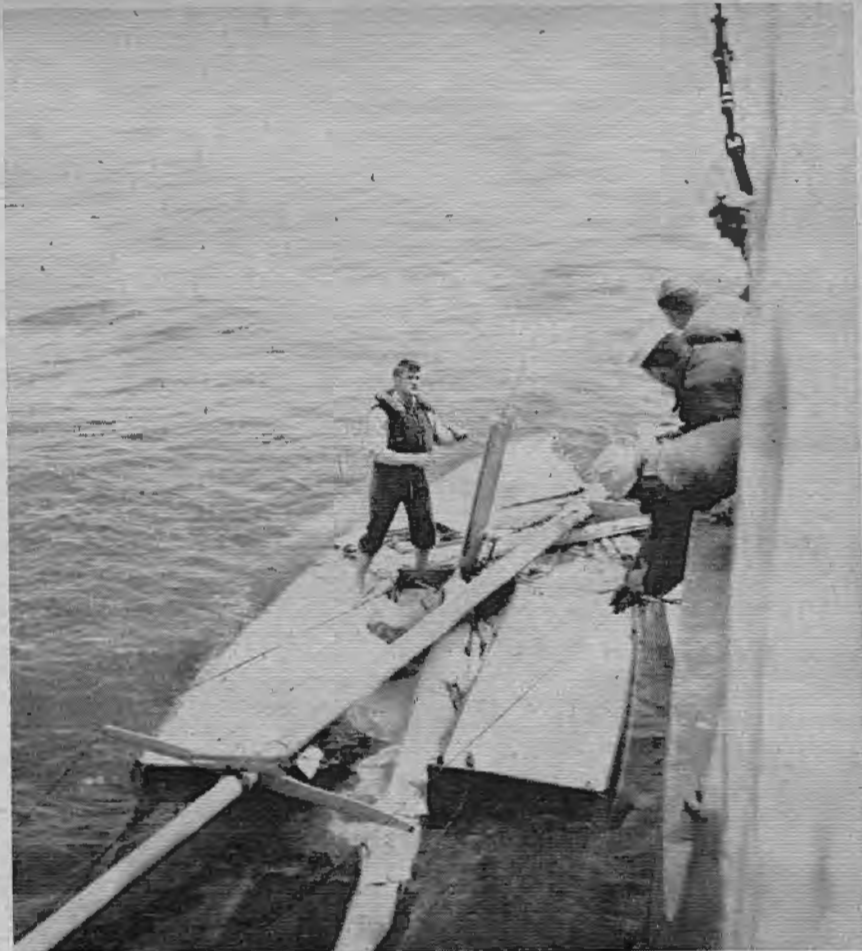
Figure 2.

Just what happened to convert a 37-foot auxiliary sloop to the wreckage pictured in Figure 2 will probably be never known and must be listed in the annals of the mysteries of the sea. Two intelligent and well-educated adults, inexperienced in boating but enthusiastic and willing to go cruising, purchased this 47-year old sloop and announced their intention to cruise it for a considerable distance up the coast in the early spring. This decision was met with dismay by the seller of the boat and other persons, and they strongly advised against the trip unless experienced yachtsmen were taken along. However, the new owners started out on the first leg of the trip. They neglected to affix to the bow the new number awarded to this boat by the Coast Guard upon change of ownership, and set out with the old number still showing. This neglect

When this vessel was purchased, some repair work had been done to the hull, but it is most likely that the 47-year-old wooden hull was in highly questionable condition for a coastal trip, especially in the early spring. This fact was well known to those who advised the new owners not to attempt the trip without experienced persons along. Aside from the questionable condition of the hull, the hazards of the trip, piloting, seamanship, heavy weather, lurking shoals and reefs, unpredictable currents and local conditions presented the amateur navigators with overwhelming difficulties

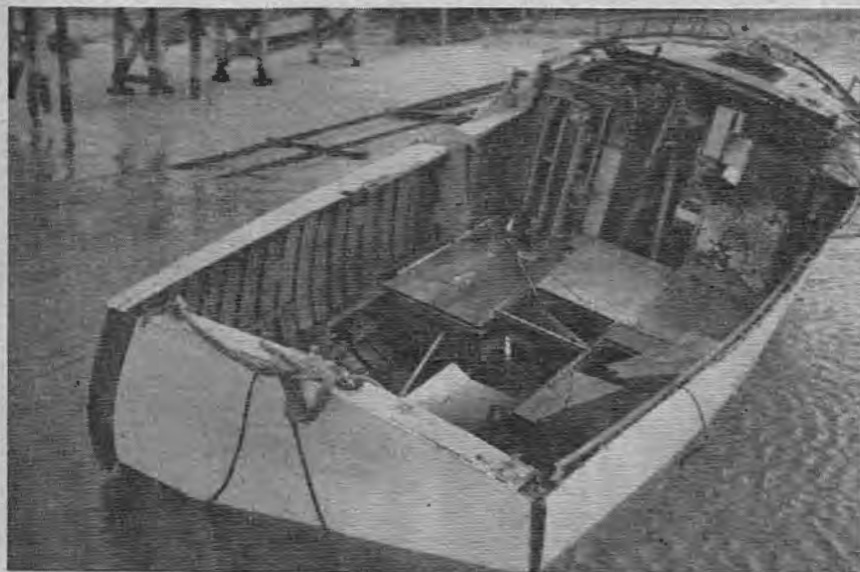
Figure 3.

A 30-foot party fishing boat (Figure 3) was severely damaged and its owner hospitalized for shock, second- and third-degree burns and injuries when the faulty carburetor on the boat's gasoline engine was continued in use. The owner had hired a mechanic to tune up his engine and overhaul the carburetor only a few days before. Although the mechanic installed new points and a new condenser and adjusted the carburetor, the owner was not satisfied with the carburetor and stated after the accident that he felt the carburetor should have been cleaned out and "soaked in a solution to remove all that scum in it."

Some of the motorboat's bottom seams had been opened by the blast, and the boat settled rapidly. However, after submerging to the point where all fire was extinguished, it stayed awash long enough to be dragged ashore and beached. While the owner-operator suffered painful burns and the financial loss of the damage to the boat and the hospitalization, he was fortunate indeed not to have lost his life. It is also a sure bet that this operator will, in the future, keep his engine and especially his carburetor in clean and efficient running order.

The importance of avoiding any condition tending to flood a carburetor in a gasoline-fueled motorboat should be obvious from the above casualty. Similarly the need for stowing or arranging life preservers in a location or locations on a pleas-

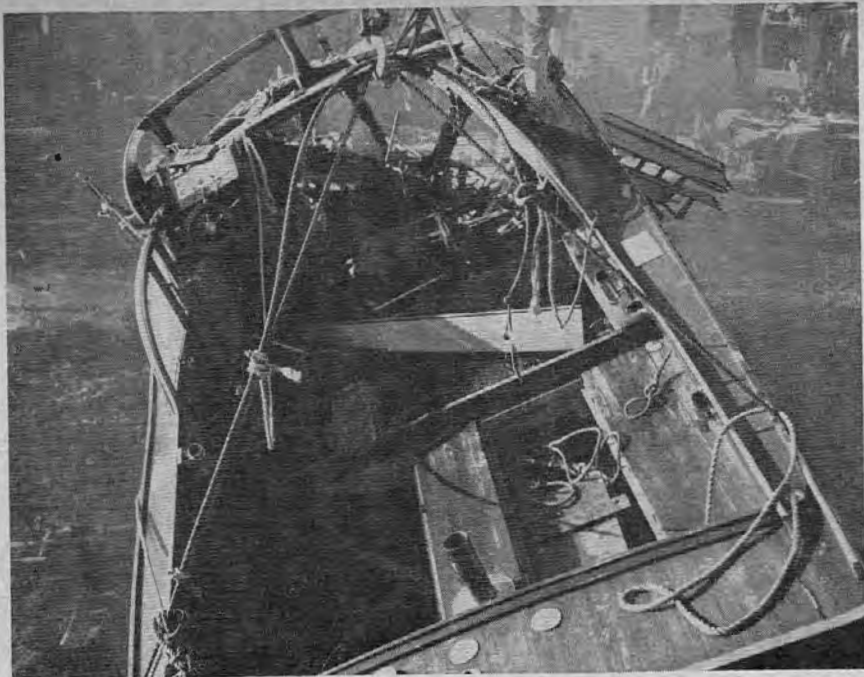
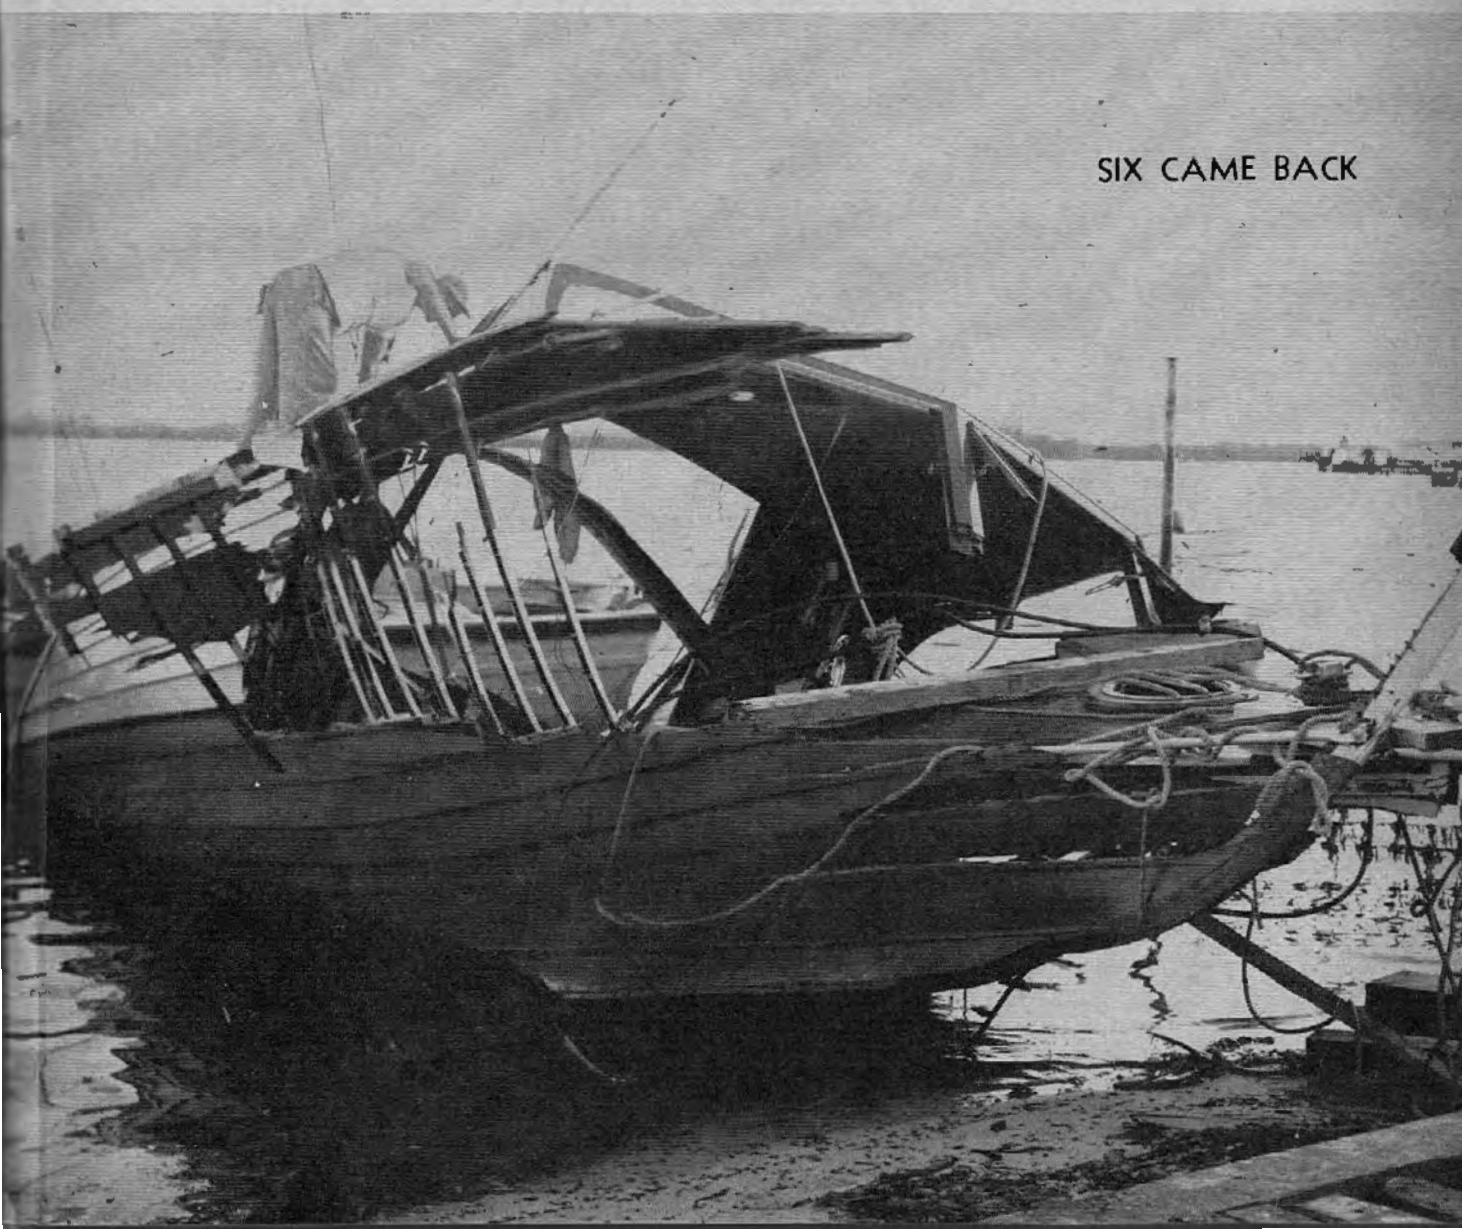
Figure 4.

A most unusual motorboat casualty in which a terrific gas-vapor explosion shattered a deluxe runabout but did not seriously injure any of the 6 occupants is vividly portrayed in Figure 4 and on the front cover. This boat was so completely racked and torn by the force of the blast that it is almost unimaginable that, of the 6 persons aboard, including 2 women and a young boy, none was fatally injured. Built only 5 years before, the runabout was well constructed and sturdy but had 1 grave defect. The enclosed spaces of the hull, other than the engine compartment, had no ventilation. An electric blower system ventilated the engine space, but the ventilation ducts did not lead down to the bilges.

The runabout was completely shattered forward of the cockpit and was severely damaged aft of the cockpit—a total loss. It sank at the dock, but the depth of water was small, and the wreck could be easily hauled out. Extensive investigation and analysis led only to the conclusion that gasoline had leaked from the fuel system, probably from the newly installed fuel tank, and had run into the bilges in the forward end of the boat. Therefore, when the ignition system was activated at the time of the explosion, the forward bilges were probably loaded with a gas-air mixture equivalent in explosive power to many pounds of dynamite. The lack of any ventilation for the forward bilges and the lack of vent ducts from the blower to the engine bilges created a highly hazardous situation which would lead inevitably to disaster. The gun was loaded.

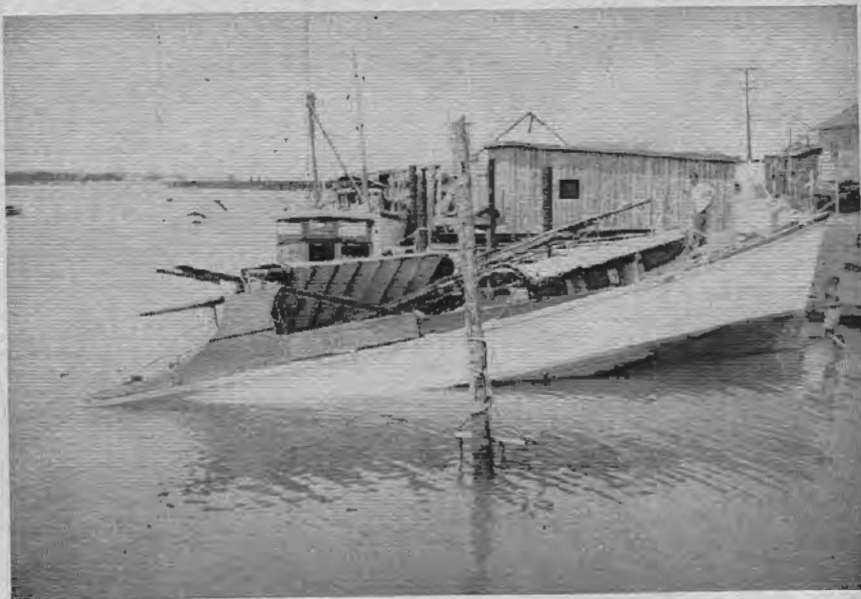
Figure 5.

bear. They got lost, ran aground, claimed to have been lured ashore, almost capsized, were pulled off and taken in tow by the Coast Guard; their boat exploded and almost sank, and was finally beached at the repair yard (see Figure 5) in badly damaged condition—all in the space of about 12 hours. The group had originally planned to make the harbor entrance at their destination before dark, but engine trouble delayed them several hours en route, and they found themselves searching for any buoy or recognizable landmark along an unfamiliar beach long after sunset.

As the vessel was not settling too badly, the tow was continued while first aid was given to the occupants who were suffering from shock and minor burns. The tow was safely completed, and the dismantled sloop was beached at a repair yard in a safe harbor. Examination of the port electric blower showed it to have had several vanes rusted off, or nearly off, leading to the conclusion that a contact between the metallic parts of the blower had supplied the spark which ignited the fumes.

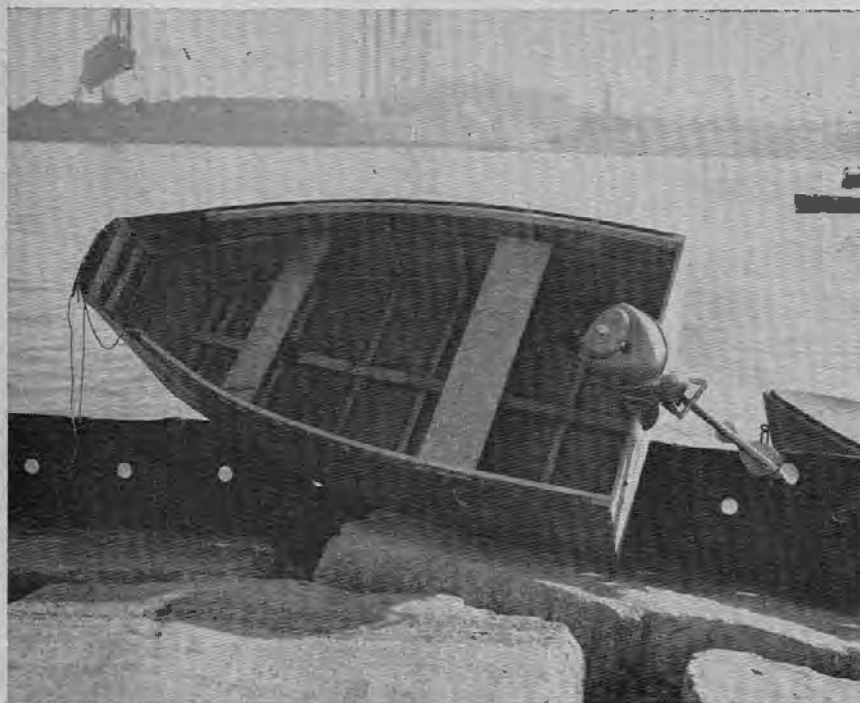
Figure 6.

As fantastic as it may seem, there were 4 persons in the tiny craft pictured in *Figure 6*, traveling at a speed of better than 15 m. p. h. when catastrophe struck and 2 of them drowned. Two small boys, aged 9 and 11, lost their lives due to the reckless operation of this little punt, home made, lightly constructed, and terribly inadequate for the safe carriage of 1 person at high speed, not to speak of 4 persons.

A rule of safety which could save many lives in high speed outboard motorboat cruising would be the requiring of any occupant who could not swim to wear a life preserver while underway. The record of casualties in this country indicates an alarming increase in lives lost due to reckless, ill-considered, and imprudent operation of outboard motor boats, usually craft with too much power. "Forewarned is Forearmed." Don't let it be you.

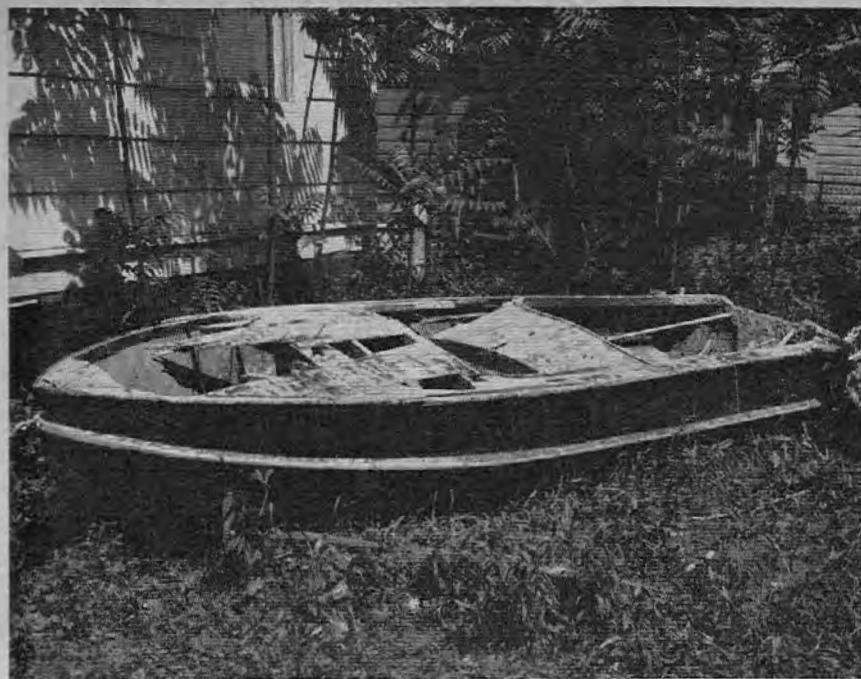
Figure 7.

warning by their friends must be condemned in hindsight, the most pertinent factor which led to loss of life was their failure to wear lifejackets.

If prudence ever dictated the wearing of lifejackets in the teeth of danger, this was certainly the occasion. It is tragically true that this lesson is so often clear only after disaster has struck, and the young lady of the above case will never again have to be convinced of its importance. Lifejackets require a minute or so to put on and to adjust properly. When small vessels start to capsize, swamp, or sink, it is already too late. A feeling of reluctance to wear a lifejacket before catastrophe has struck may be modish, but is contrary to common sense and the instinct of self-preservation.

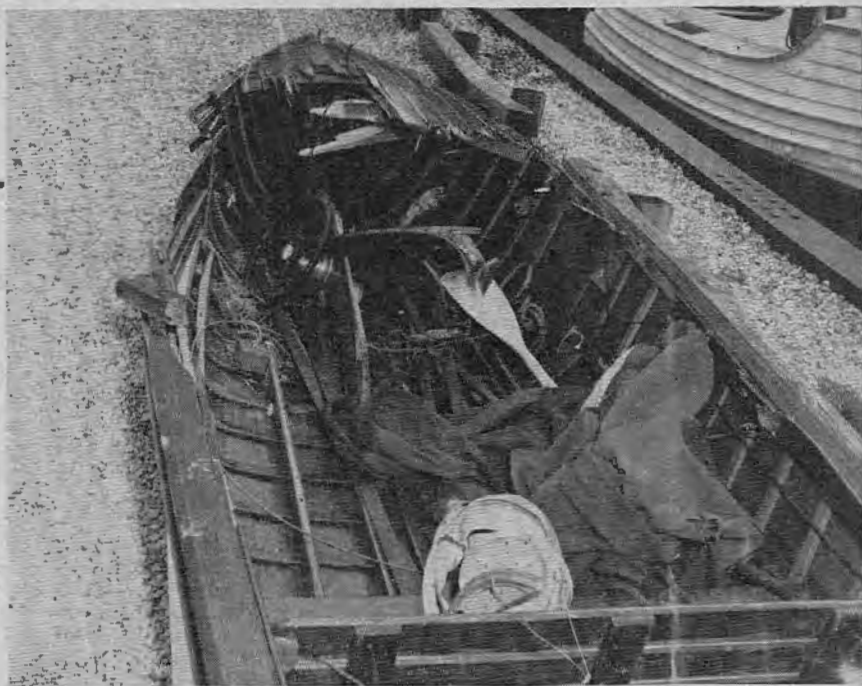
The substitution of mechanical and electronic devices for any of the practices and precautions of good seamanship may lead to a disaster such as encountered by the outboard motorboat pictured in Figure 8. This small pleasure craft was run down by a high-powered 45-foot twin screw cruiser which was under the control of an automatic pilot at the time. Two men suffered a horrible death

The principal cause of this sad episode, was directly due to the failure of both vessels involved to keep a proper lookout. This failure was not as serious on the part of the outboard motorboat operator, as he apparently saw the other craft before the collision and attempted to take evasive action. Such lookout as was kept on the cruiser was utterly useless, as this craft plowed right into the outboard without any change of course or speed. It is an anomaly of human nature that ordinary intelligent human beings, who would not dream of driving down a busy street without keeping a sharp and alert lookout for other cars, will go out upon the water in a powerful boat which is far less capable than a car of stopping quickly, and completely relax their alertness, sometimes keeping no lookout at all. Granted that a pleasure boat is one of the better places to relax and enjoy oneself, still the devastating power and terrible suddenness with which moving vessels can come together must never be forgotten.

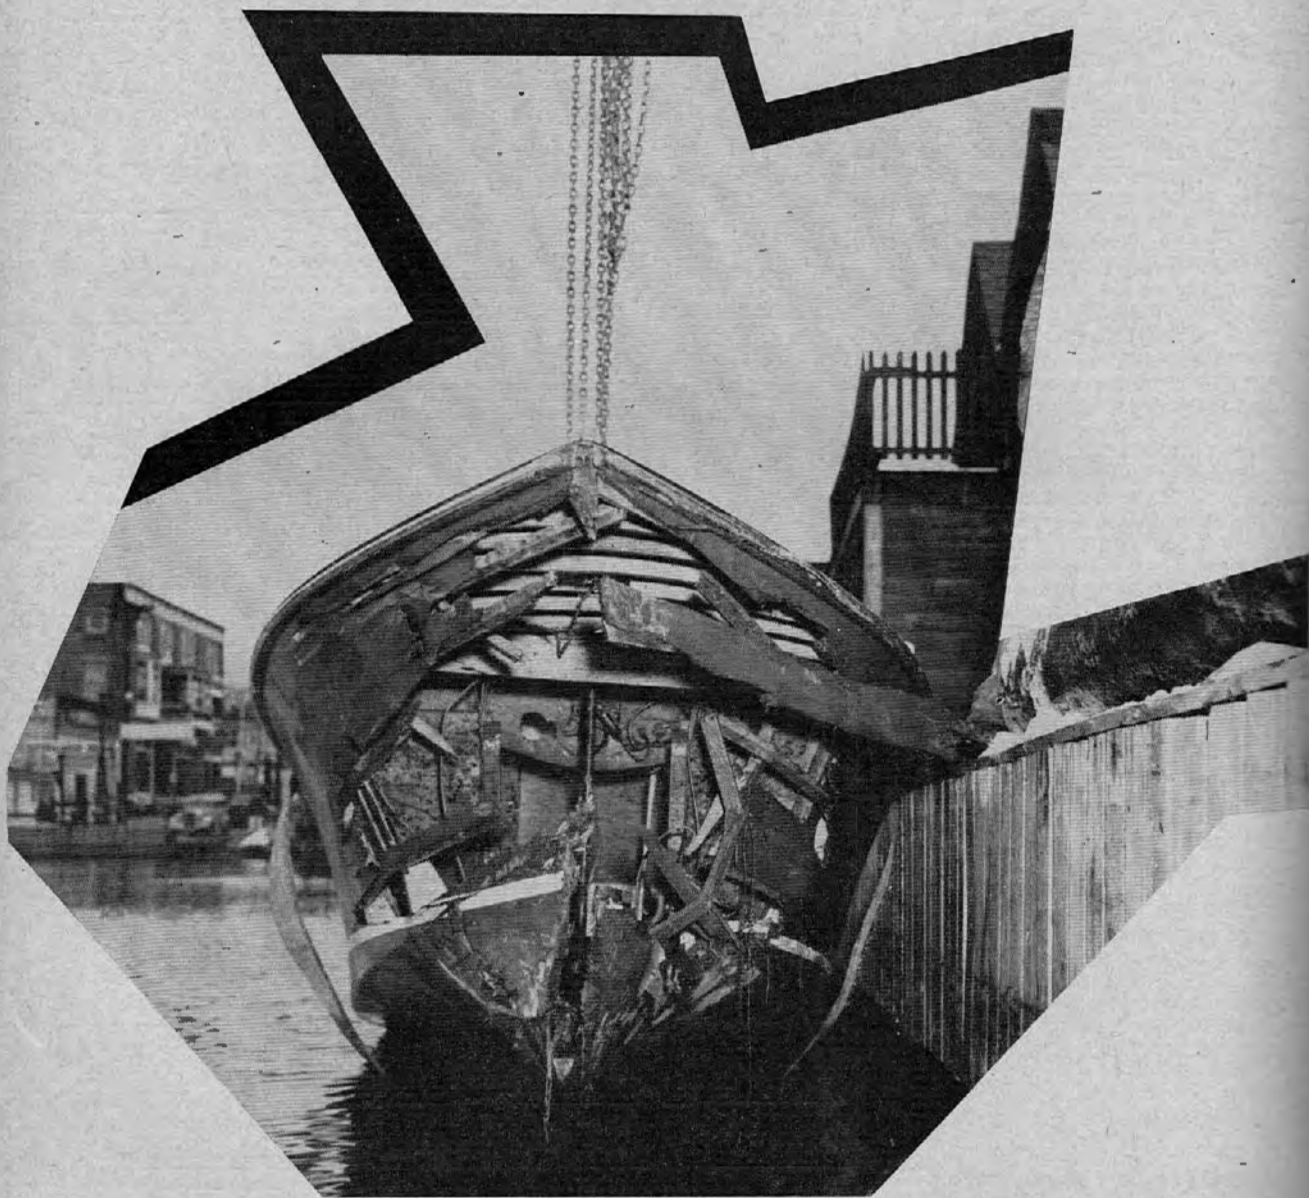
HE LED WITH HIS CHIN

The gaping snout of the 24-foot pleasure craft (*See Back Cover*) represents what happened when this runabout plowed into the side of a 30-foot heavily constructed wooden workboat at 25 m. p. h. Two occupants of this speedboat were severely injured—one narrowly escaped with his life and was probably permanently disabled, the other suffered what will probably be a permanent heart condition.
