PROCEEDINGS OF THE MERCHANT MARINE COUNCIL

November 1956

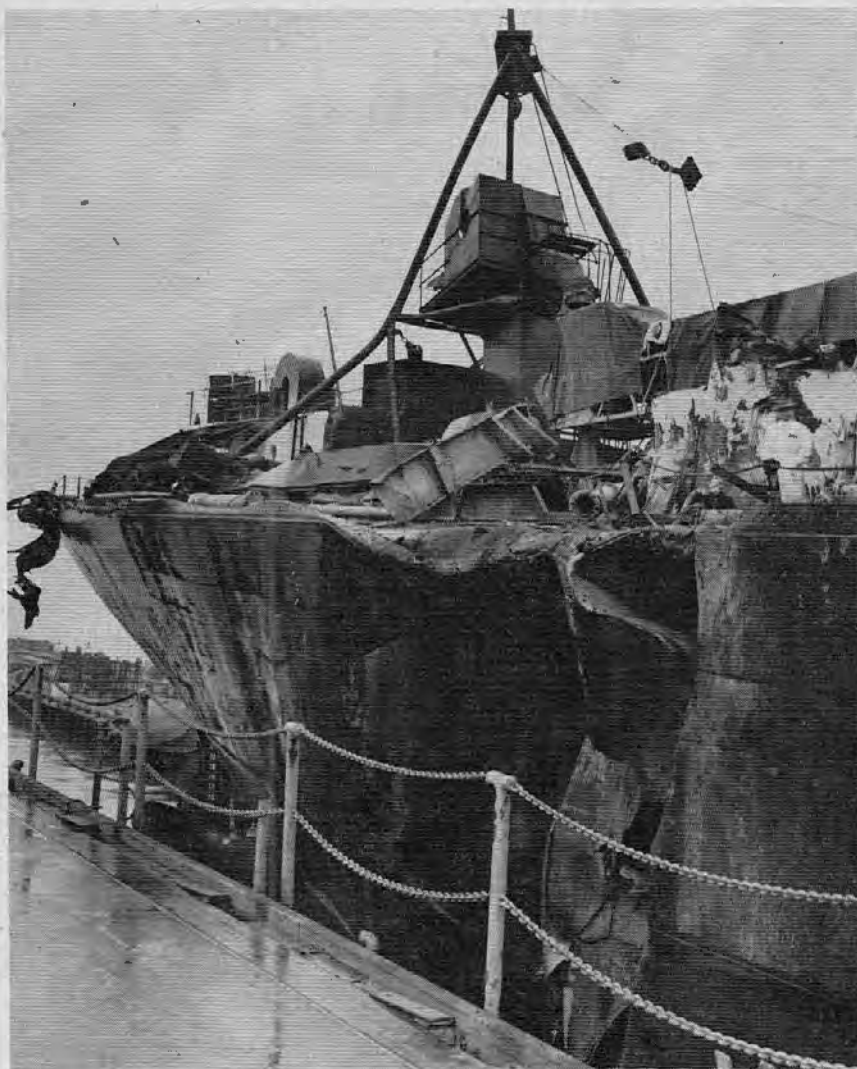
Closeup shows battered starboard side of SS PERMANENTE SILVERBOW.

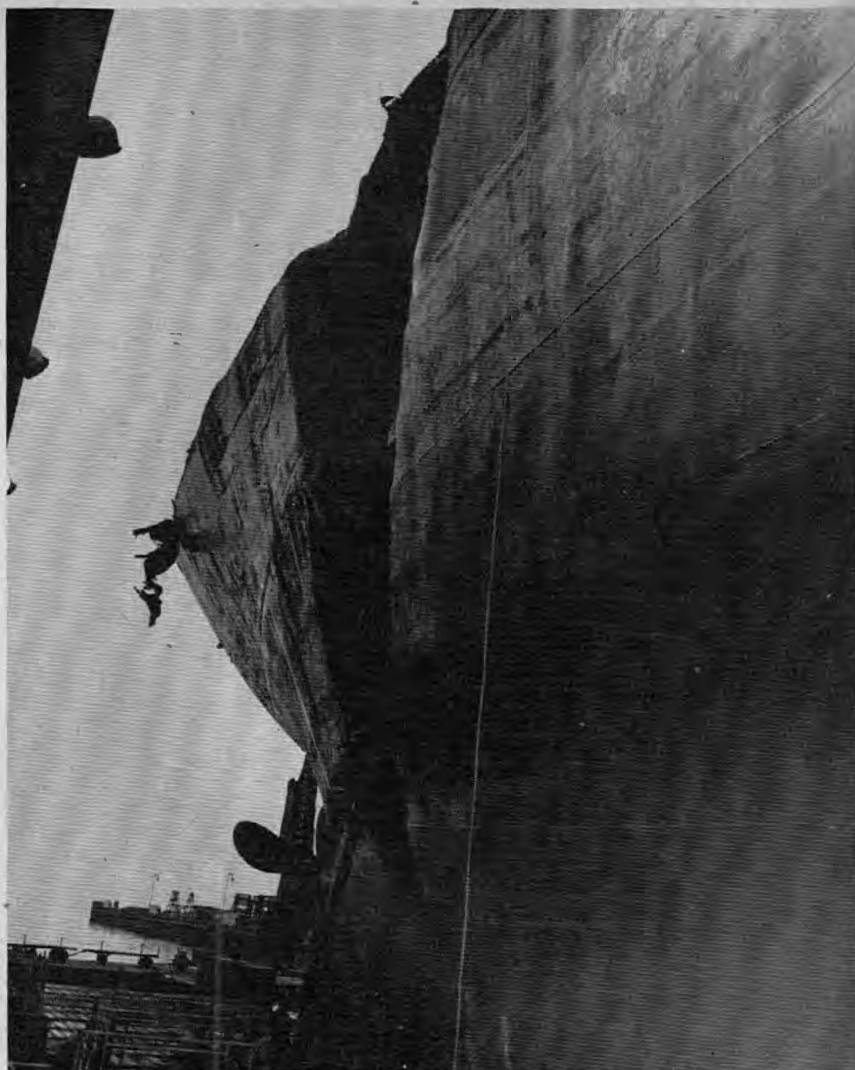
Looking aft on starboard side of SS PERMANENTE SILVERBOW prior to start of repair work.

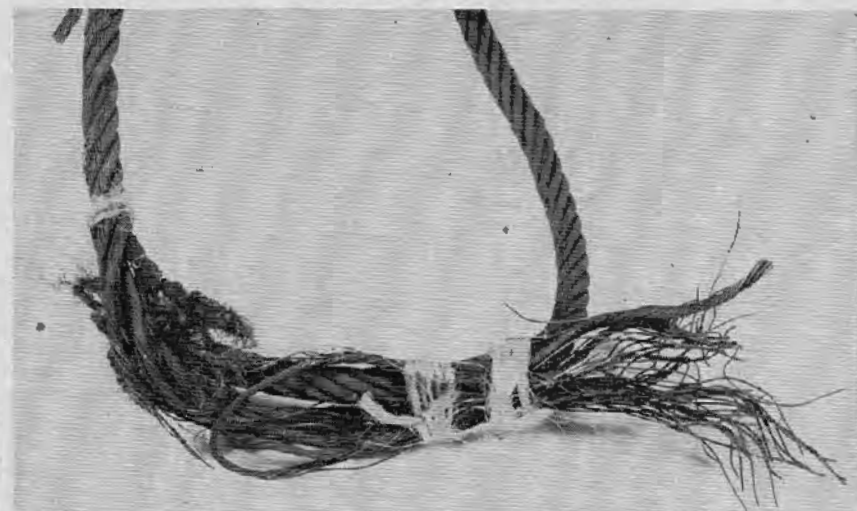
Figure 1. Section of $\frac{3}{4}$ -inch 6-19 plow steel toppinglift which parted in boom test.

Examination of the section of the 3/4-inch topping lift wire which failed (see fig. 1) revealed numerous broken and flattened strands on both sides of the break. This condition was not noted in any other portions of the wire. Since this wire had been installed new only 13 months before the casualty, had been examined visually by the ship's officers at periodic intervals once every trip, or about every 6 or 7 weeks, and had not been subjected to any undue wear in use as a topping lift, the most reasonable conclusion was that the failure was due to excessive strain placed on the wire in the vicinity of the upper king post block during the early part of the test, when the "whipping" stress reached 20,000 pounds or more. Probably some strands were broken when the sharp cracking sound was heard, and the wire parted later when the applied load got up near 13,000 pounds.

The advisability of continuing the test after the "cracking sound" was heard may be questioned by hindsight, but the parting of the wire during the further testing with moderate damage and no injuries may well have prevented its failure at some future time with possible serious injuries or property damage. The principal point of questionable judgment, however, was not in continuing the test after the wire may have been (and was) damaged, but in the method of "whipping" or jerking the wire to get the test load up to the desired stress or a load of twice the normal safe working load. The method of exerting the test load by hauling on the topping lift is also questionable as the prescribed method of weight-testing cargo gear is to exert the load through the cargo fall and winch. Winch capacity on this type of vessel is usually less than 5 tons necessitating doubling the cargo fall or runner if a load of 5 tons or more is to be applied. The topping lift winch was severely overloaded in attempting to pull 20,000 pounds. In addition, the amount of dynamic load applied to the wire by jerking the winch could be very much higher than the load applied by a smooth operation of the winch, and could easily have been considerably more than the 20,000-pound maximum reading of the spring scale.
