# PROCEEDINGS OF THE MERCHANT MARINE COUNCIL

Vol. 13

January 1956

No. 1

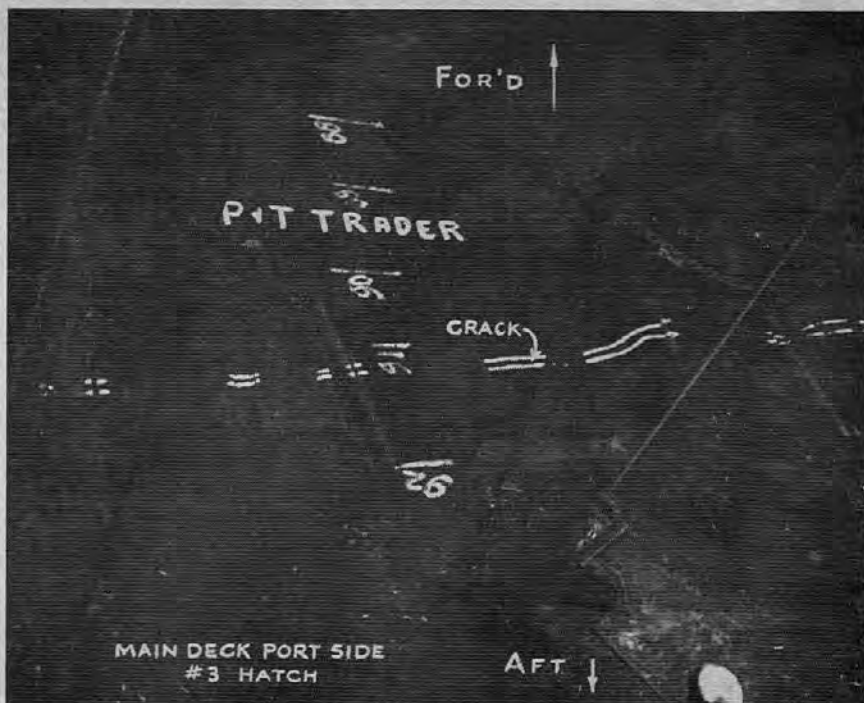
The speed was immediately reduced to 45 r. p. m. and the vessel was brought around away from the wind and sea. The Master and Chief Engineer made an immediate inspection in the driving rain and rising wind and discovered that the main deck was cracked from the vicinity of the after port corner of No. 3 hatch over to the sheer strake. The crack ran slightly aft as it went outboard. With the aid of a flashlight the Master was able to determine that the crack extended down the vessel's side through three shell plates. The strengthening strap on the sheer strake was buckled outboard and was cracked approximately one-third of the way through. Several rows of rivets on either side of the crack had been sheared and others had been started.

After the first hurried inspection, a complete inspection of the forward end of the vessel was made. It was discovered that in addition to the main deck and shell plate fractures, there was a small crack at the forward starboard corner of No. 3 hatch on the main deck and a small secondary crack leading off at a 45° angle, tending aft, one-third of the way to the sheer strake from the after port corner of No. 3 hatch. In the lower 'tween deck it was found that the shell plating crack had ruptured frame No. 92. It was also found that in the upper 'tween deck there was a crack at the after port corner of No. 3 hold.

Figure 1. Looking forward on port side main deck of SS P & T Trader showing crack and emergency welding repairs.

The emergency equipment drill was used to drill the ends of the main deck crack both in the hatch coaming and in the shell plating. Holes were also drilled at the ends of the smaller cracks in the 'tween deck, on the main deck, and at the forward starboard corner of the hatch. *With one exception, none of the cracks extended beyond the drilled holes.* The exception was the crack in the upper 'tween deck plating at the port after corner of No. 3 hatch. The first hole was drilled approximately 4 inches from the corner and after the crack continued to run, a second one was drilled approximately 7 inches from the corner. The crack did not extend beyond the second hole.

It was decided to weld several plates over the main deck crack and to install strengthening angle bars over the shell plating crack. Five steel blank flange plates from the No. 2 deep tank bilge wells were removed for this purpose. These plates were 25 inches by 18 inches by ¾ inch. These plates were fairly evenly spaced over the crack and were welded in place. (See Figure 1.) Difficulty was experienced at first in making the weld hold since the crack was working approximately three-eighths of an inch, but, upon tightening the winch falls, the amount of movement was materially reduced.

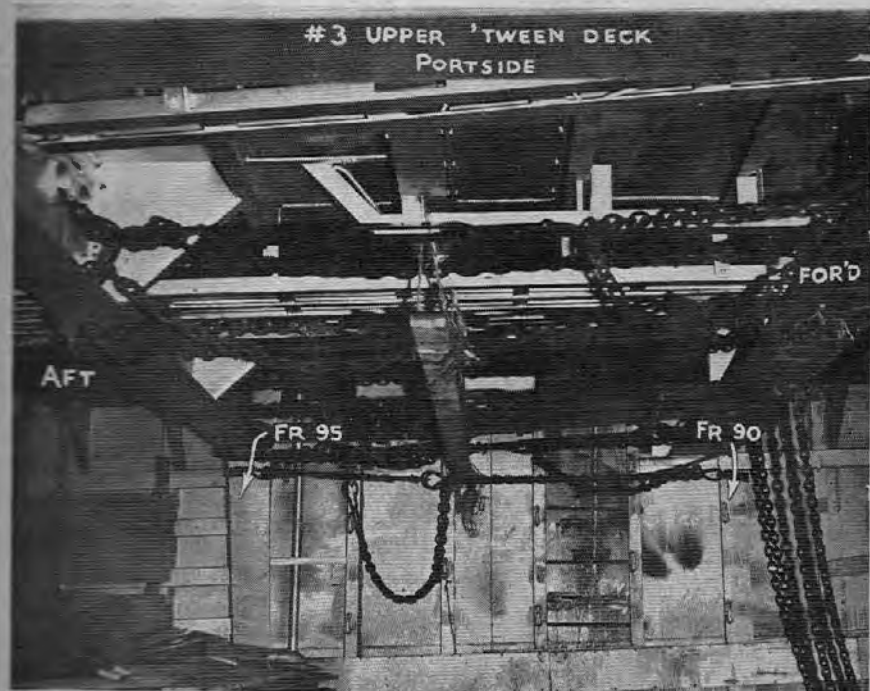
Figure 2. Looking outboard from port side upper 'tween deck showing turnbuckle arrangement.

1¼-inch diameter steel rod and threaded on both ends, were inserted and bolted to frames 91 and 92. Holes were cut in the frames for this purpose. Seven cargo deck lashing chains of seven-eighths inch pear-shaped links were brought up tight with turnbuckles between deep web beams 90 and 95. The jumbo boom turnbuckle was also installed between these web beams. Holes were burned in the beam flanges and the turnbuckle shackles were bolted to the beams. (See Figure 2.)

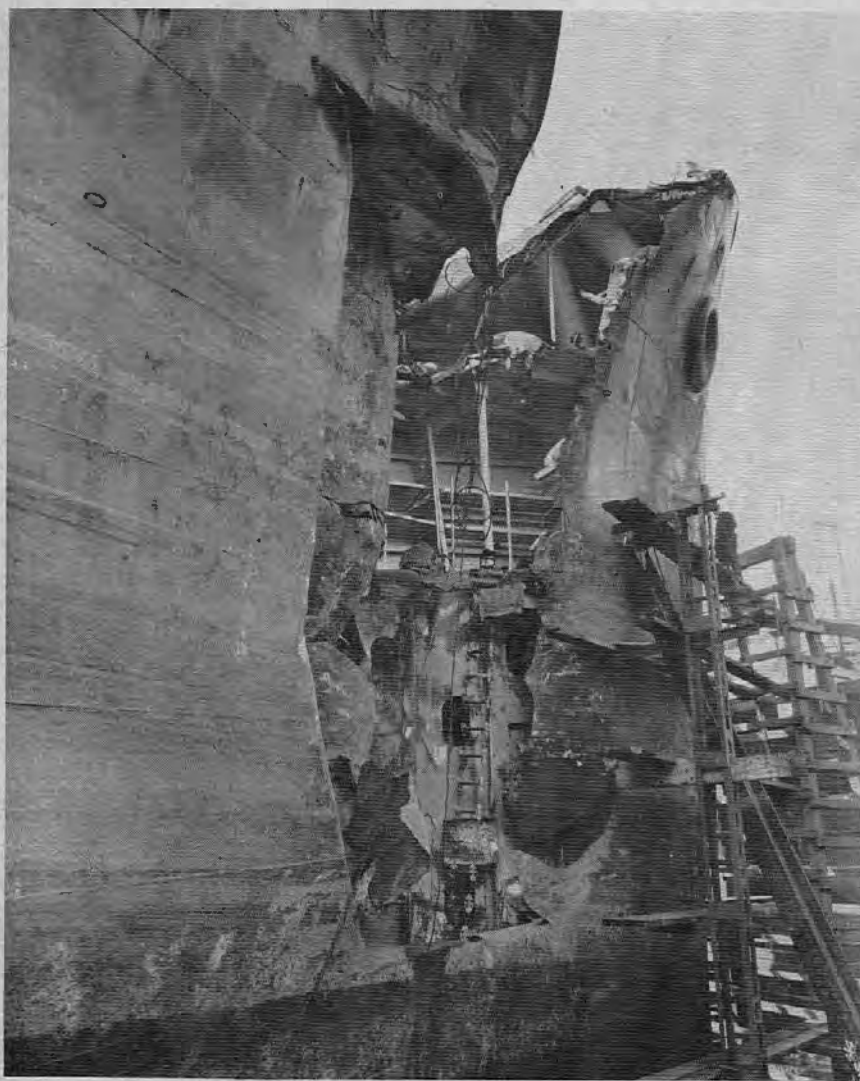
Figure 2. Starboard bow of upbound vessel following collision.

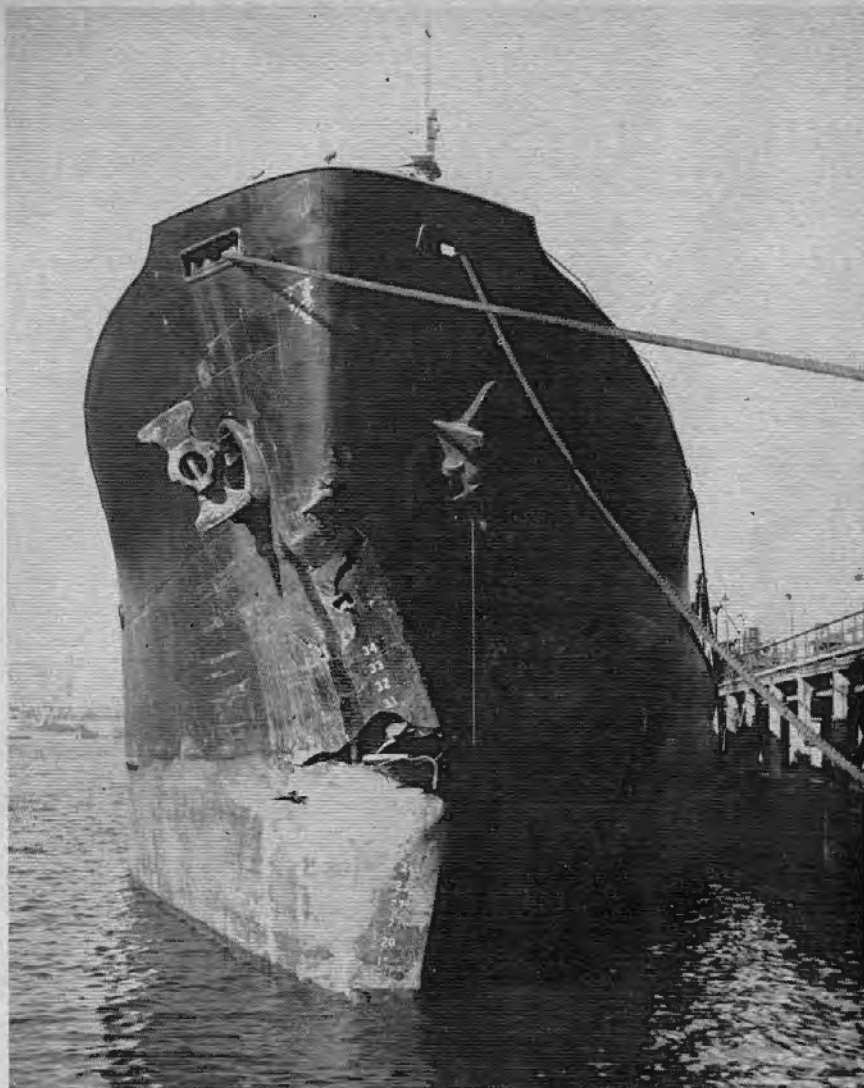
Figure 3. Bow of downbound vessel following collision.

deck, forepeak, boatswain's stores and chain locker of the other vessel, from starboard to port, in a knifelike fashion. The illustrations attest to the damage sustained and to the force of impact.

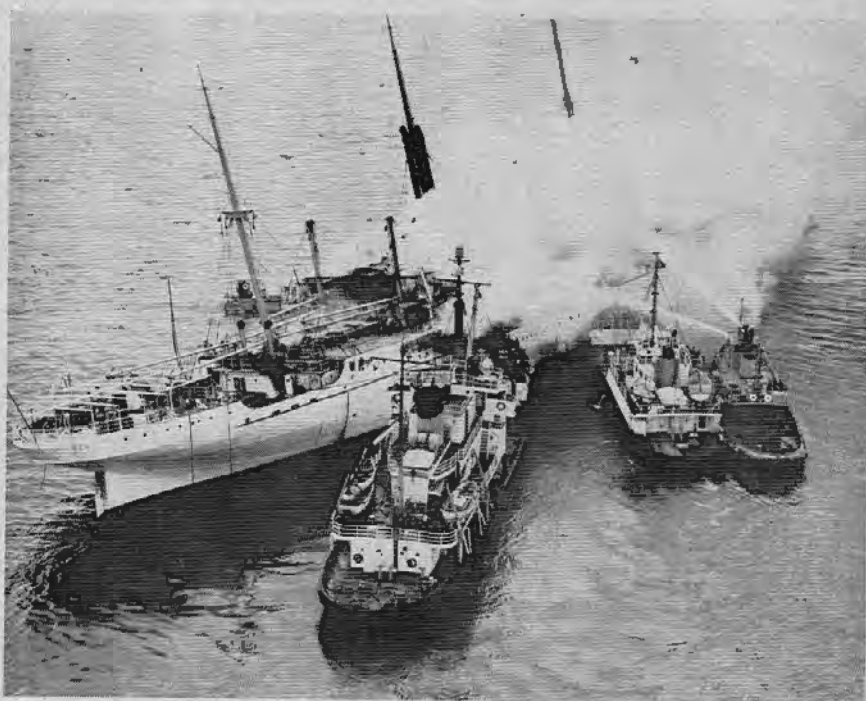
Figure 1. Coast Guard and Navy vessels fight fire on foreign passenger ship.

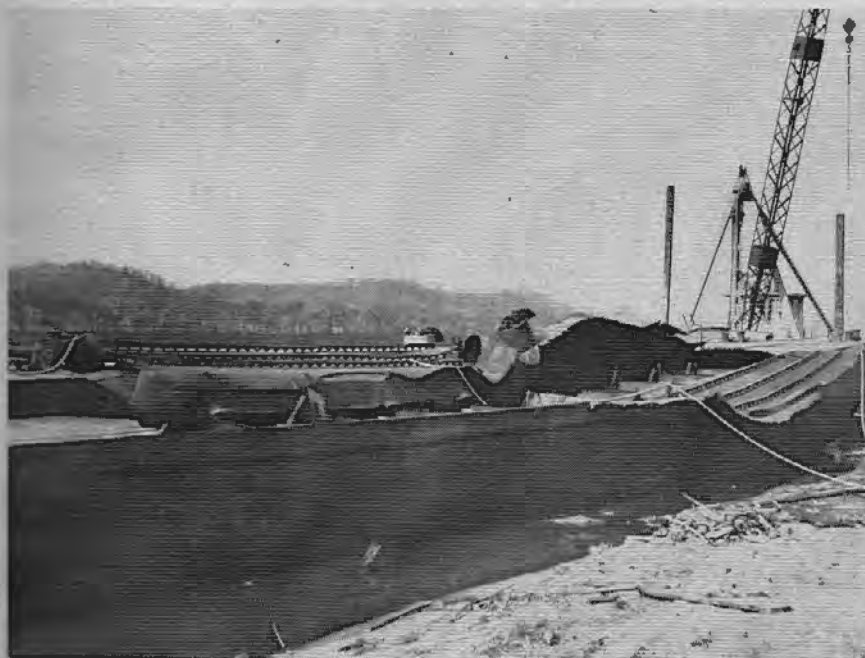
Figure 2. Main deck of tank barge showing effects of vapor explosion.

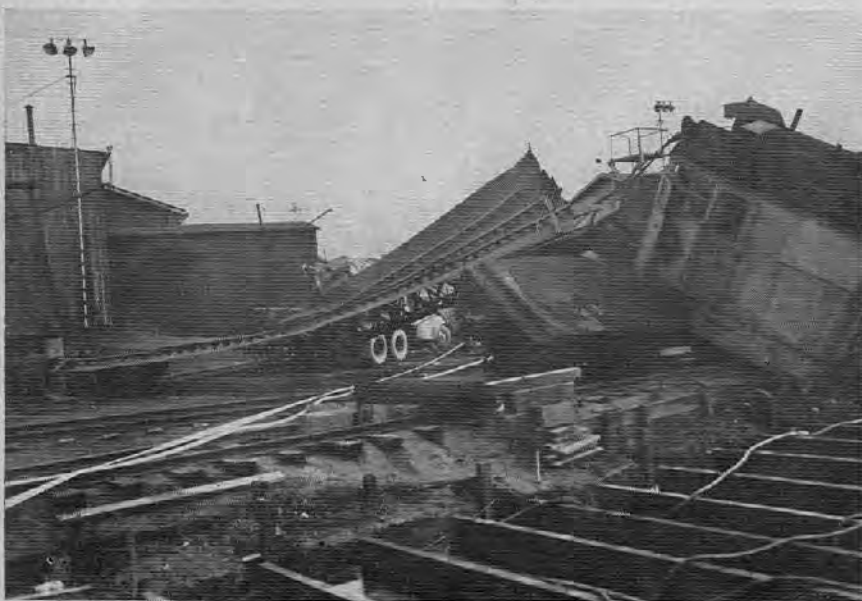
Figure 3. Portion of deck plating hurled 200 feet by force of explosion.

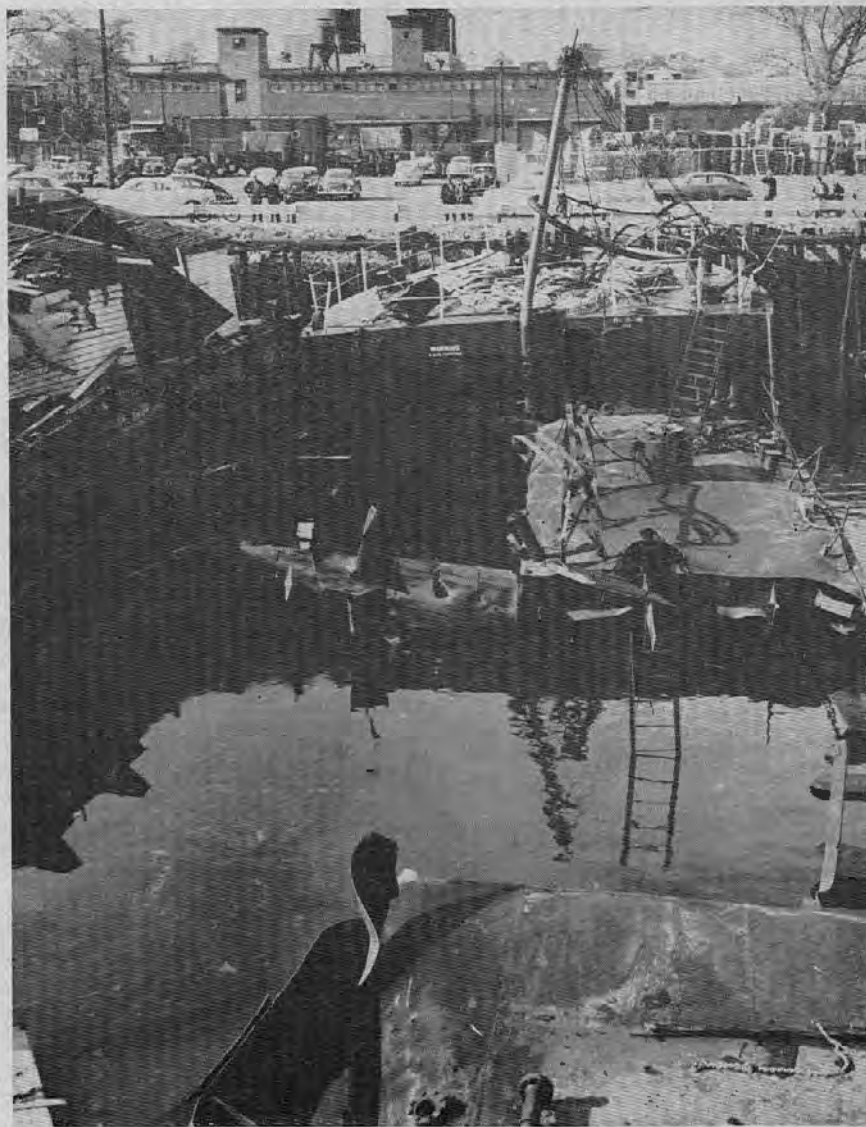
As closely as could be determined upon later analysis, the initial detonation took place in either port No. 3 tank or port No. 1 tank, followed closely by detonations in No. 2 port and starboard, and there was no actual burning or welding carried on for approximately 15 minutes before

Figure 1. Looking forward from bridge of a harbor tanker following explosion.
