# PROCEEDINGS OF THE MERCHANT MARINE COUNCIL

Vol. 13

April 1956

### LESSONS FROM CASUALTIES

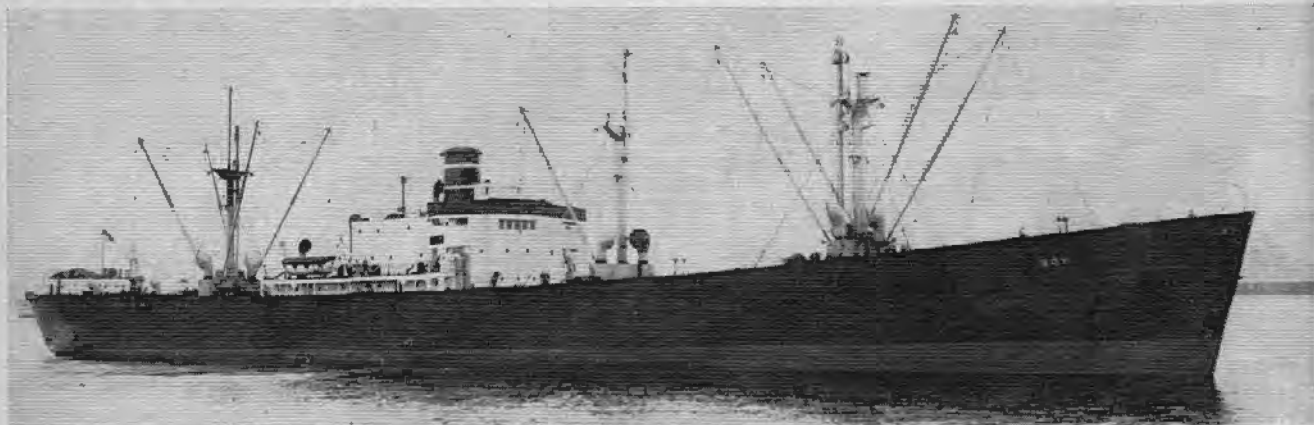
As soon as the Chief arrived, both men went aft to the shaft alley and discovered that the tail shaft had become completely uncoupled from the intermediate. And this in the middle of the North Atlantic in December with a storm blowing! What to do? The decision that confronted the Master and Chief Engineer was whether to take the easy way out, send a distress message and call for a tow, or whether to take the hard way and try to repair the damage themselves under the worse possible conditions. Without hesitation the latter course was chosen, and then began a 33-hour period of frustration, danger, turmoil, and just plain sweat. During those hours every man in the crew

Figure 1.—SS *Boy* on arriving in New York December 26, 1955, following unusual Atlantic crossing.

In drydock, it was found necessary to renew the tail shaft and wheel. The wheel had been badly banged up striking the rudder post during the critical period. It must certainly have been with mixed feelings that the engineers watched the tail shaft being pulled and carted away, as most of them had been as close to danger working on that shaft as any seamen would ever want to be. The officers and crew of the *Boy* can be justly proud of their admirable performance of duty, without thought of self, in the face of danger, for the good of their ship. It is a job like this which reminds the entire marine industry of the true worth and ingenuity of American seamen when they are called upon to meet an emergency.

Precautions against a casualty of this type, such as welding the nuts, using lock washers or cotter pins, or drilling and wiring the nuts could be considered. However, since this type of failure is so rare, the conclusion must be made that well-machined bolts and nuts in shaft couplings, properly set up, do not need such extra precautions. One measure with which no seaman or operator could argue would be to insure that the shaft couplings are inspected by shipboard personnel at frequent intervals, especially during heavy weather when a failure would be most apt to occur.

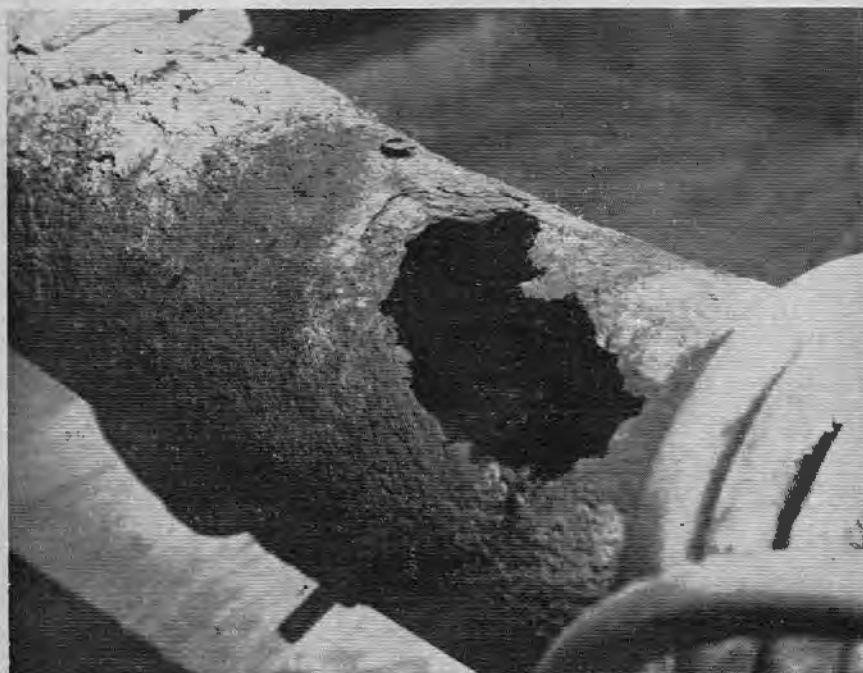
An investigation of the machinery space after the accident revealed that the section of exhaust pipe beneath the cabin floor had deteriorated and there was a large hole in it. (See Figure 1.) A coil of copper tubing in which cooling water circulated was wrapped around the exhaust pipe. The close turns of the tubing hid the pipe from visual inspection and presumably muffled the sound of the escaping exhaust so there was no way

to detect the leak without removing the coil.

Figure 1.—Section of exhaust line showing hole and coil of tubing which hid it from view.

*Third*—the exhaust system should be inspected regularly so that any wasting away of the lines can be discovered before an actual failure occurs. Where the exhaust pipe is hidden by other pieces of machinery or, as in this case, by tubing, particular care should be taken to see that every section of the tube is examined.
