PROCEEDINGS

OF THE MERCHANT MARINE COUNCIL

UNITED STATES COAST GUARD
Vol. 16, No. 3 • March 1959

CG-129

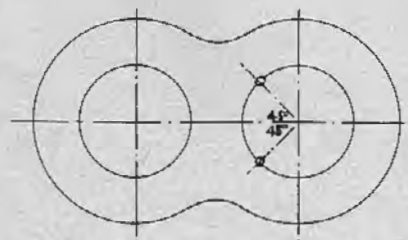
Figure 2.

One of the most controversial problems which can arise on oil engine survey and repair work, is what action to take with a crankshaft shrink fit which has slipped slightly, say $\frac{3}{4}$ inch or so at the witness marks. The opinion is often put forward that once a shrink has slipped it will never slip again under normal conditions, and all that is necessary is slightly to alter the engine timing to suit the new crank angle. Whereas this line of action may be quite acceptable in a twin screw vessel, it is in my opinion a dubious one for a single engine installation, especially so when it is one of the after shrinks which is affected. The trouble in such cases is that even if the cause of the slip is known, be it water in a cylinder, or shock of another nature, the condition of the mating surfaces of the shrink and the hoop stress cannot be ascertained. In view of these facts and the possibility that the hoop stress has been lessened by the slip, it has always seemed safe policy to me in the case of a single

screw vessel to resort to dowels, two small diameter dowels at 90° to one another in preference to one large one which tends to lessen the shrink (see figure 2). I know of instances on single screw vessels where those responsible for the safe operation of the

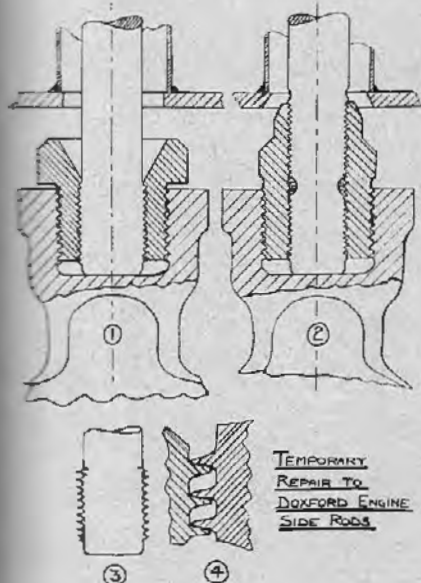
Figure 1.

One such case occurred on an opposed piston-engined cargo vessel, where it was found that the differential nuts, securing the side rods to the crossheads, were all slack and had been operating in this condition. The general arrangement of these attachments is as in figure 1^a and running them in a slack condition had resulted in the threads on the side rods and in the inside of the nuts becoming dangerously thin (see figure 1^b and 1^c). Two of the rods had in fact developed slight fractures at the base of their top threads.

Every effort was made to obtain new side rods, but these were not forthcoming, and after some calculations had been made it was decided, as a temporary repair, to remachine the bottom ends of the rods using a negative instead of a plus thread, with new nuts of extended length (see figure 1^b).

Any fractures at the base of the threads were machined out in the form of a shallow smooth groove—it was subsequently found that the extended nuts when fitted were dangerously near the entablature top, and they had to be chamfered to clear same.

This temporary repair enabled the vessel to continue trading while new forgings were made and machined.

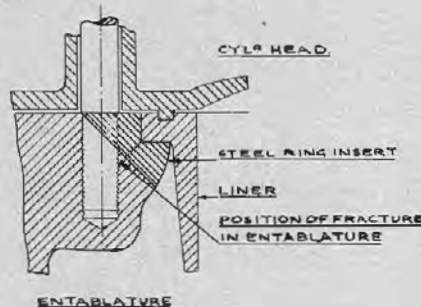
Figure 3.

Cracked cylinder entablatures, especially in the case of some of the small main propulsion engines largely used in coasters, can sometimes look unrepairable. Excessive tightening down of cylinder heads to stop water leaks has no doubt been responsible for initiating and propagating many fractures in cylinder entablature liner landings (see figure 3).

In one such coaster the landing of a cylinder liner, in the single piece cast iron entablature of the 6-cylinder engine, was badly cracked circumferentially in the aforementioned manner. It looked as if a complete new entablature would be required and this was a matter of great concern to the captain who was part owner. After consultation with the various parties concerned it was decided to try and effect a temporary repair. A boring bar was fitted up vertically in the entablature, and the cracked landing and entablature top bored out at 45° back to the circle of studs. A steel insert ring, fabricated from welded bar, was then turned up in the lathe and, after grinding into the entablature, was put in place with a smear of red lead paint and the liner replaced. The cylinder head held the whole assembly solid and the repair was completely successful.

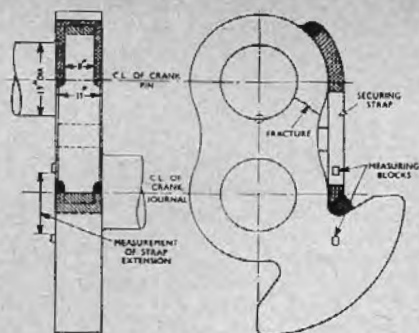
Figure 4.

Fractures of main engine crankshafts, either partial or complete, which have occurred while vessels have been far distant from their home ports, have been the subject of many very interesting temporary repairs. An example of a repair of this type effected to a fractured crankweb of a Burmeister and Wain engine, in Australia in 1946, is shown in figure 4.

In this case a strap of heavy section (11 inches by 4 inches) was laid in place along the fractured crankweb, secured at one end, and heated by a system of electric elements until its extension, measured at the points shown in the illustration, equalled the width of the crack when final welding commenced. The additional heat generated during welding produced a further slight extension, and when the assembly cooled down after completion of the welding, the crack was effectively closed.

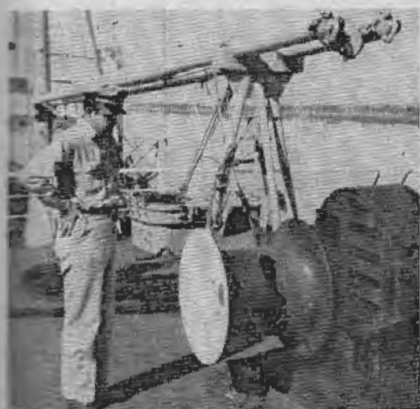
A case in point was recently reported to Coast Guard Headquarters. A tanker was being moored in a large Gulf port under good conditions. Two 8-inch manila head lines had been made fast on the dock and the crew on the fo'c'sle head were heaving them in simultaneously using the starboard and port drums on the anchor windlass.

Suddenly, without warning, a portion of the plating on the starboard drum caved in under the pressure and the jagged edges severed the line. Released from terrific tension, the mooring line whipped across the deck sweeping two seamen against the outboard bulwark. One man was only shaken up, but the second suffered a compound fracture of the leg, head injuries, and contusions of the body.

Subsequent inspection of the drum disclosed that internal corrosion had reduced the original thickness and the broken metal measured approximately $\frac{1}{8}$ of an inch.

However, like any machinery it is subject to wear and tear and should be periodically lubricated and checked. Its position on the bow makes it particularly vulnerable to corrosive action by storm and sea.

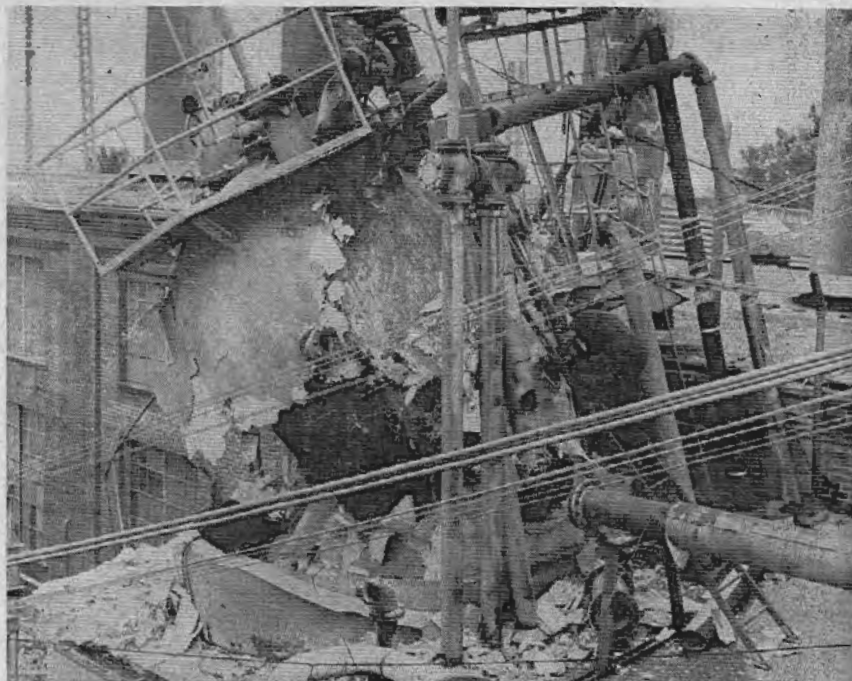
A vacuum occurred in a feedwater heater so suddenly a 16-inch vacuum breaker was unable to relieve the vacuum quickly enough to prevent

damage. The feedwater heater, fabricated of a quarter of an inch steel, collapsed when an operator attempted to fill it with water after the vessel had been cleaned. Apparently the vessel was not known to contain steam. The steam condensed, causing

a partial vacuum, allowing the vessel to collapse to the extent that the sides buckled and touched each other, the metal cracked, and the seams tore. Reprinted from *The Locomotive of the Hartford Steam Boiler Inspection and Insurance Company*.
