# PROCEEDINGS

OF THE MERCHANT MARINE COUNCIL

UNITED STATES COAST GUARD  
Vol. 18, No. 11 • November 1961

### Commandant's Action on Marine Board of Investigation; structural failure of tanker *Pine Ridge* on 21 December 1960, off Cape Hatteras, with loss of life

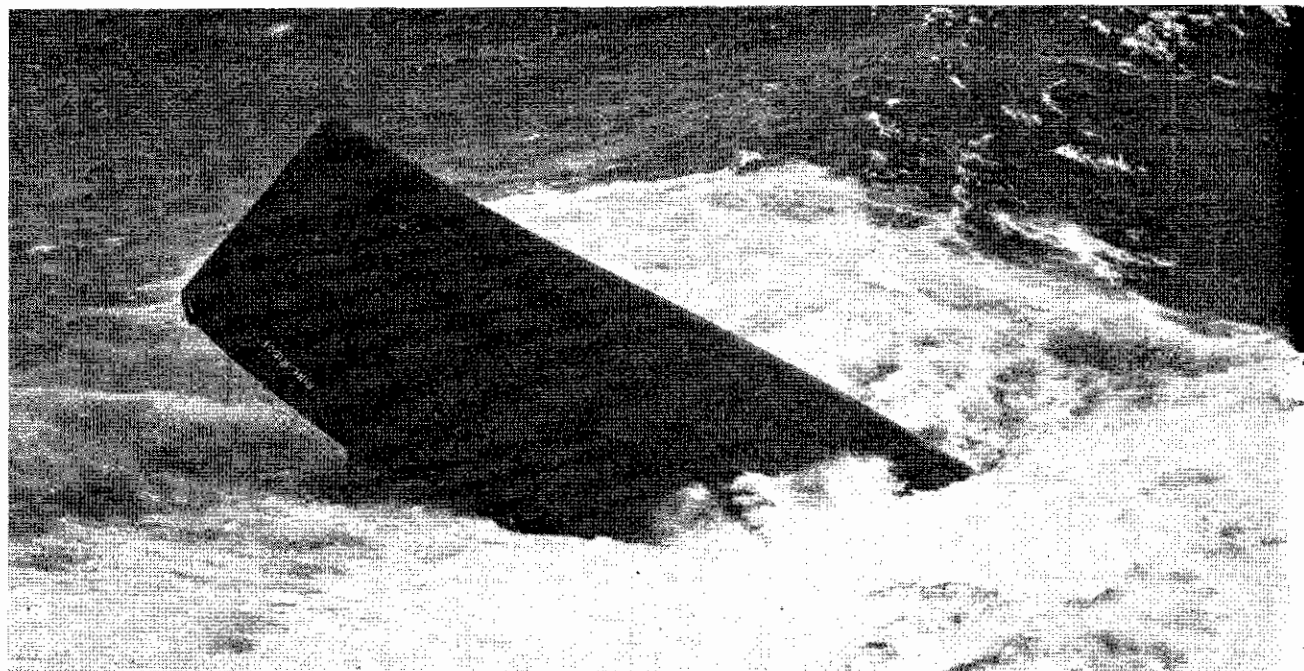
## SS PINE RIDGE

ON WEDNESDAY, DECEMBER 21, 1960, the 10,417-ton T-2 American tanker SS *Pine Ridge*, which had broken in two, became the object of a large scale search and rescue operation. There were 29 survivors of the 37 persons on board; Captain Clark Snyder, the mates, and the radio officer were among the 8 persons lost. The stern portion of the vessel was successfully salvaged.
