# *PROCEEDINGS*

OF THE MERCHANT MARINE COUNCIL

Vol. 21, No. 7

• July 1964

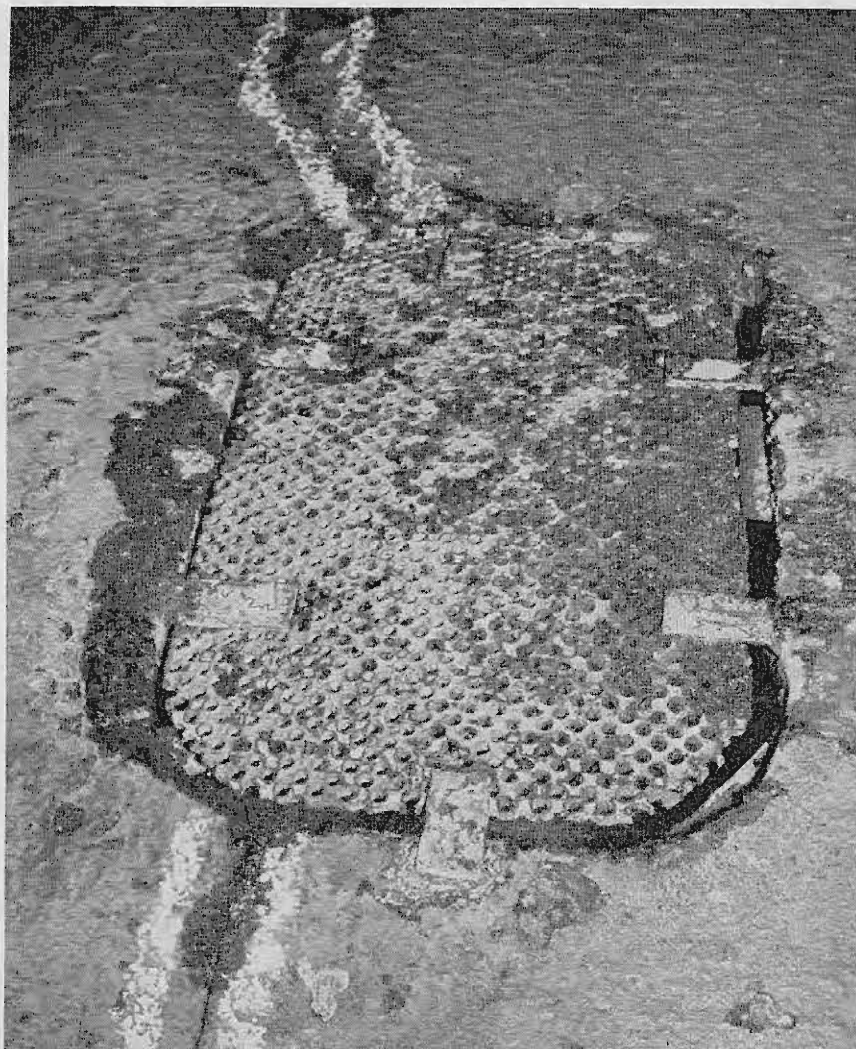
## STRUCTURAL FAILURE ECONOMICS

In areas of stress concentration such as exist near the corners of openings, it is doubly important that the edges be fair and smooth. Where fair guided burning is not possible, this may be achieved by grinding after burning. However, use of a fair burn in the first place is, in all but the most critical areas, sufficient, and is more economical.

In the case illustrated, the total length of the resulting cracks was 15 feet. Repairs involved replacing of plate from three strakes as well as the sea chest insert plate. The sea chest opening on the other side of the vessel had cracked similarly a little

more than a year before. Both fractures and the resulting costly repairs might have been avoided if a little

more care, and possibly a few more dollars, had been spent on the original fabrication.
