# Proceedings

of the Marine Safety Council

July/August 1985

# Major Disaster Averted in the Gulf of Mexico

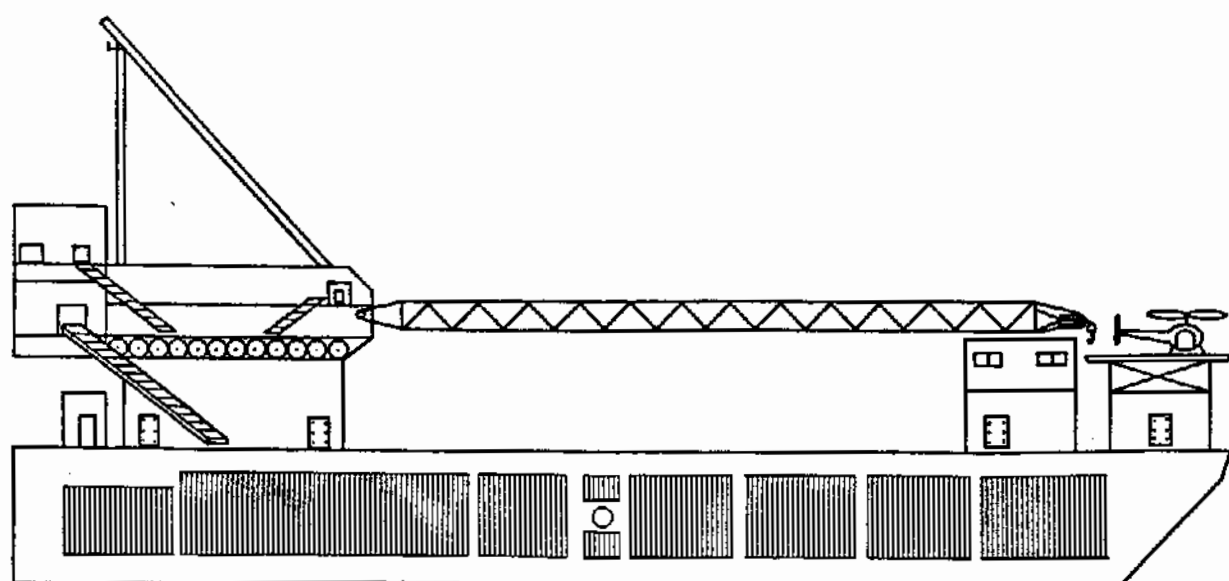
Figure 1

McDermott Derrick Barge No. 16

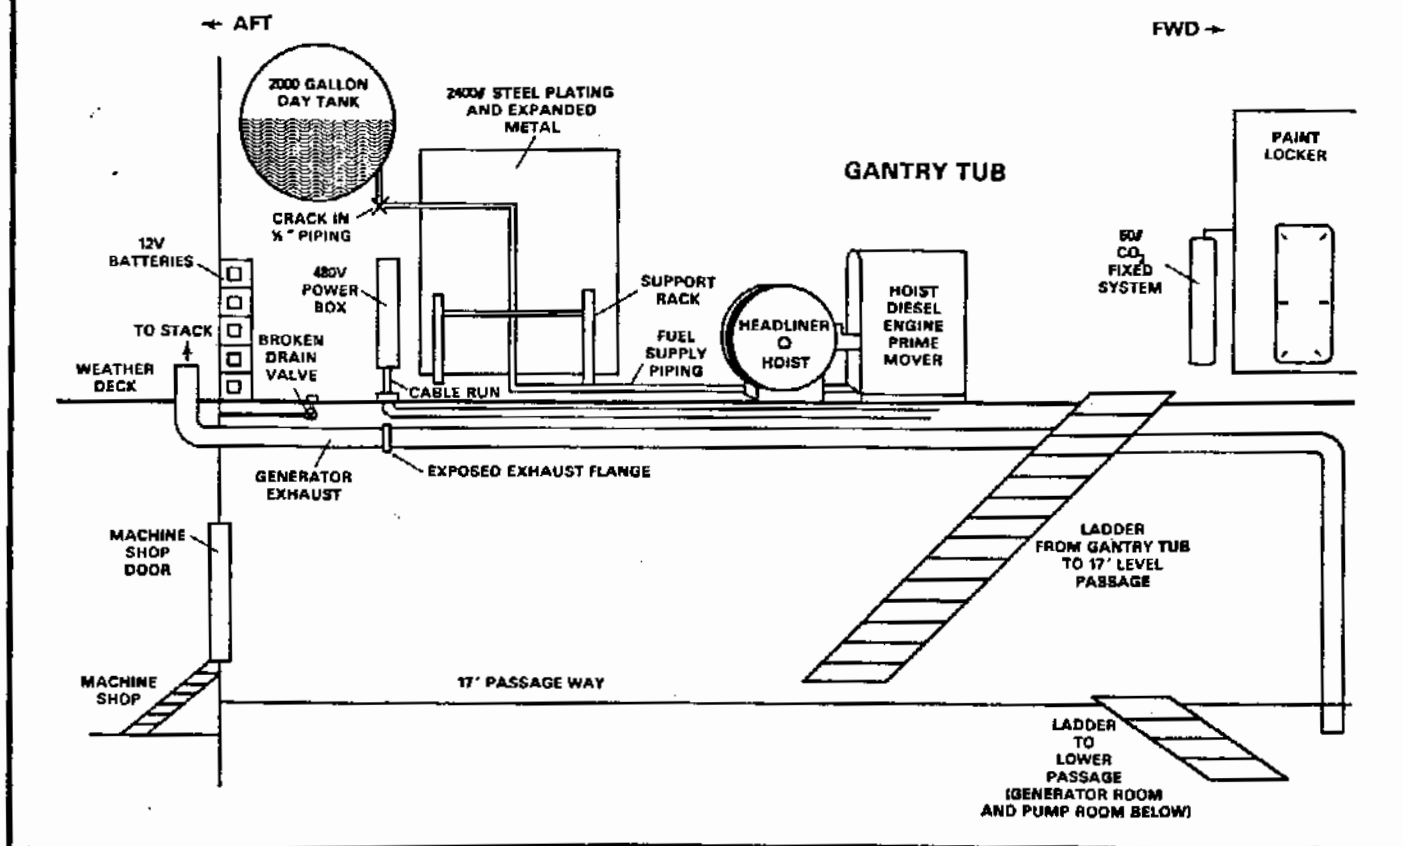
Figure 2

**DIAGRAM OF VESSEL IN VICINITY OF FIRE  
(VIEW FROM STARBOARD)**

When the lower passageway was reexamined, investigators discovered an exposed exhaust flange located directly beneath the cable run through the deck from the 480-volt panelboard. Close examination of the insulation blanket which appeared to be protecting the steel exhaust flange revealed a 2-inch gap of exposed metal between the wire lacings directly beneath the overhead panelboard. Since number two diesel fuel has an ignition temperature of about 500°F, the temperature of the hot exhaust piping with gases between 750-900°F was more than sufficient as an ignition source.

A heavy roll of the vessel at about 1500 on September 7, 1984 caused a rack supporting 2,400 pounds of steel plating and expanded metal to collapse. The plating fell against a half-inch fuel supply pipe, cracking it, and allowing as much as 1000 gallons of diesel fuel

to spill on the deck. Some of the fuel passed through a cable run in the deck, falling directly atop hot exhaust piping. This fuel ignited.

- Equipment and gear aboard vessels should be properly secured for sea. Had the stack of steel plating been secure and unable to move, the piping would probably not have been cracked.
- Fuel piping should be properly supported and located for maximum protection from its surroundings.
- Cable penetrations through bulkheads and decks should be made through stuffing tubes to provide maximum watertight protection and prevent the spread of flood and fire. Newer industrial vessels are constructed to meet this standard.
- Exhaust piping insulation should receive proper attention and maintenance.
- Everpresent high exhaust temperatures are a proven fire hazard. Foresight and attention to detail by crew members could have prevented this incident.
