Proceedings

of the Marine Safety Council

Vol. 43, No. 1

January 1986

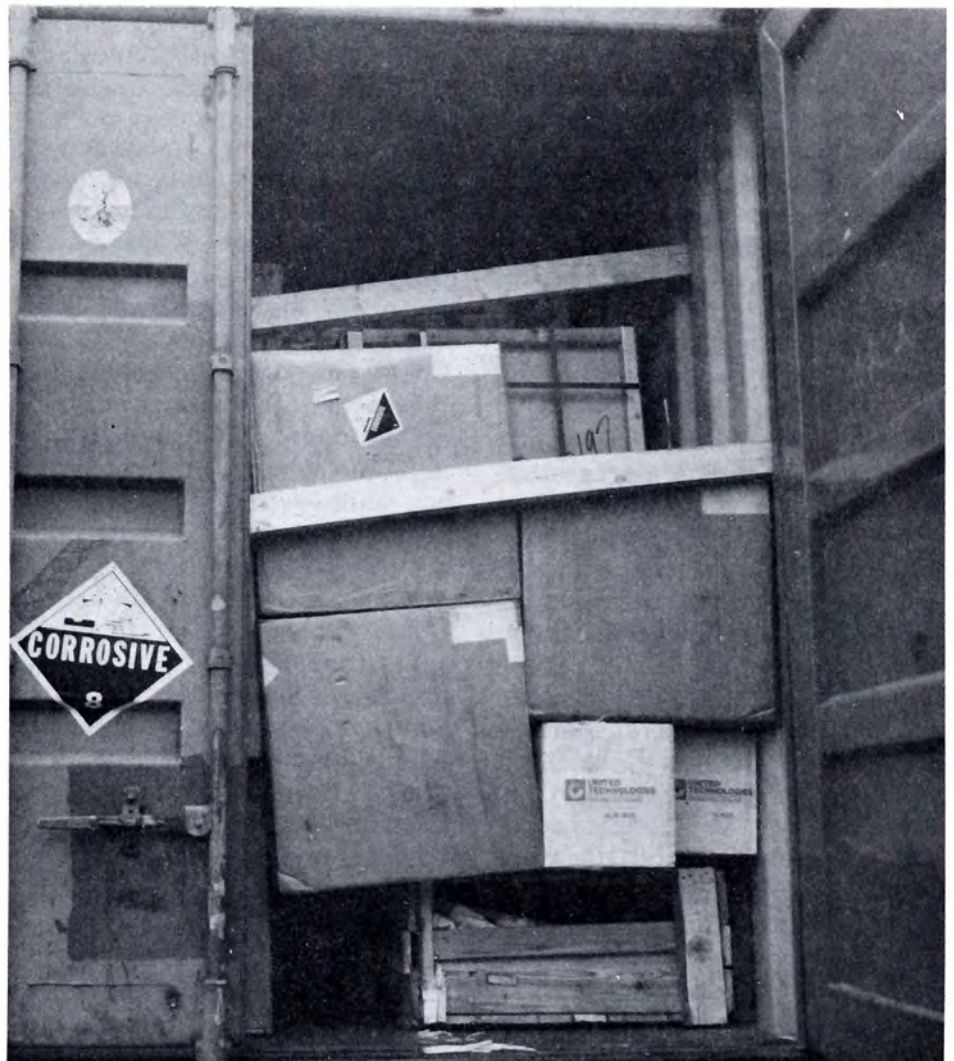
Inspectors required this load to be repacked and secured before leaving the marine terminal. Photo by John P. Aherne.

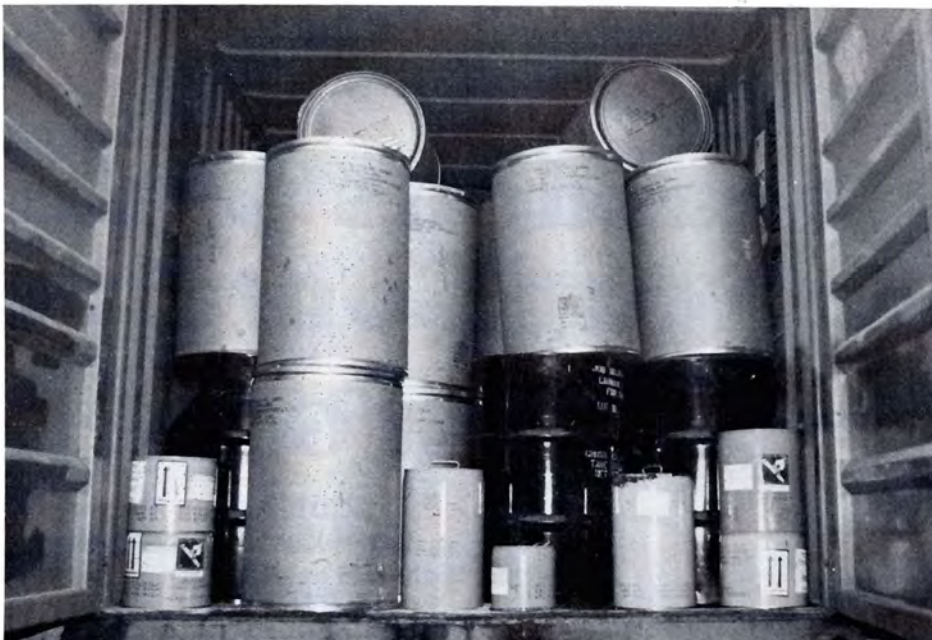
Unsecured drums may roll and break open during shipment. Photo by John P. Aherne.

Insufficient blocking and bracing of goods within a container may be the greatest safety problem with hazardous material shipments. Packages approved to carry a particular hazardous material are not meant to withstand the punishment that can occur during transportation when improperly secured in a freight container.

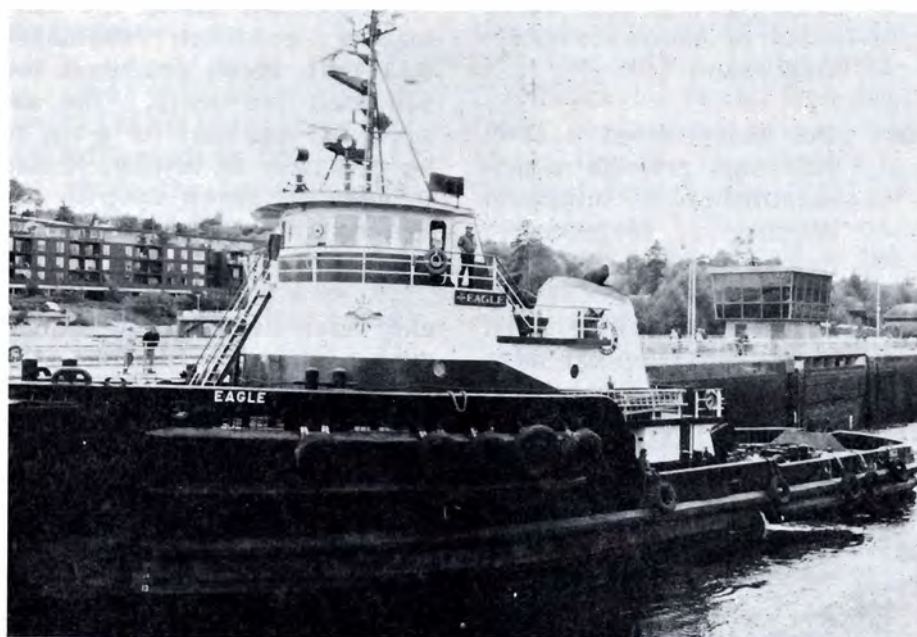
This picture was taken while the EAGLE was in the locks in Seattle, just prior to leaving for Anchorage. The EAGLE's captain is standing on the bridge deck. He and seven crew members perished on the return trip; only the chief engineer survived. (Photo ©1984 by David J. Holdsworth)

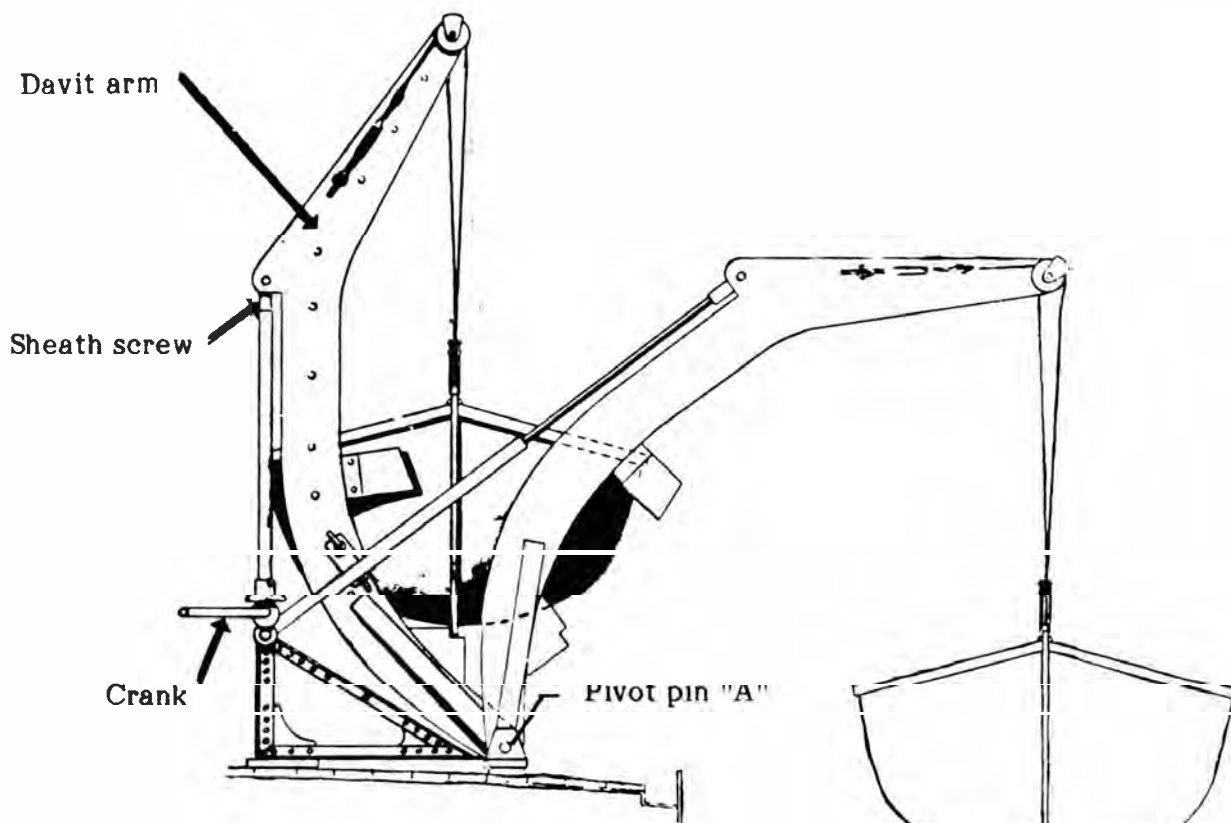
Figure 1

An equipment failure report of July 1985 brings to attention the importance of close examination and lubrication of the smaller parts of a lifeboat davit. This particular report dealt with the failure of a pivot pin in a sheath-screw davit of the basic design shown in figure 1. In this design, hand-cranking the sheath screw causes the davit arm to move in or out as it pivots about the pin marked "A." According to the report, "During abandon ship drill, as the No. 1 boat was being cranked in (sheath screw), the

after davit arm pivot broke off at the junction of the arm and the forward mounting bushing. The weight of the boat pulled the arm back, bending the pin and mounting bushing at the after end until the boat's keel landed on the deck edge. Boat was not damaged."

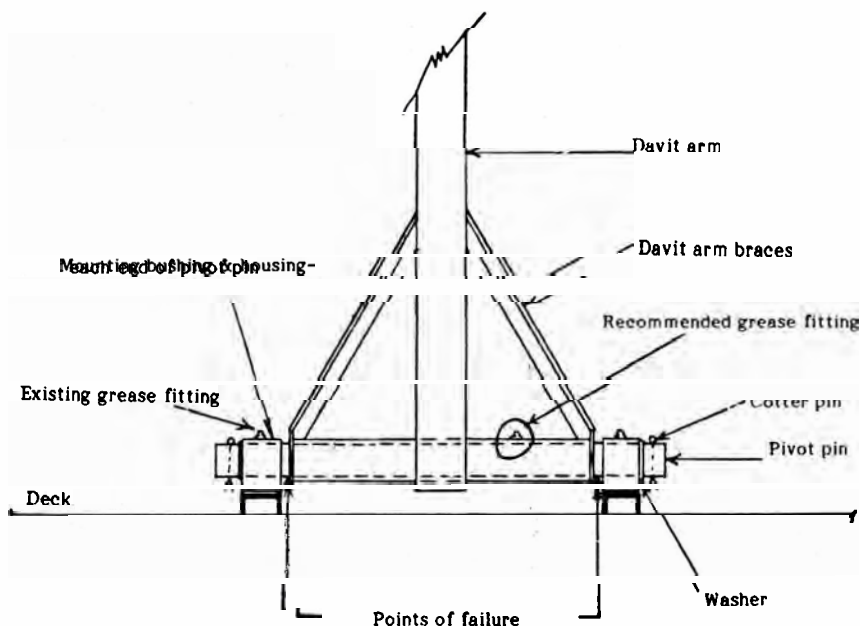
Figure 2 View of Davit Arm's Base Looking Inboard

The report describes the failed pivot pin as twisted because "...both sections froze in the bushings (figure 2). After end of same pin was bent up and back. After pivot bushing housing and mounting pad were bent, as was the forward

bushing housing and the lower sheath screw mounting bracket." The report gave the cause of failure as "binding of pin in bushings due to lack of lubrication and maintenance."

The out-of-the-way location of pivot pins makes it easy to overlook their maintenance. Lubrication via the "existing grease fittings" shown in figure 2 may be impossible if they are missing or have become clogged under several layers of paint. Lubrication is necessary to permit a

revolving fit of the pivot pin within its two mounting bushings while simultaneously applying a heavy coating of grease inside the cross tube by means of the "recommended grease fitting" shown on the diagram. Such grease inside the cross tube acts as a stopwater, the lack of which will ultimately permit corrosion to start within the tube and wastage of the pivot pin from the entrance of water. Lubrication of these pivot pins should aim for lubrication to (1) ease the movement of the davit arm about its pivot and (2) prevent internal corrosion.

The addition of "recommended grease fitting" to the cross tube, figure 2, of the davits of this design now in service will be the subject of a forthcoming change to NVC 4-85, "Recalls and Other Corrective Measures for Lifesaving Equipment," dated 29 May 1985.
