# Proceedings

October 1987

# The Loss of the Pride of Baltimore

CAPT J. C. Maxham and LT W. E. Diaduk

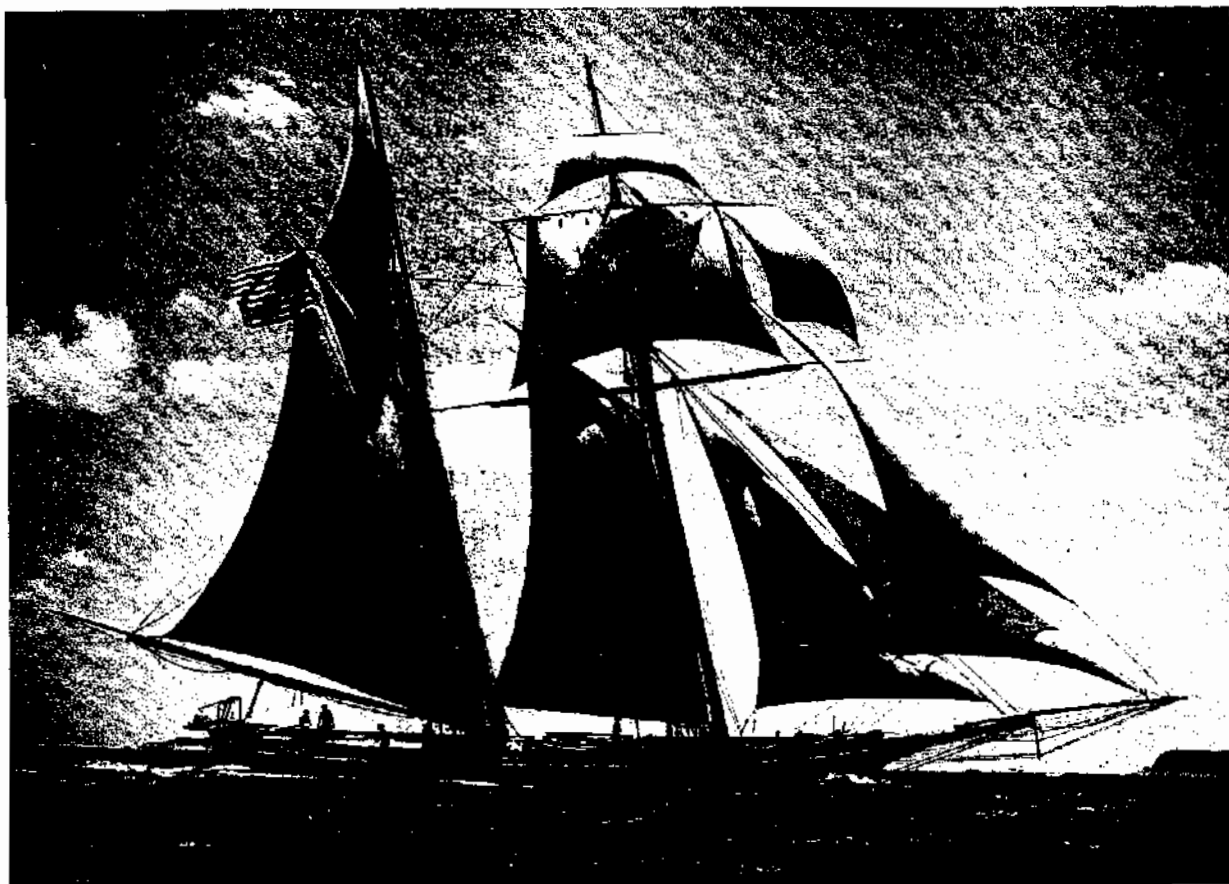
Surviving crew member Scott Jeffrey took this photo of the *Pride of Baltimore* in the Virgin Islands shortly before the vessel capsized.

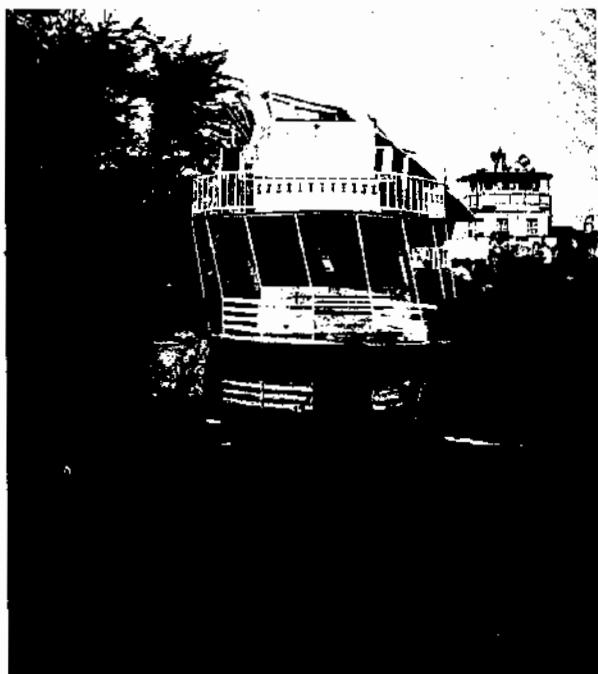
The **Scitanic's** hull was distorted during salvage, and the top of the pilothouse was sheared off. (Photo from the Coast Guard casualty file)

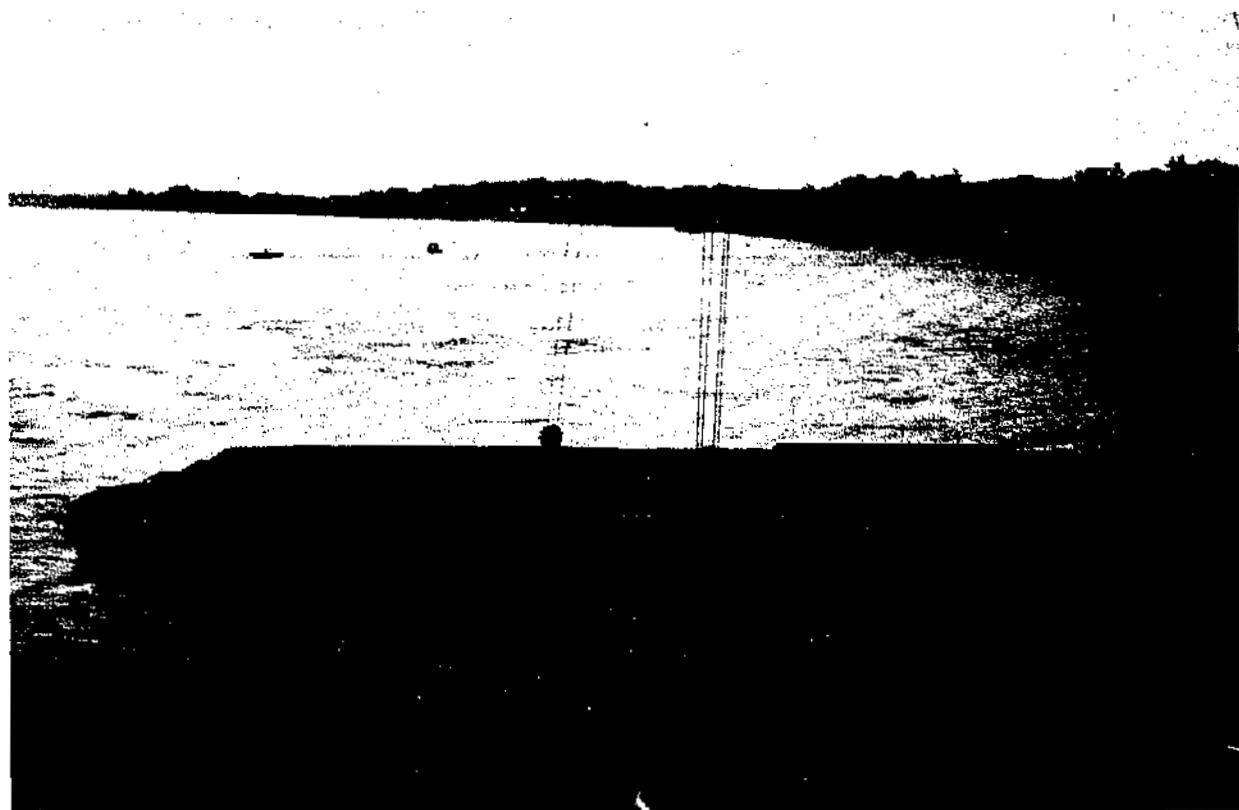
Salvors used a floating crane to right the *Scitanic*. Repairs were estimated to exceed \$65,000. The owner decided not to restore the vessel. (Photo from the Coast Guard casualty file)

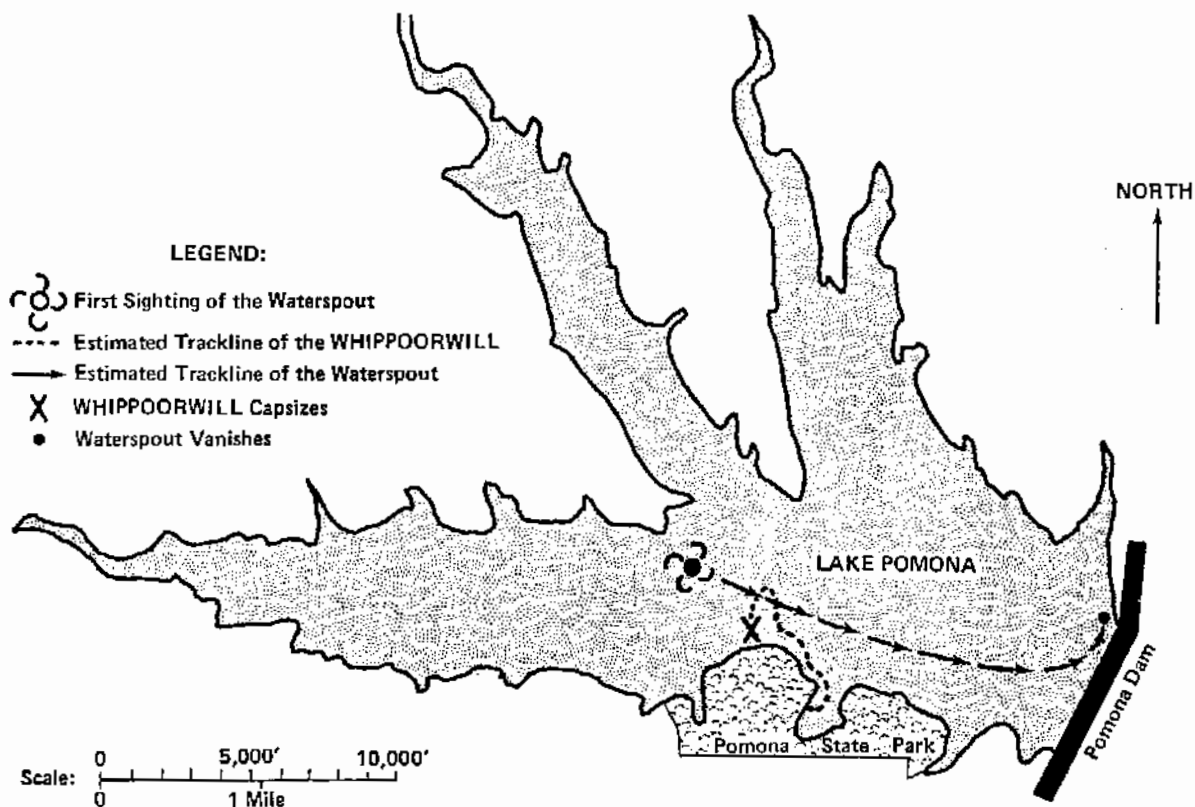
The Whippoorwill's course through the waterspout's path.
