# Proceedings

January/February 1989

# Explosive Vapors, Flammable Liquids, and Welding Never Mix

# Barge Ballistics

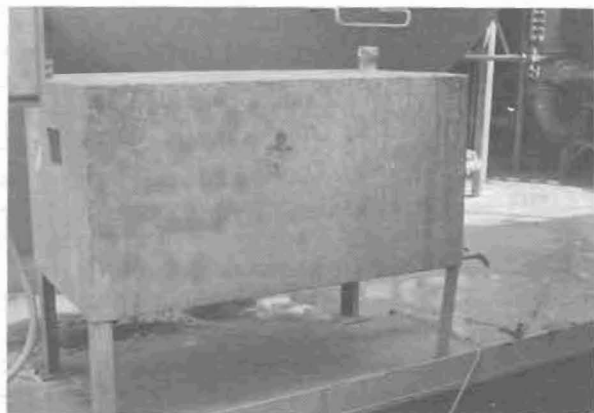
This chemical tank -- unused -- is similar to the one which exploded. Note this tank is marked as containing flammable liquid. (Mineral Management Service photo)

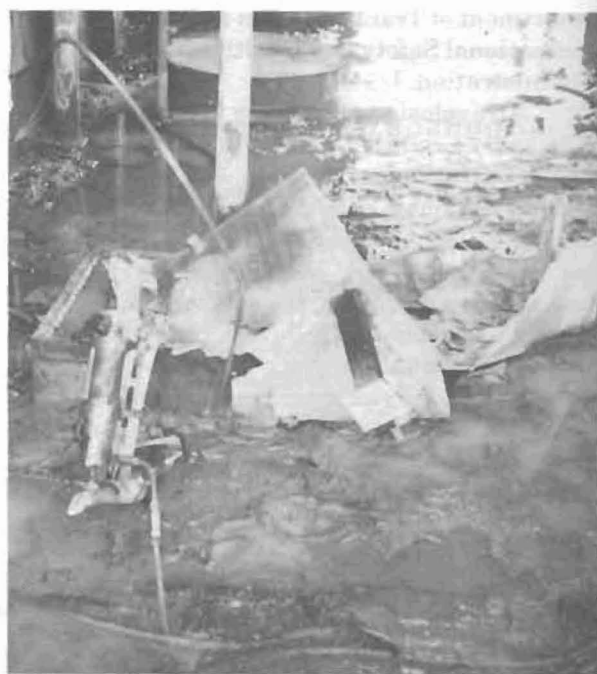
An explosion and raging fire occurred when sparks and slag, descending from the cutting operation one deck above, apparently ignited flammable vapors from the tank located directly below. Thirty-five minutes later the fire was extinguished, and what began as a routine work operation ended in tragedy for four men. The investigation that followed, conducted by the Department of Interior's Minerals Management Service, revealed that the tank was unshielded, and flame-cutting operations conducted so close to an unprotected tank of a flammable liquid was the probable cause of the

fire. It was impossible to determine exactly how the ignition source met with the flammable substance. It was also impossible to determine whether a fill cap was in place on the tank. Had the tank been clearly labeled to the identity of the hazardous nature of its contents, or had the welder been aware of this dangerous situation, he might be alive today, and three other men would have avoided serious injuries. No fuels, gases, or other materials other than the chemicals in the tank made any significant contribution to the fire.

View of damaged chemical tank on deck of well bay area, showing (center foreground) small pump used for injecting chemical into production manifold. (Minerals Management Service photo)

Operators of platforms should strive to maintain the highest standards of safety. Guidelines should be established and enforced which direct the amount of required protective gear to be worn during welding operations (gear should be worn by all personnel in a welding area). Gear that is defective should be replaced. Welding operations should be blocked off so sparks won't ignite materials in the vicinity, and welding operations should be performed only by qualified personnel. Such guidelines will lessen the risk of exposure from gases, fumes, electric shock, heat, and light radiation. Always ensure the work area and surrounding vicinity are certified safe for hot work. Welding is a specialized skill -- respect and guard against its hazards. ■

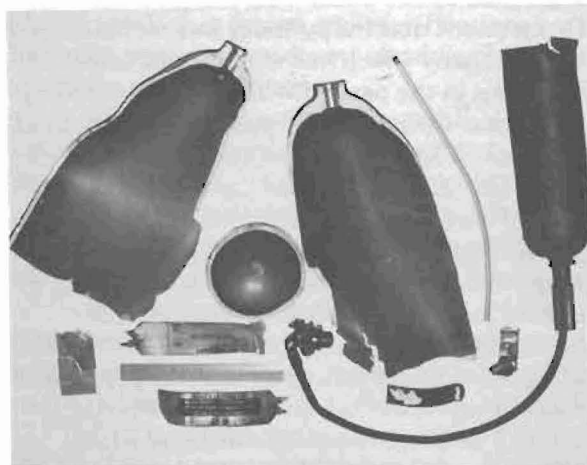
Remnants of the fire extinguisher. (Photo by LTJG Donald Novello)

The investigator and inspectors found that the bulkhead on which the cylinder was mounted was pushed out at least 2 inches. The cylinder itself was split longitudinally from the valve to the base. Deep gouges were noted in the cylinder fragments from where they had struck various objects during their ballistic flight. The remnants of one storage locker had been dragged out on the deck for closer inspection while the other locker was still wedged in place like a crumpled beer can.

The explosion was linked directly to the presence of an unsuitable rupture disk in the valve assembly. Since no paper trail links the service company to overfilling the extinguisher or substituting a bad rupture disk, one can only speculate as to the contributing causes of the incident. These causes lay in keeping the extinguisher in a space where there were elevated temperatures and a *possible* overfill during the last servicing. Even a cylinder with a normal charge of CO<sub>2</sub> will experience an increase in pressure due to an elevated temperature.

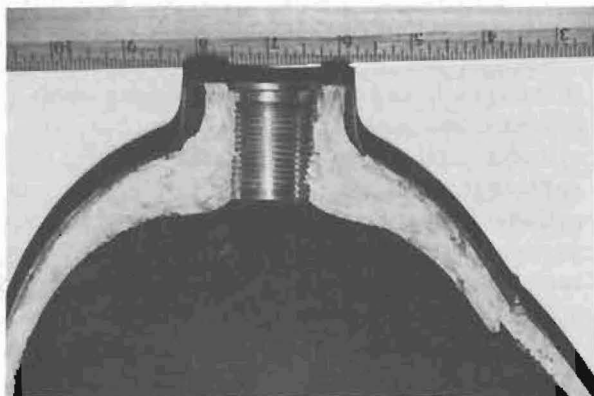
The culprit had been found, or so it seemed. The valve was now opened for the first time following the explosion, and a rupture disk which was unsuitable for that type of valve was found inside. It showed signs of deformation but it could not be concluded that this was a result of the test or the actual incident. The reason the valve did not blow when it should have was now known: an improper disk. One difficult question remained: what caused the pressure in the cylinder to exceed 4,800 psi?

Detail of the fire extinguisher's neck. Note secondary crack below 3" tick mark. (Photo by LTJG Donald Noviello)

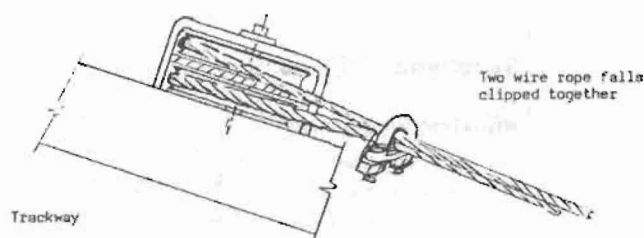
Showing use of a wire rope clip as a stopper adjacent to a double-sheaved fairlead bracket

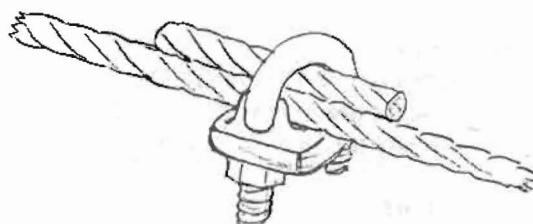
For the fairlead of a single fall, where the second wire is missing, the extra clearance within the bend of the U-bolt will require filling with a scrap of wire so that the clip will not slip from the load carried by the fall when the clip jams against the fairlead bracket.
