Proceedings of the Marine Safety Council

October-November 1989

Vol. 46, No. 6

While the U.S. tanker **SS Blue Ridge** was topping off with a cargo of several products, its number 1 center cargo tank overpressurized and suddenly expanded upward about 3 feet. Although the damage to the tank top and underdeck structure was severe, no one was injured.

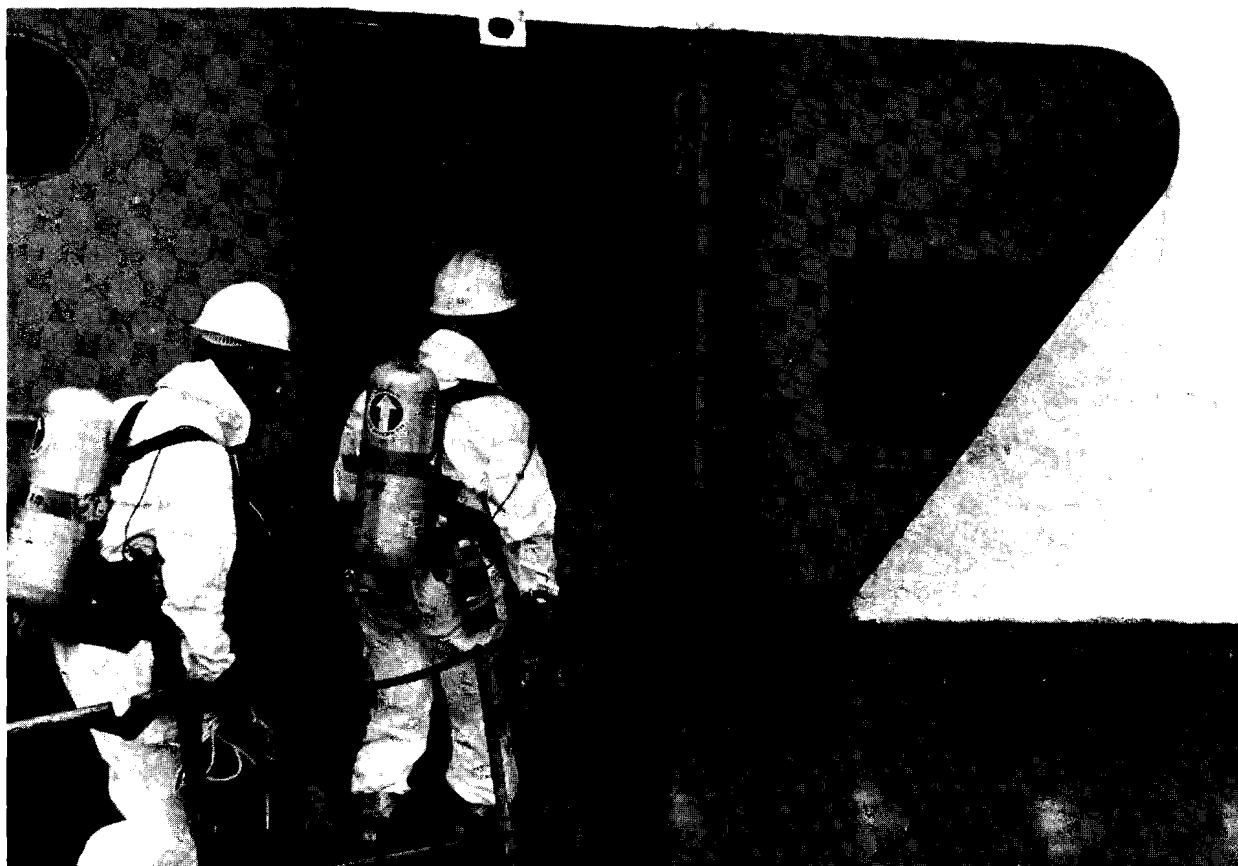
In 1984, an incident occurred at the Port of Houston which demonstrated the danger that hazardous materials pose when improperly packaged and shipped. The Argentine vessel Rio Neuquen was offloading containers at City Dock

Strike Team personnel begin cleanup operations aboard the Rio Neuquen. (Official U.S. Coast Guard photo by PA1 Keith Spangler)

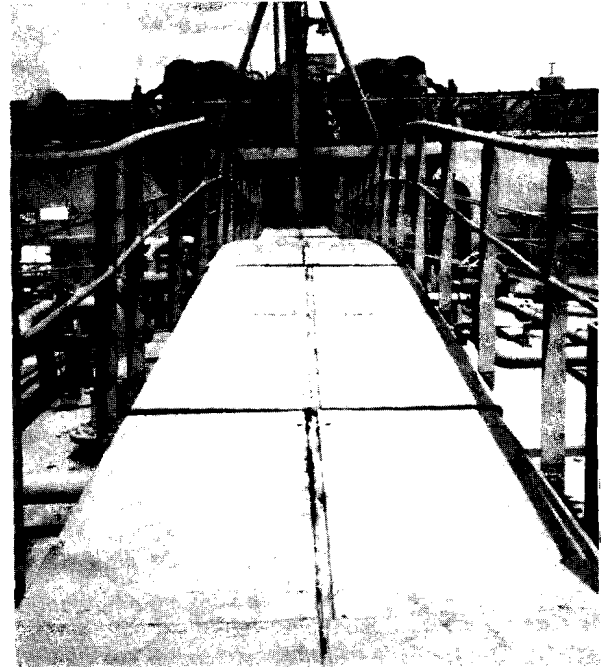
Looking forward on the tank vessel **Blue Ridge**. Catwalk over No. 1 Center showing pronounced distortion of tank top. (Photo provided by the author)

The Master and Chief Engineer found the deck above number 1 center deformed into a dome shape, uniformly elevated to a height of nearly 3 feet at the tank center. The tank top was split in several areas around its periphery and, surprisingly, relatively little diesel oil had escaped. The small amount of leaked oil was contained on deck, and no water pollution occurred. The crew then began to investigate why the tank had overpressurized, and they checked for internal ship damage.

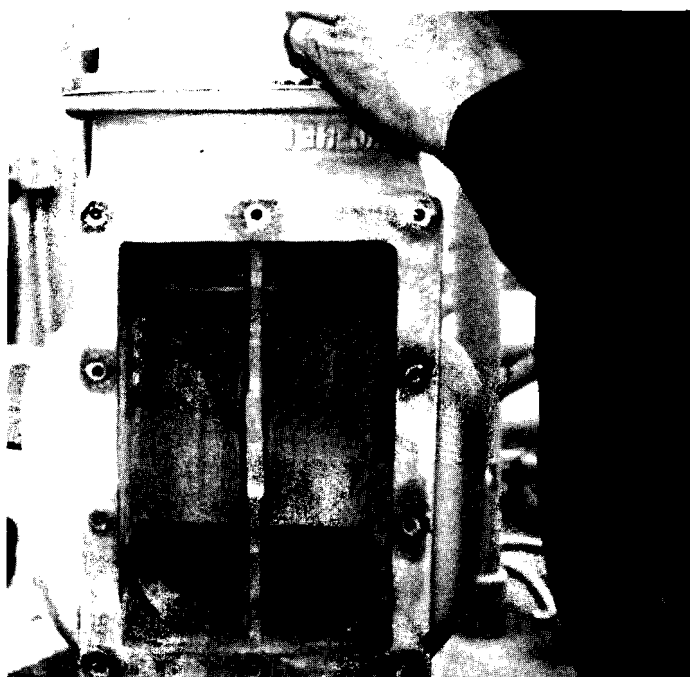
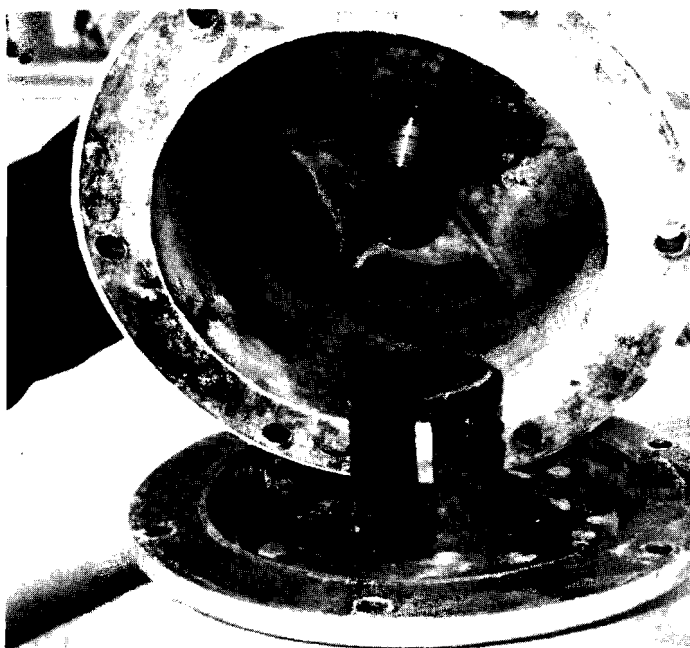
Top: P/V valve with louver and flame screen removed. Poppet in upper (pressure side) chamber could not be lifted without opening hand wheel. **Bottom:** Bonnet removed from P/V valve showing valve stem with flared end intended to fit under fitting on top of poppet.

The independent pressure vacuum (P/V) relief valve mounted at about eye level off the tank trunk appeared to be normal. However, when the crew removed the louvered cover and flame screen, they were unable to move the valve's pressure-side poppet from its seat unless the hand wheel was opened. At this point, the Master decided to secure the inert gas branch line valve and P/V valve from further examination by covering them with plastic garbage bags. This was done to preserve their condition until Coast Guard investigators, the American Bureau of Shipping, and company representatives had an opportunity to observe the valves.

The day after the accident, all inspection personnel witnessed the dismantling of the P/V valve. When the bonnet was removed, the cause of the valve's failure to lift (and the primary cause of the casualty) was readily apparent. Instead of the poppet's being suspended from the end of the stem as it should have been, the bonnet and stem assembly had been installed so that the stem rested on *top* of the poppet instead of suspending it. Thus, when the stem was cranked down to enable the valve to function in the "automatic" or P/V mode, there was no way for the poppet to lift. Consequently, excessive internal tank pressures could not be released since the poppet was basically "gagged" by the stem. With this valve essentially closed and the inert gas branch line valve closed, the displaced inert gas atmosphere had no place to escape.

The P/V valves on the *SS Blue Ridge* had been completely overhauled during a shipyard period about 1 month prior to the casualty. The overhaul consisted of dismantling the valves, cleaning and dressing up their components where necessary, then reassembling them. It is likely that this valve and four others were reassembled incorrectly, probably by the same individual since the valves were all in the same vicinity aboard ship. One of the other P/V valves opened for examination was found to have an undersized internal diameter gasket between the bonnet and the valve's body. This caused the poppet to hang up on the excess gasket material when it was opened.

It is strongly recommended that shipowners of vessels having similar P/V valves -- capable of being manually opened -- conduct the following examinations:

1. Remove the P/V valve's bonnet and ensure that the pressure poppet has been properly attached to and suspended from the stem. If in lifting the bonnet from the valve body the poppet stays in place, assume that it was improperly assembled.
2. Ensure that the inside gasket diameter that is fitted between the bonnet and lower valve body is the proper size. This prevents the poppet from getting hung up on the gasket if it is opened. The gasket should be the same width as the two mating surfaces of the bonnet and body.

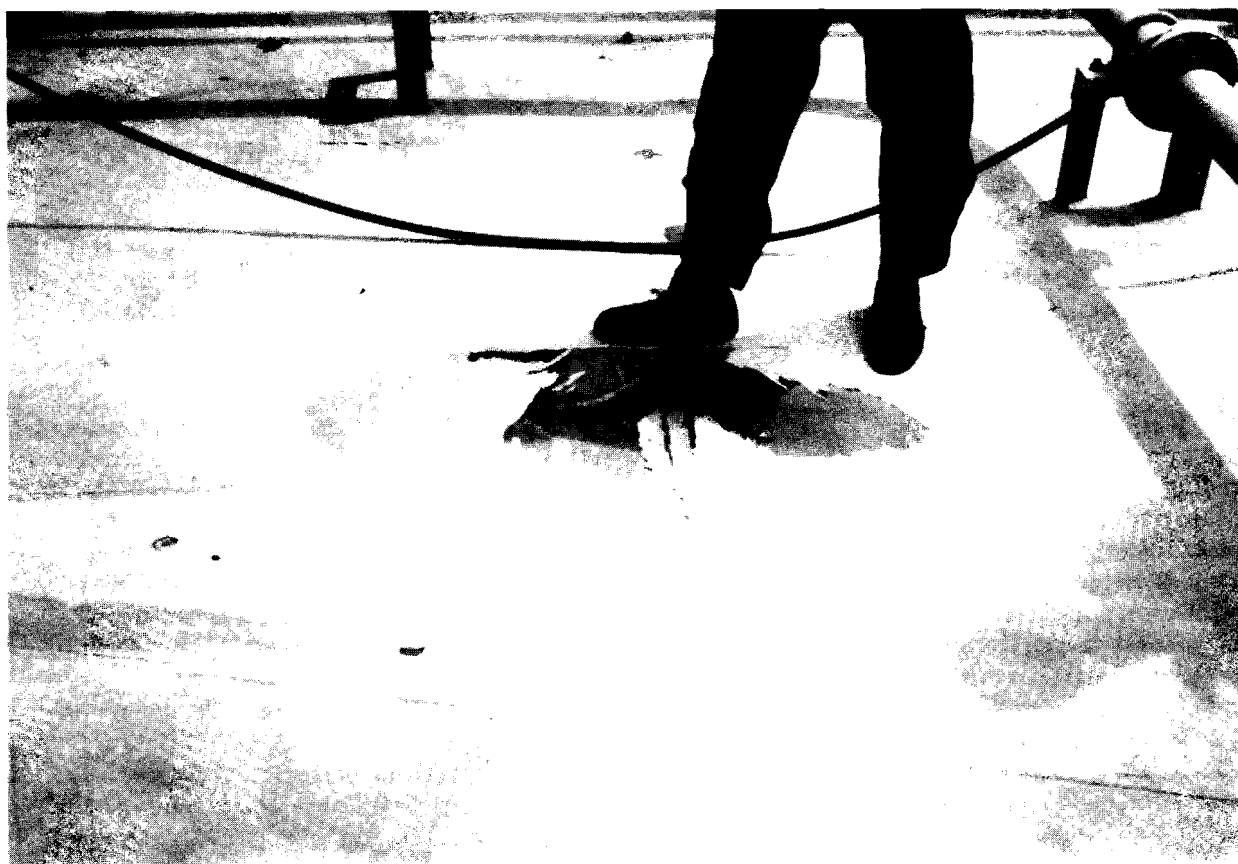
Because the cargo tanks surrounding number 1 center were full when the casualty happened, internal tank damage was confined primarily to its upper portions. Nevertheless, initial damage estimates were almost \$500,000. All of the transverse deep web frames were split in their upper crotch, and the main underdeck

centerline girder fractured just forward of where it intersected with the tank's after bulkhead. Numerous other small strength members, mostly underdeck beams or stiffeners, were severed.

Fracture on the Blue Ridge. The main underdeck centerline girder fractured just forward of where it intersected with the tank's after bulkhead.
