Proceedings

Vol. 48, No. 3

May-June 1991

***Special issue
on marine casualty
investigations***

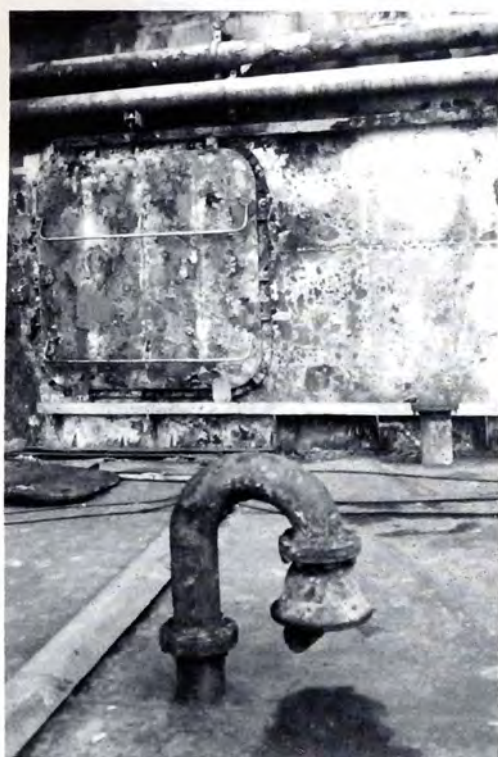
The proximate cause of the explosions and fires aboard the *Omi Yukon* was the contamination of the vessel's bunkers (fuel oil) with distillate products (flush oil) during bunkering through an undersea pipeline. An equally significant causal factor was the absence of a flame screen in the after starboard fuel oil tank vent.

*Damage to Omi Yukon's
fuel-oil storage tank vent,
located port-side forward.*

3. The extent of fire and explosion damage limited the ability to determine the source of ignition. Possible sources included hot slag or sparks from the burner's torch falling into the vapor plume from the unprotected fuel oil storage tank vent, a dropped friction ignitor, discarded smoking materials or an electrical short in an on-deck fixture located near the vent.

The commandant concurred with recommendation 2, remarking: "While Coast Guard regulations, specifically 46 CFR 56.50-85(a)(7), currently require flame screens on fuel oil tank vents, SOLAS does not. The Coast Guard will propose that the International Maritime Organization require flame screens on fuel tank vents for all passenger, cargo and tank ships."

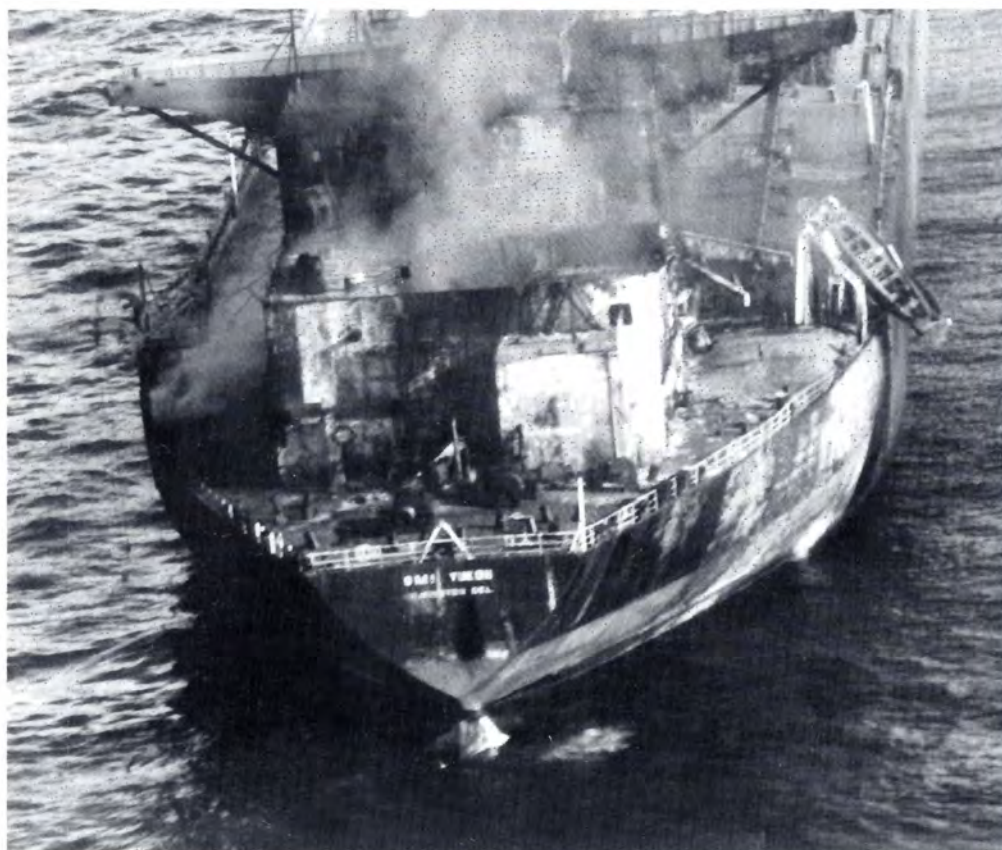
The explosions extensively damaged the engine room, and removed the stack deck and the stack completely off the vessel.

Stern view of
Omi Yukon after
the explosion.

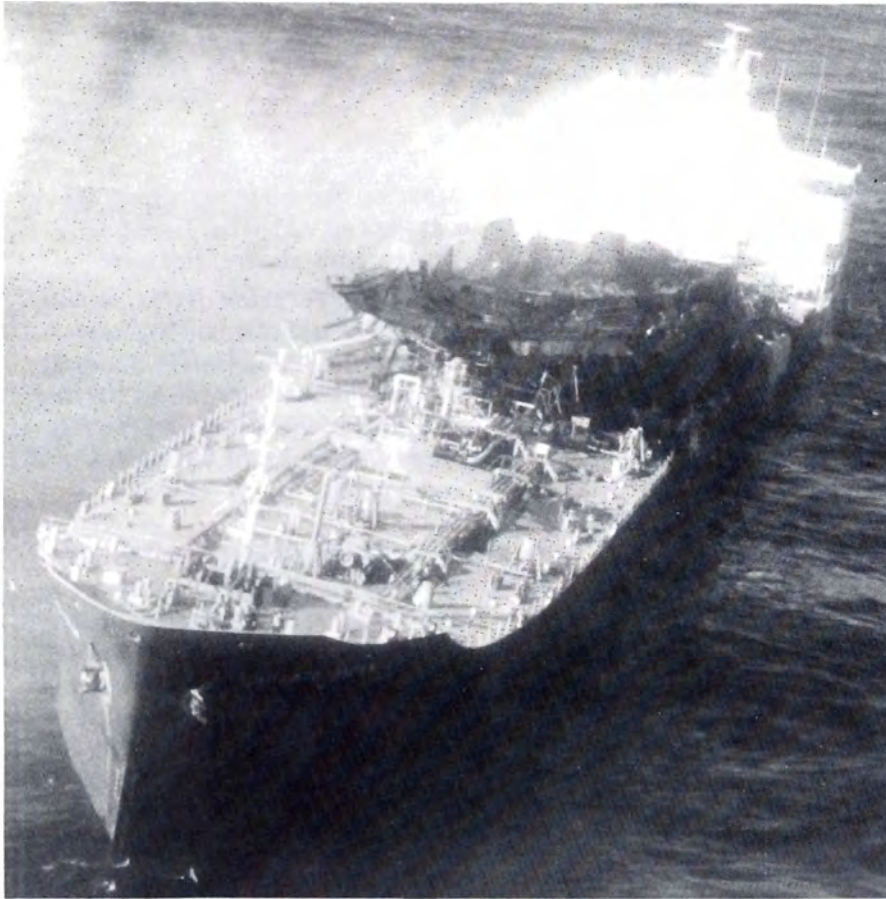
Puerto Rican on October 31, 1984, at about 10:30 a.m., a little more than 15 miles from Point Bonita.

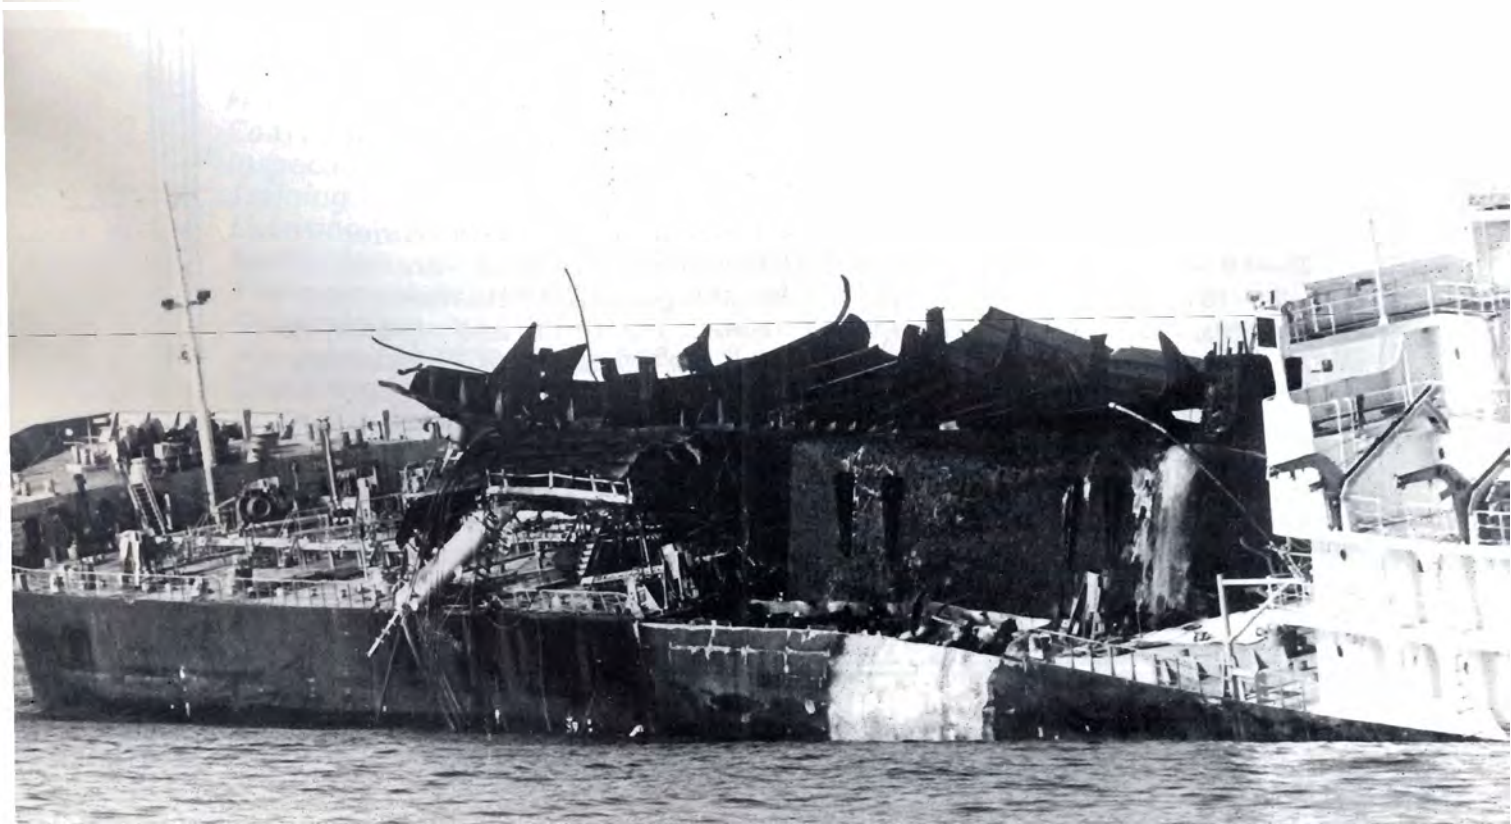
- (a) The proximate cause of this casualty was the failure to repair a gouge through the stainless steel cladding on the bulkhead separating 5CP and 6CV. The gouge was most probably made while the tank was being constructed.

- (b) The gouge exposed the mild steel bulkhead behind it, which then corroded due to repeated exposure to caustic soda. The corrosion process created a hole that fully penetrated the 5CP after bulkhead sometime before the vessel's arrival at the GATX Terminal in San Pedro on October 21.

Puerto Rican on November 1, at about 9:30 a.m., approximately 35.5 miles from Point Bonita. The angular difference at the gunwale shows the area where the forebody separated from the stern on the port side at the main deck.
