# *Proceedings*

*of the Marine Safety Council*

*September-October, 1993*

**Special issue on fire protection**

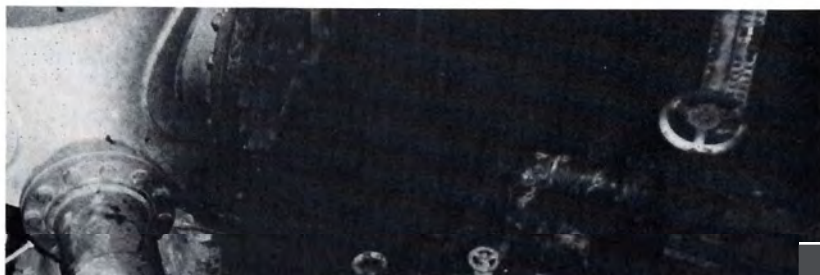
(Left) At the 2 o'clock position, the small valve is white from heat. This is the source of fuel. (Below) A similar valve shows epoxy bedding at its base, compensating for undersize threads.

the Coast Guard investigator's theory. The base of the valve on the #1 pump casing had received repairs similar to those of the unaffected pump. As the pump casing was warmed by the flow of the preheated oil, a small leak developed at the base of the valve. Under pressure from the pump, an oily mist sprayed from this base.

The oil collected and dripped down onto the spinning pump shaft, slinging leakage throughout the compartment. Slowly a concentration of explosive vapors grew in the space, allowing an arc of electricity from the preheater coil to ignite the mist. When this happened, the flames followed a course back to the fuel source — the base of the valve.

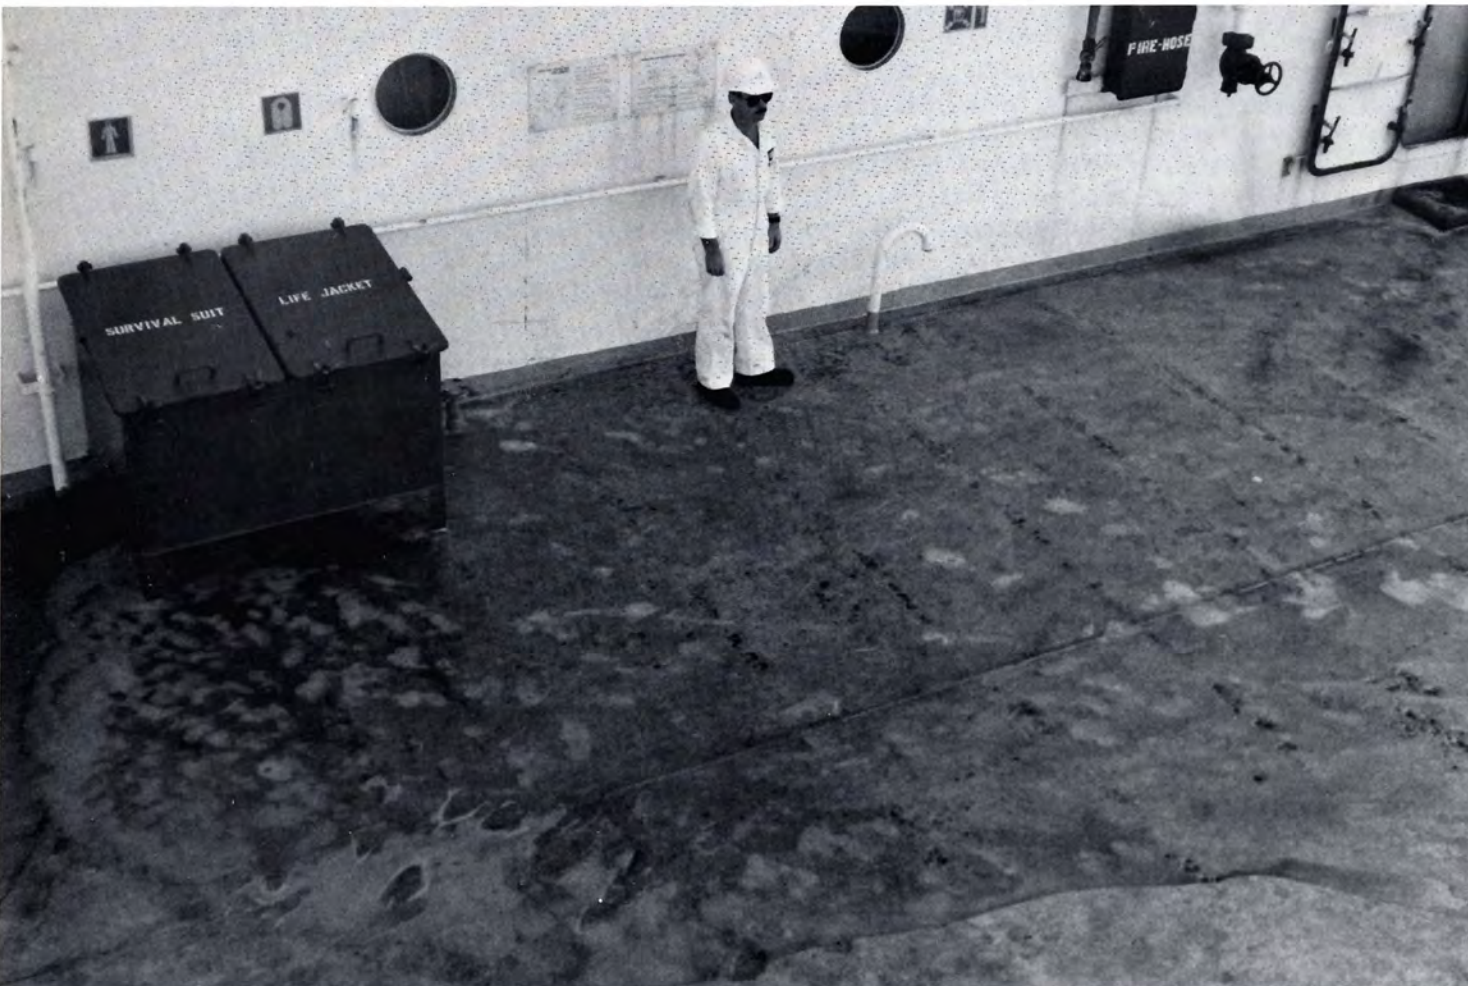
*Much of the foam which should have gone to fight the fire in the pumproom spilled out through vents and fire stations onto the weather decks.*

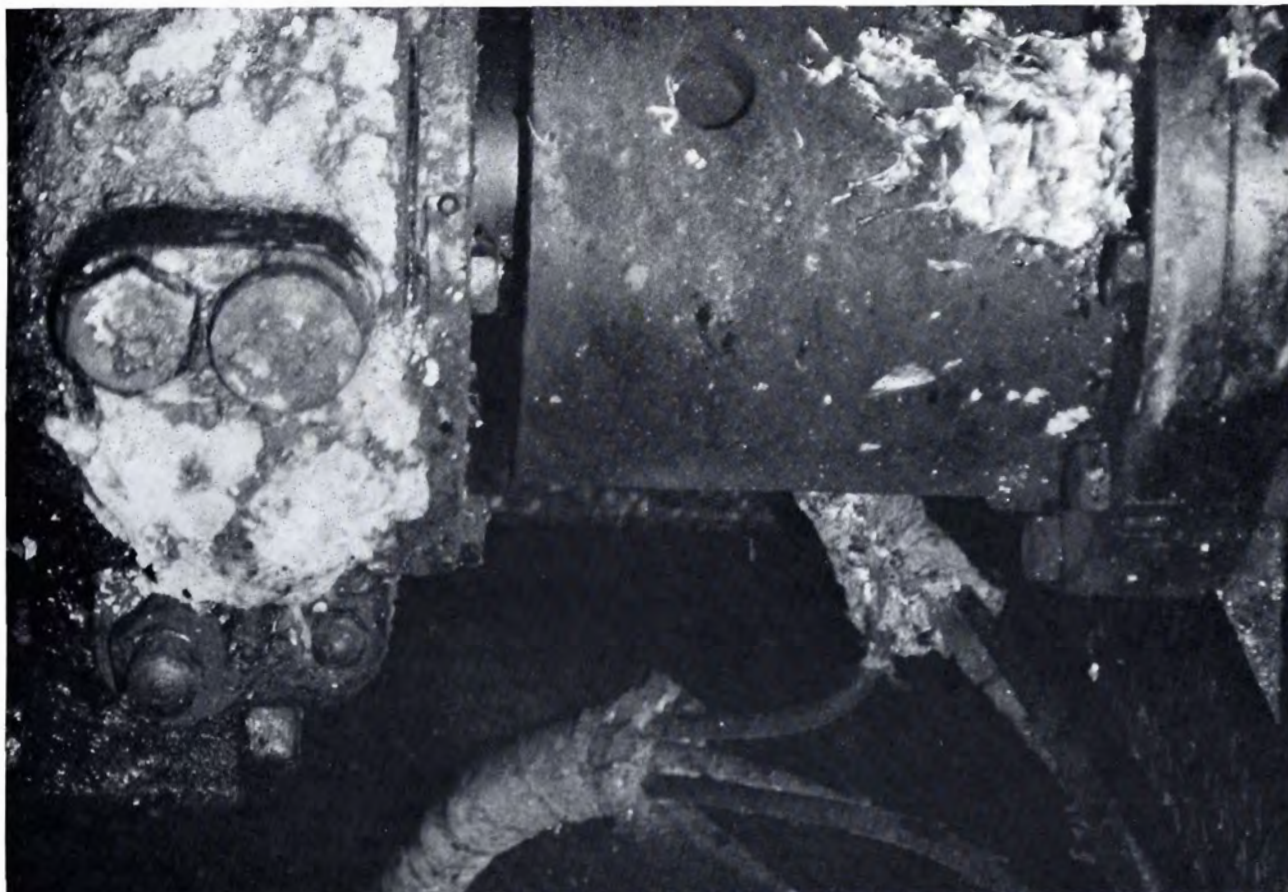
*The broken wire (lower right) in the pre-heater circuit provided the heat source for ignition. Pitting caused by electrical arcing is clearly visible on the surface of the exposed wires.*

The flash exposure had provided a good overall view of the affected pump, pointing to the fuel source or hot spot of the fire. Only one of the 70 photographs taken revealed the source of ignition. Illumination from the flash exposed a broken wire in a preheater coil below the pump casing. The wire had been hidden by the darkness and only luck had included it in the photograph. Pitting on the wire from electrical arcing was clearly visible.

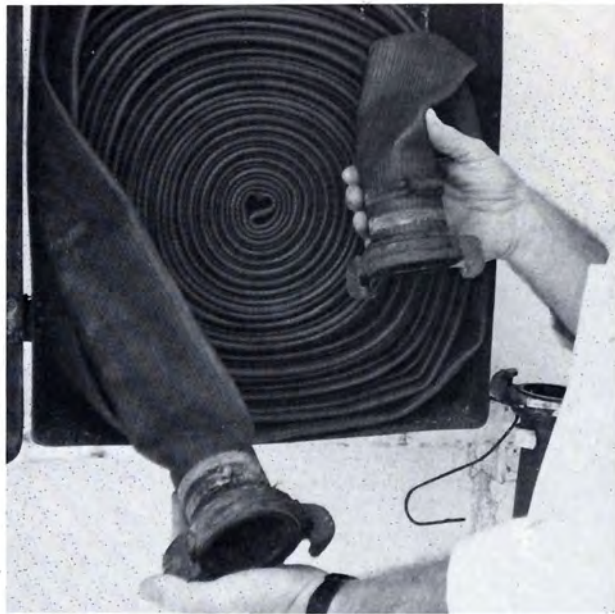
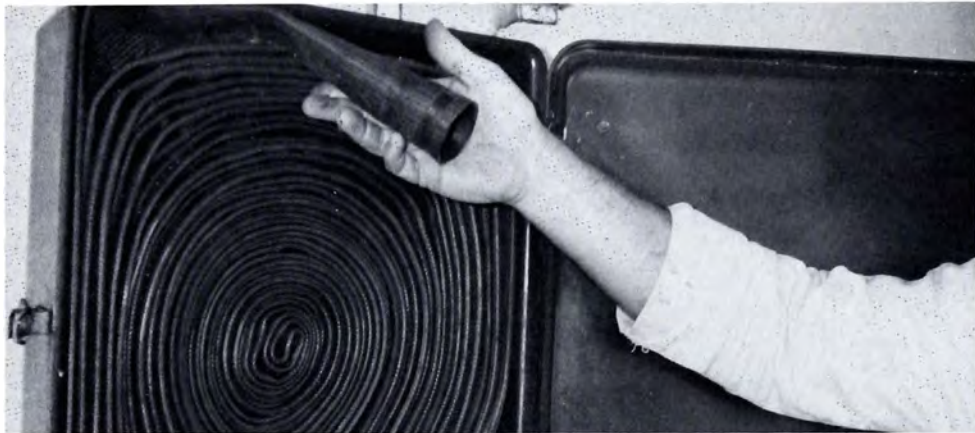
However, the initial surge of pressure from the shore-side firemain ruptures many of the hoses laid out on deck. These hoses had come from various fire stations aboard the *Skaufast*. The condition of the rest of the fire equipment aboard the vessel is at best questionable, and time is too valuable to waste on setting up equipment which is likely to fail when used. Therefore, the fire party from the facility regroup and lays out its own hoses while the fire fighters get outfitted.

(Above) Hose fittings are held loosely in place by corroded fasteners.  
(Below) Hoses are missing fittings.

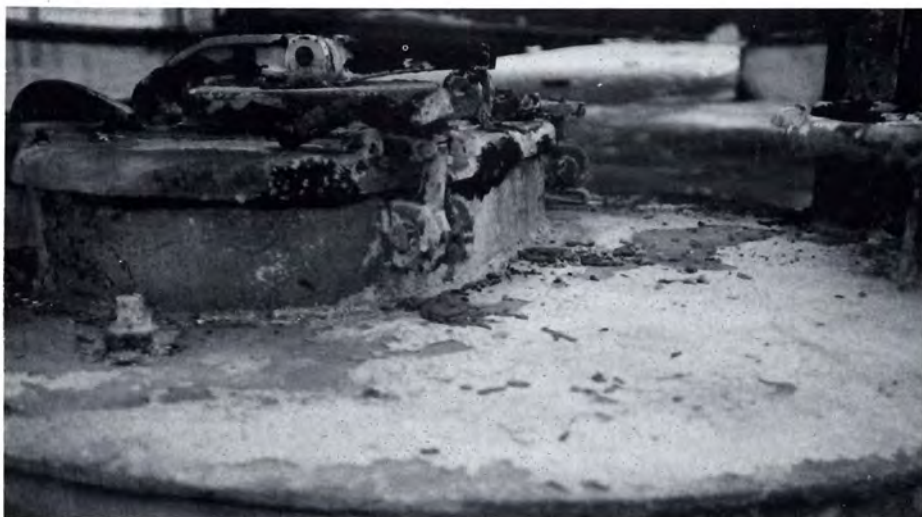
*Closing the hatch would have put out the flames much more easily.*

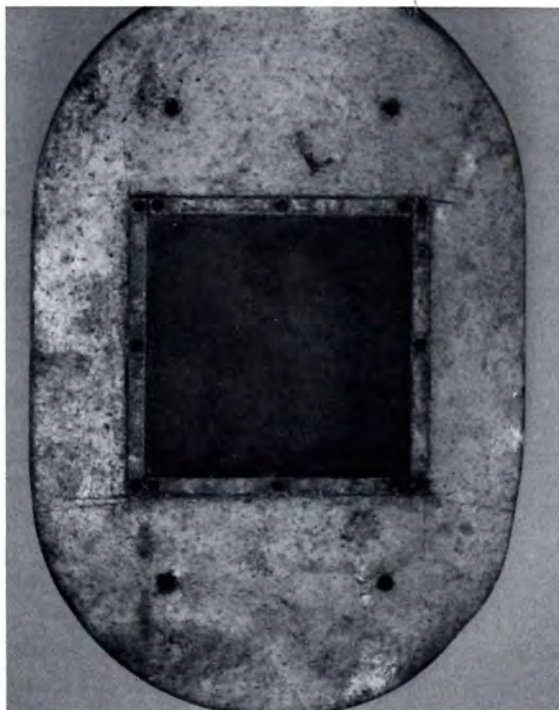
It was recalled that just before the fire, the tankerman had noted that a polypropylene mooring line was slack, and he pulled on it, letting it slide between his hands. He then grabbed the flame screen from the ullage of the #3 starboard tank. It was thought that the static buildup on his hands from working with the line created an incendiary discharge spark, igniting the vapors, which were within flammable limits.

*Discoloration on screen came from flames burning above it.*

The most effective measure to prevent electrostatic hazards is to bond all metal objects together, grounding them. This is done aboard ship by connecting all metal objects to the metal hull, which is naturally grounded through the water.

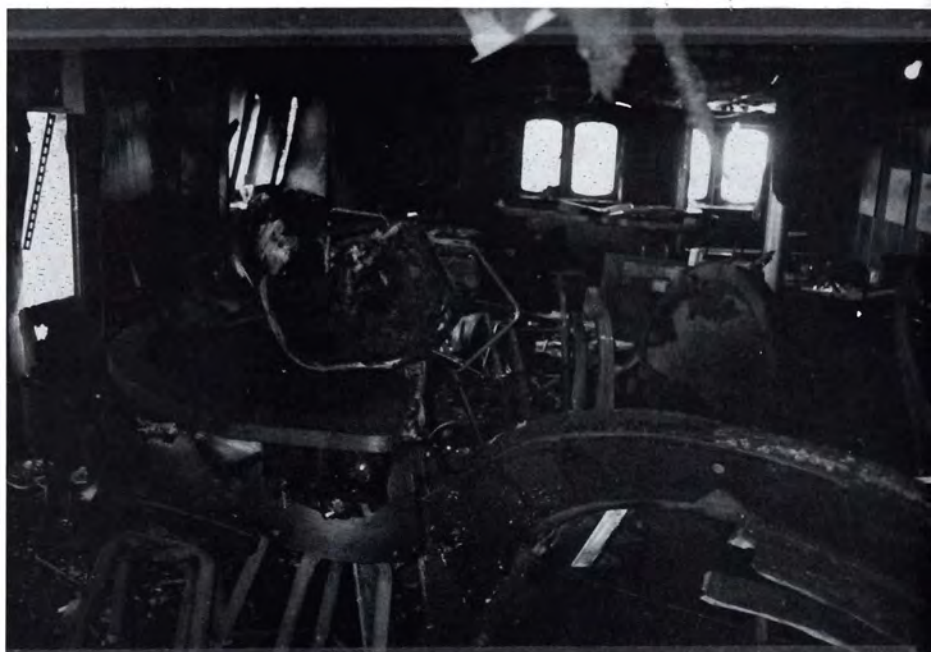
*This fire-damaged passenger ship lounge was fitted with heat detectors, but no automatic sprinklers.*

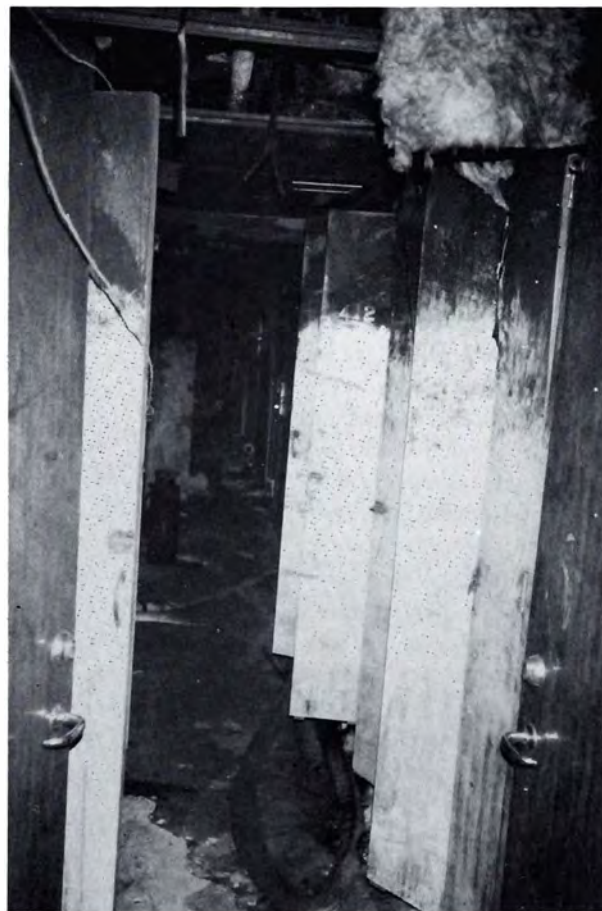
*Burned finishes and soot along the top of this corridor show what can occur during a fire at sea. The vessel had fire detectors, but no automatic sprinkler system.*

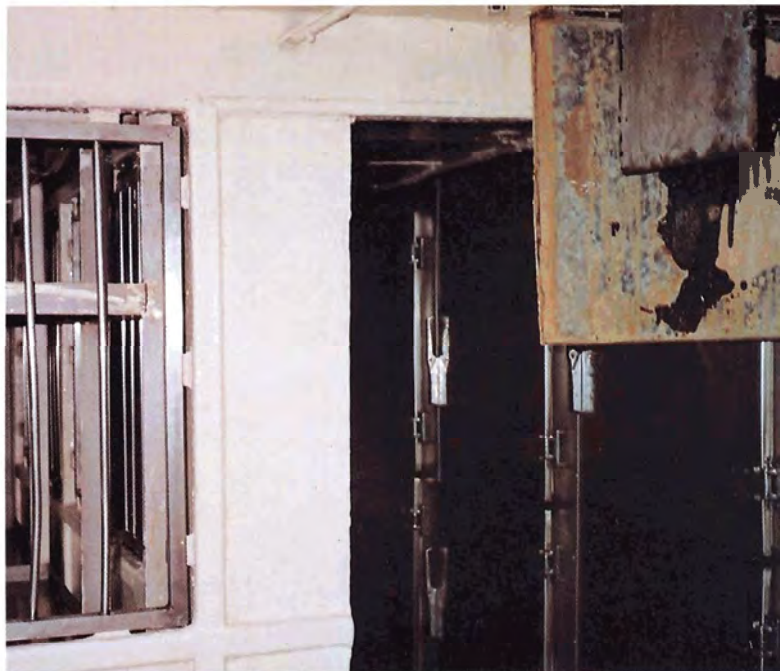
The #4 fan room sustained the most damage. A class A fire broke out on a metal storage shelf containing vent filters that burned very hot. The shelves warped and collapsed, and a duct above also warped. Some wire cable runs were destroyed in this space, affecting other vessel systems.

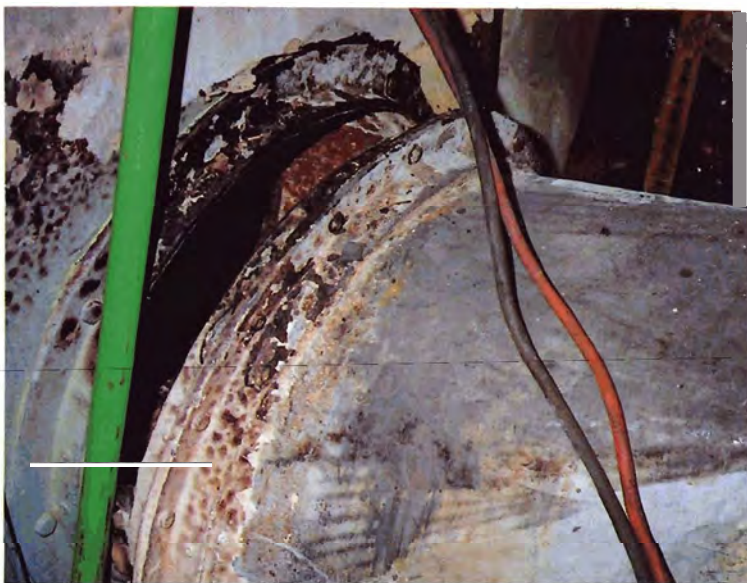
*Canvas ducting burnt away.*

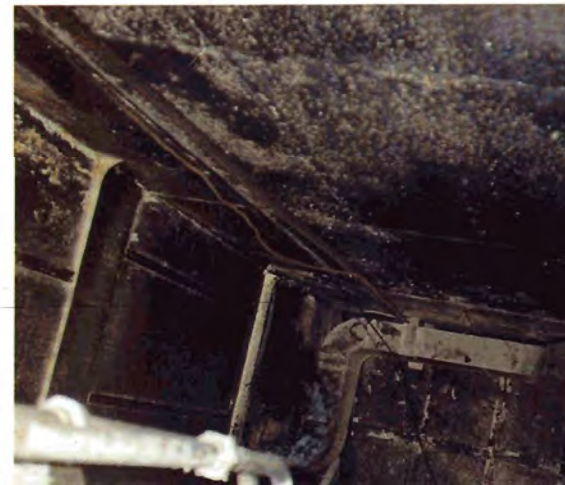
*Canvas ducting burnt away.*

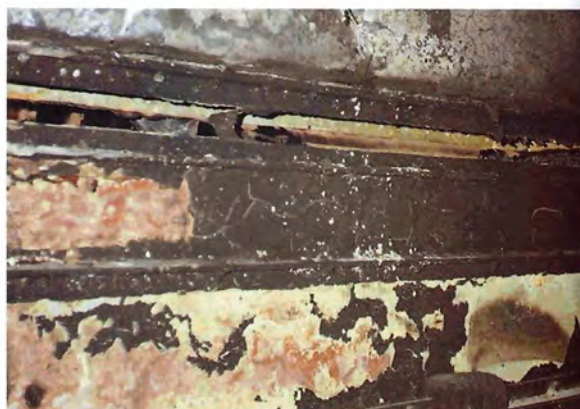
*Burnt insulation.*

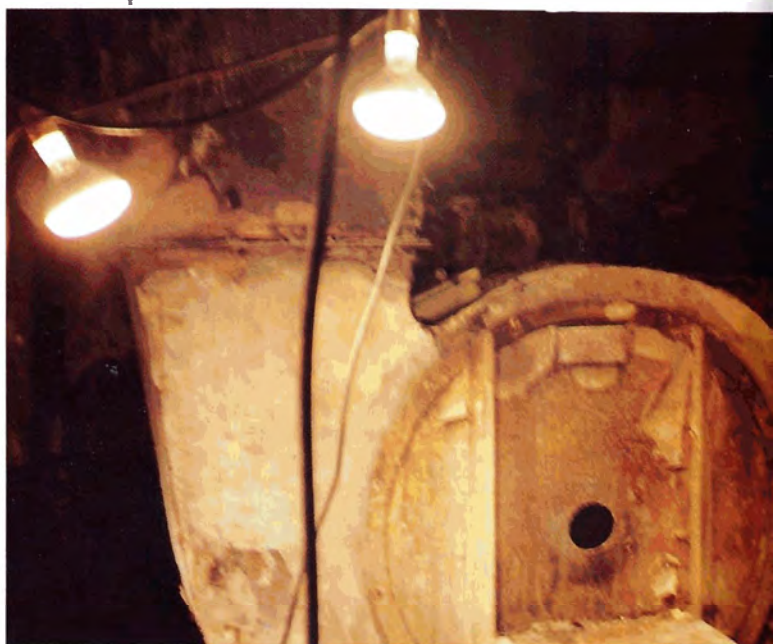
*Canvas anti-vibration duct burnt away.*
