Summer 2006

The **COAST GUARD** Journal of Safety
& Security at Sea
PROCEEDINGS
of the Marine Safety & Security Council

Lessons Learned
from U.S. Coast Guard
Casualty Investigations

Vol. 63, Number 2

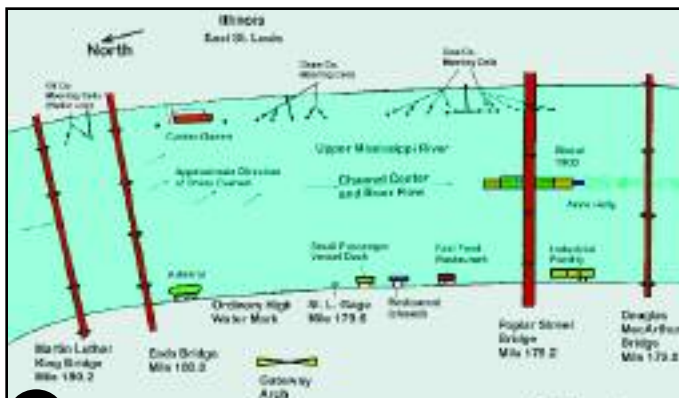
1 The *Anne Holly* crosses under both the MacArthur and Poplar Street Bridges.

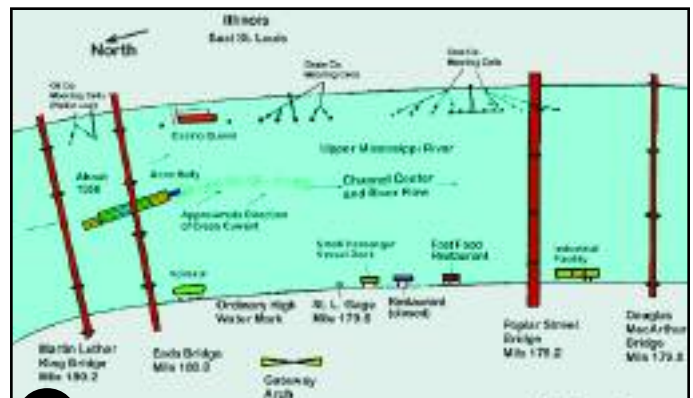
2 The vessel approaches the Eads Bridge.

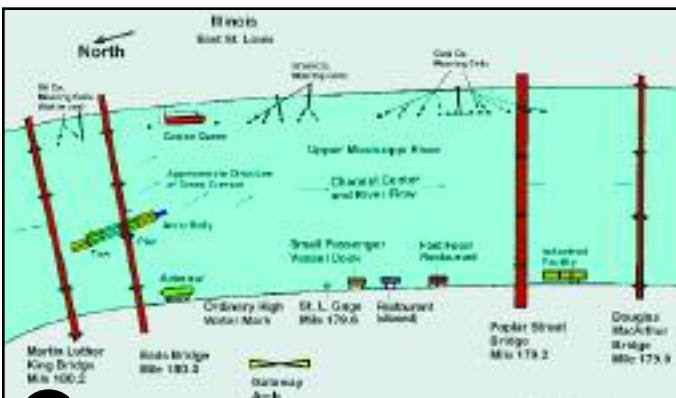
3 The only passage possible under the bridge with the increased flood stage is directly under the center span.

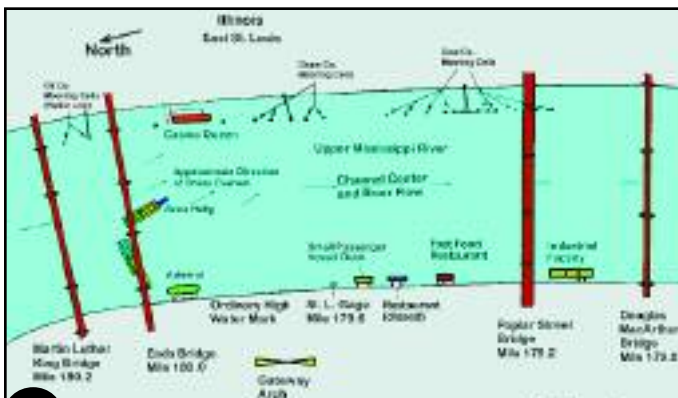
The Coast Guard and National Transportation Safety Board (NTSB) Investigation Reports, while conducted independently, both attributed the cause of the allision and subsequent breakup of the tow to poor decision-making on the part of the *Anne Holly's* captain. They both specifically cited his failure to properly account for the prevailing currents, which led him to oversteer. According to the findings of the Coast Guard Report, "as the lead barges in the unit responded to the steering maneuver, the main downriver current acted with the increasing intensity on the unit's starboard side. Meanwhile, the cross current at the Eads Bridge, flowing in a direction opposite to that expected by [the captain], intensified the

rate of turn beyond that anticipated." The high river conditions and subsequent limited vertical clearance under the Eads Bridge during a nighttime transit were also listed as potential contributing factors.

4 Partway under the bridge the vessel stalls, and the current causes the tow to drift sideways, pushing barges into a bridge support and breaking the tow coupling.

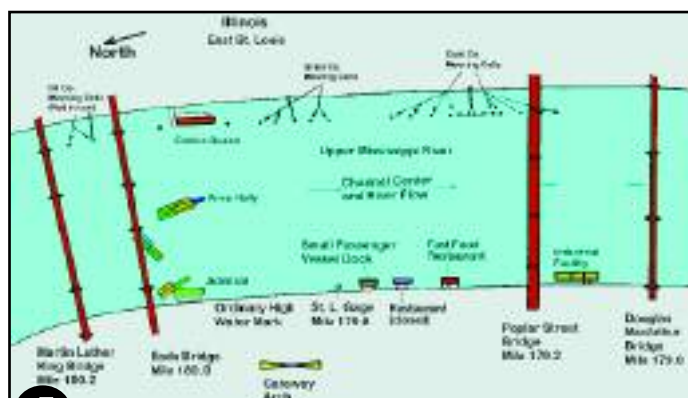
5 A number of the barges break away and drift back south.

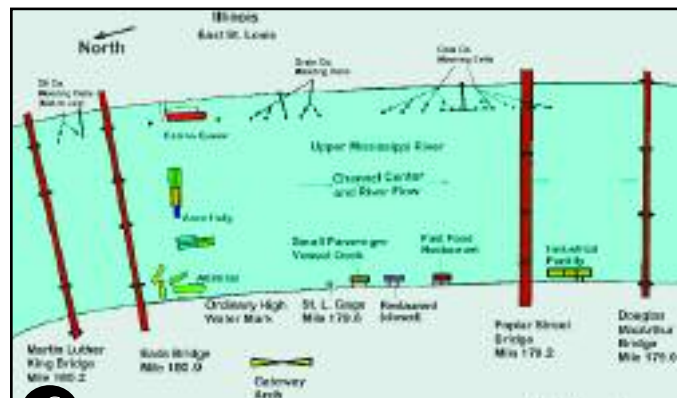
Shortly thereafter though, one or more barges allided with the *Admiral’s* bow and another struck an entrance ramp, breaking the walkway loose from its moorings. Several people on the ramp were quickly evacuated off, all of them successfully reaching the Missouri bank seconds before the ramp sank. With eight of its 10 mooring lines now parted, the *Admiral* began to rotate clockwise downriver away from the Missouri bank.

6 One or more barges allide with the *Admiral's* bow and strike an entrance ramp, breaking the walkway loose from its moorings.

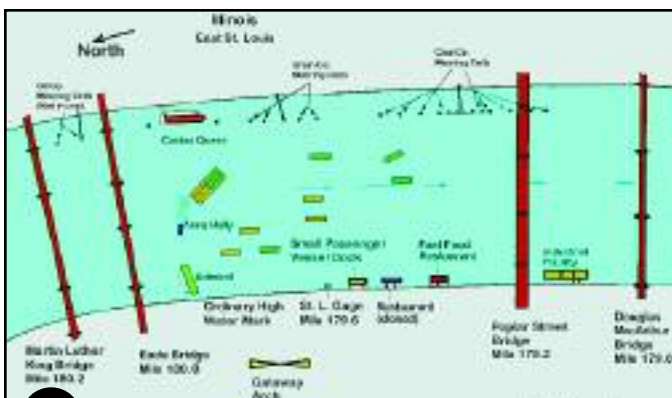
7 The captain releases the remaining barges, turns the towboat around, and places the bow against the *Admiral* as the casino’s next-to-last mooring line parts. Photos courtesy NTSB.

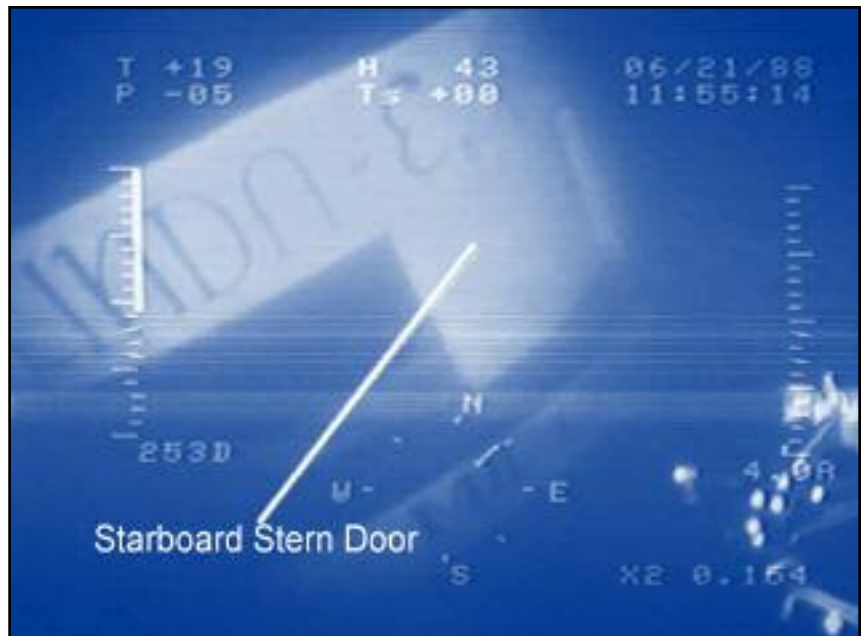
Figure 2: View of the starboard stern door.

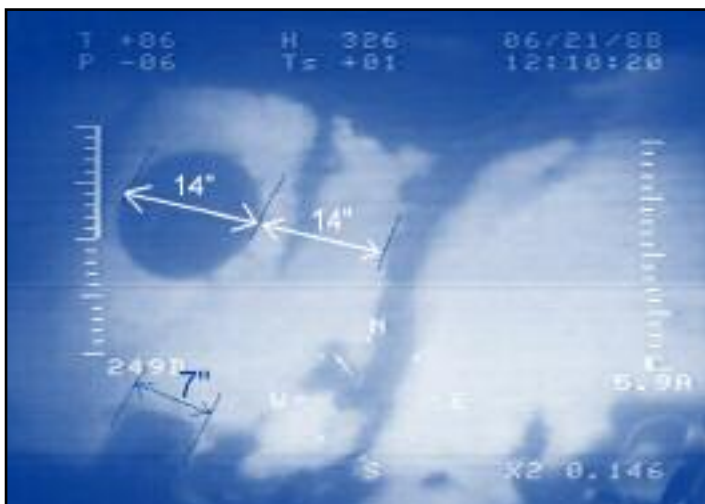
Figure 3: Damage to the vessel.

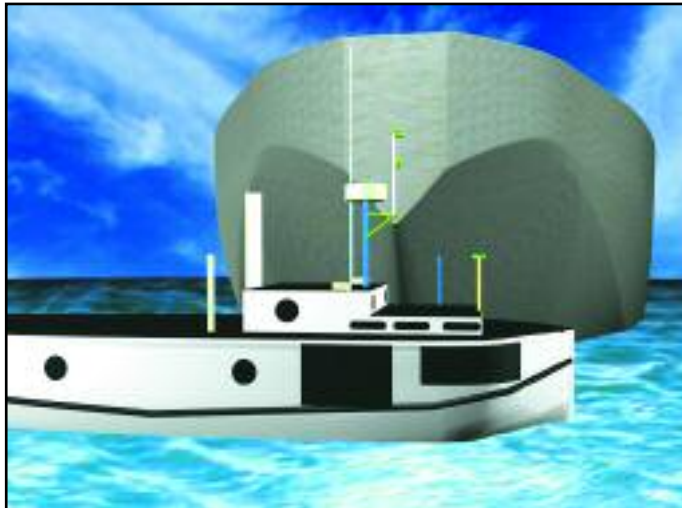
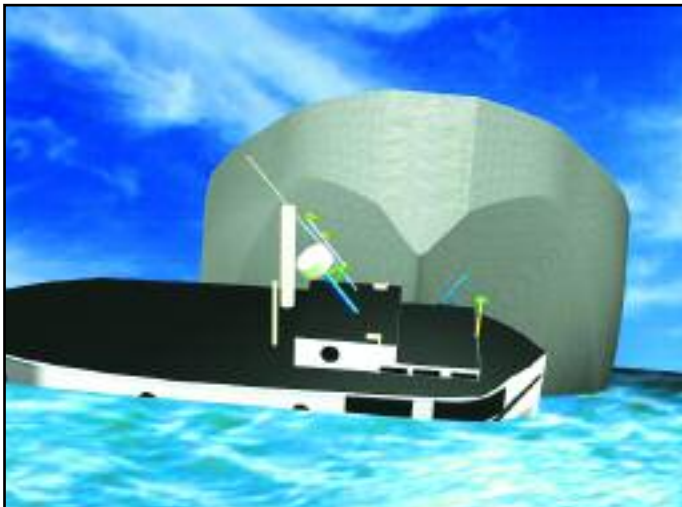
Lack of visibility from both the ITB and the *Linda E* contributed to this collision and casualty. It is possible that the sun, just off the port bow of the ITB, was shining directly into the pilothouse and obscured the *Linda E*. Because of the length of the barge, once a small vessel such as the *Linda E* was close off the bow, the tug operator's view was obscured.

Figures 4 and 5: Graphic analysis, illustrating how the accident may have taken place. Courtesy Marine Safety Center.

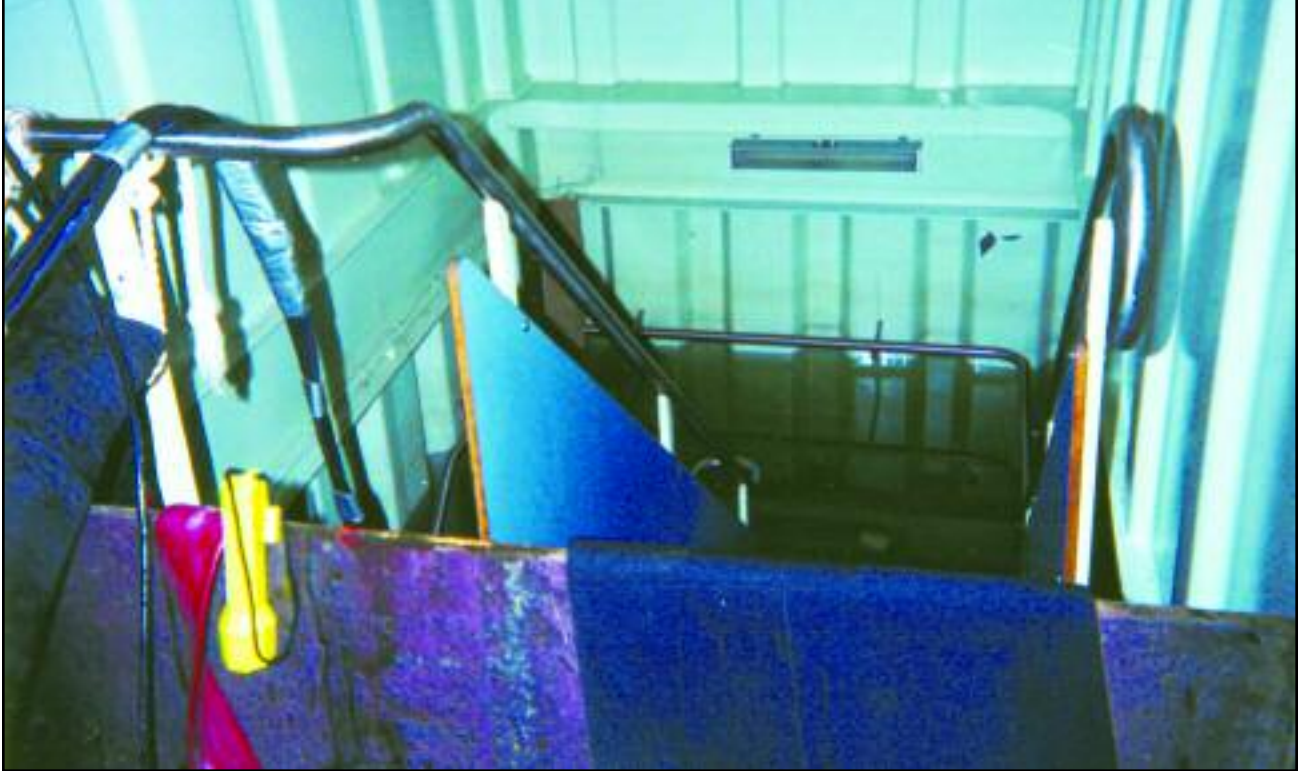
Figure 1: A shot of an interior stairway, showing water level. USCG photo.

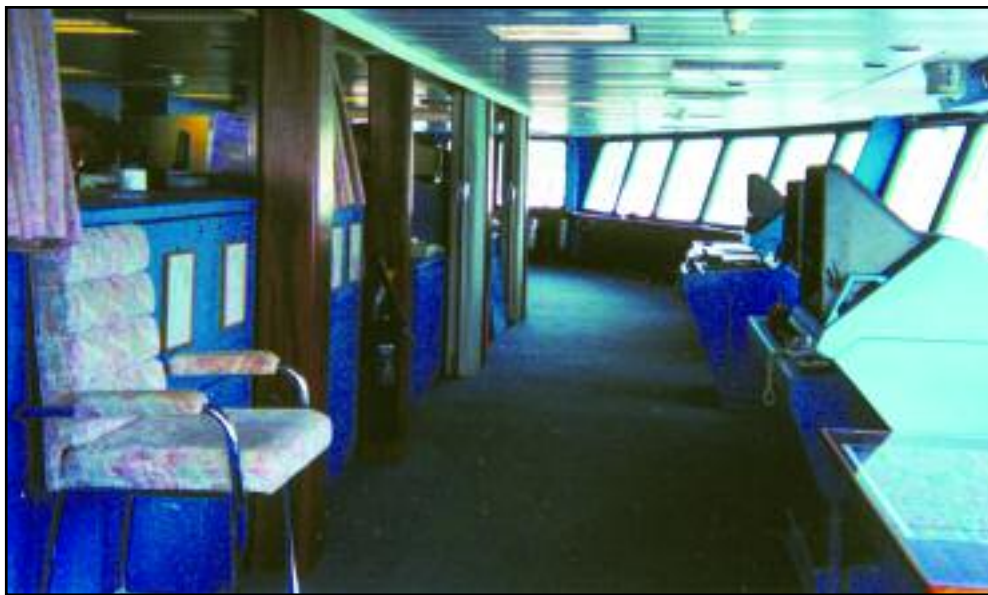
Figure 2: The bridge layout on the *Monarch of the Seas* may have contributed to the incident. USCG photo.

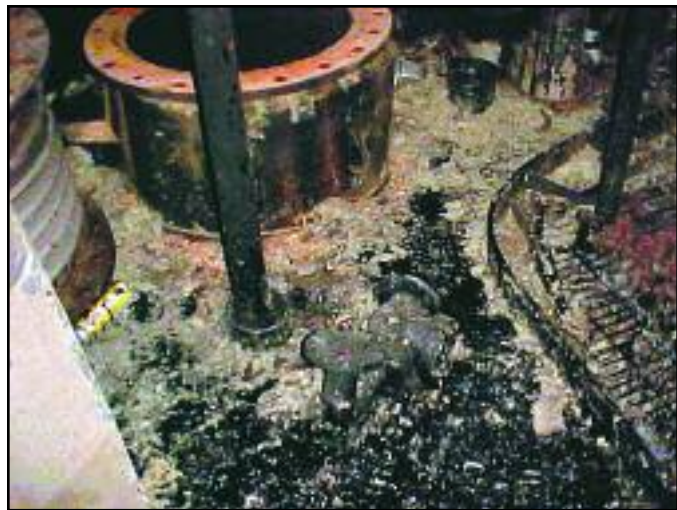
and covered the solid deck plating. Eventually the combined fuels spilled over the first level deck coaming and onto the auxiliary boiler exhaust stack. The exhaust stack was hot enough to ignite the fuels. The resulting fire sent intense heat, black smoke, and flame through the aft levels of the engine room and inside the fidley. The diesel and heavy fuel oil mixture

Residual oil on deck in the vicinity of the incinerator exhaust stack of the 03 level of the engine room. Fire damage is visible in the surrounding area. USCG Photo.

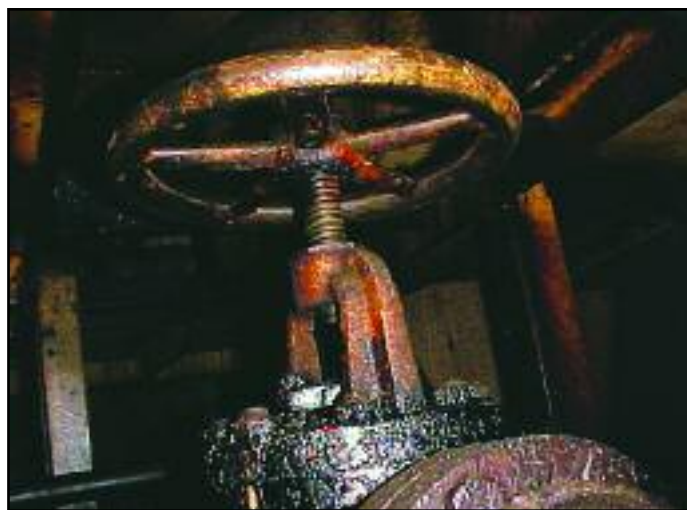
Open discharge valve from HFO (Heavy fuel oil) transfer pump in the lower level of the engine room. Oil and fire damage is visible. USCG Photo.

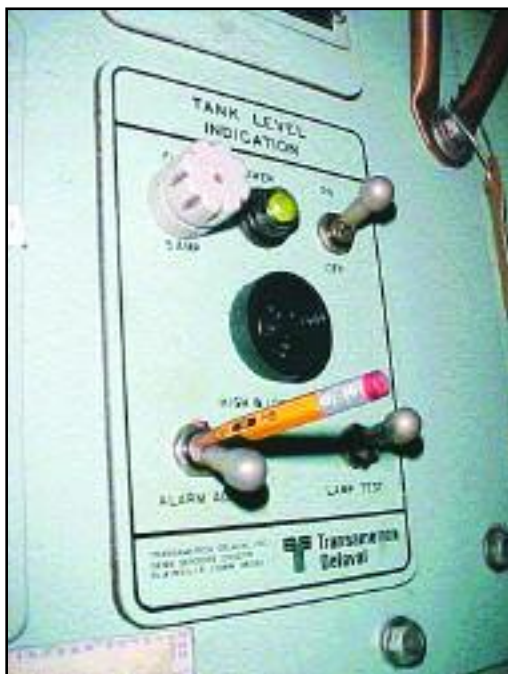
A pencil wedged into the High Tank Level Indicator audible alarm panel. Position of pencil holds switch in "Acknowledge" position. The alarm would never sound to warn of a high tank level when the switch was in this position. USCG Photo.

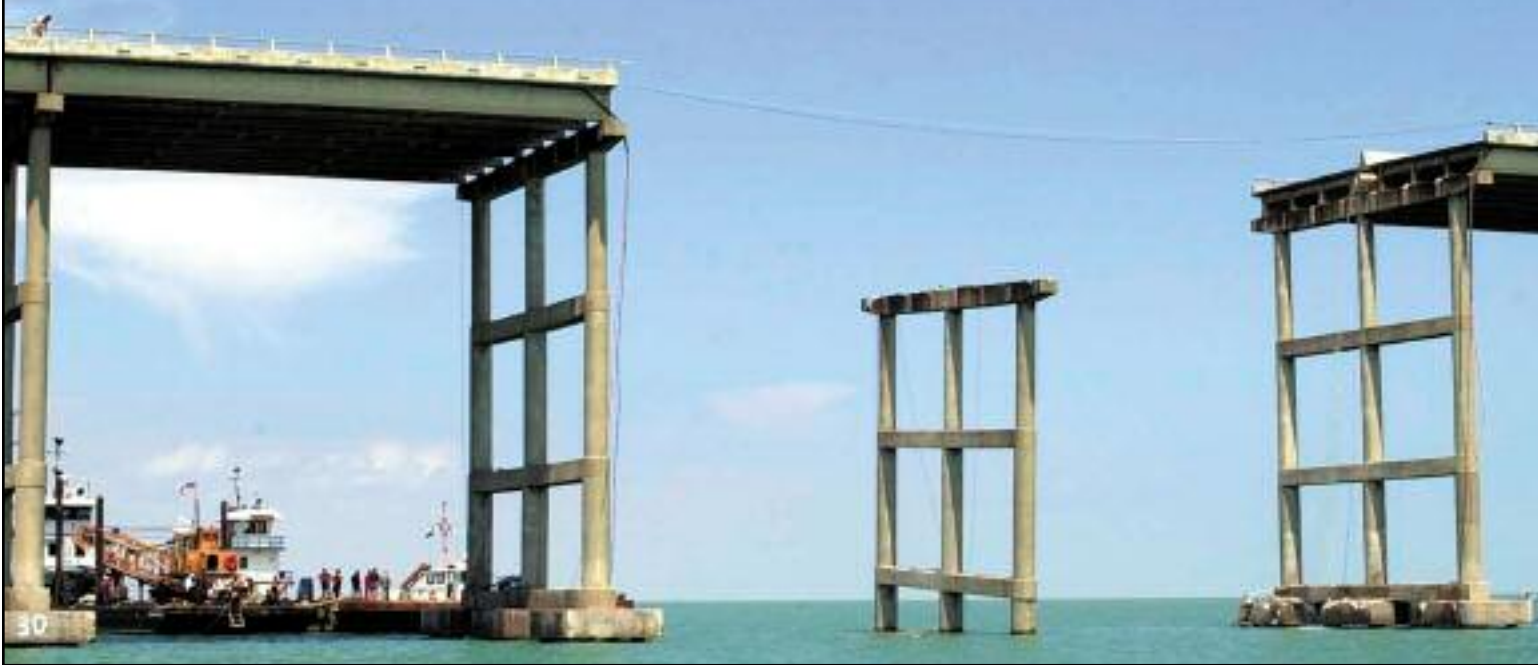
Coast Guard Cutter *Mallett* crewmembers and Department of Public Safety personnel survey the damage done to the Isabella Causeway near South Padre Island, Texas, September 15, 2001. A tug pushing four barges allided with the causeway, causing 10 cars to fall into the water. CWO2 Robert Wyman, USCG.

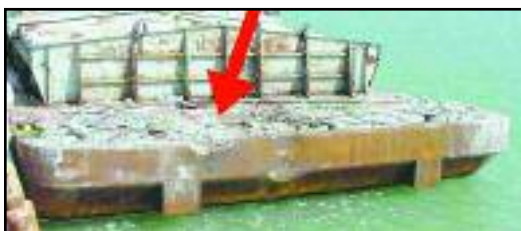
There was some damage to the alliding barge, but no flooding. USCG Photo.

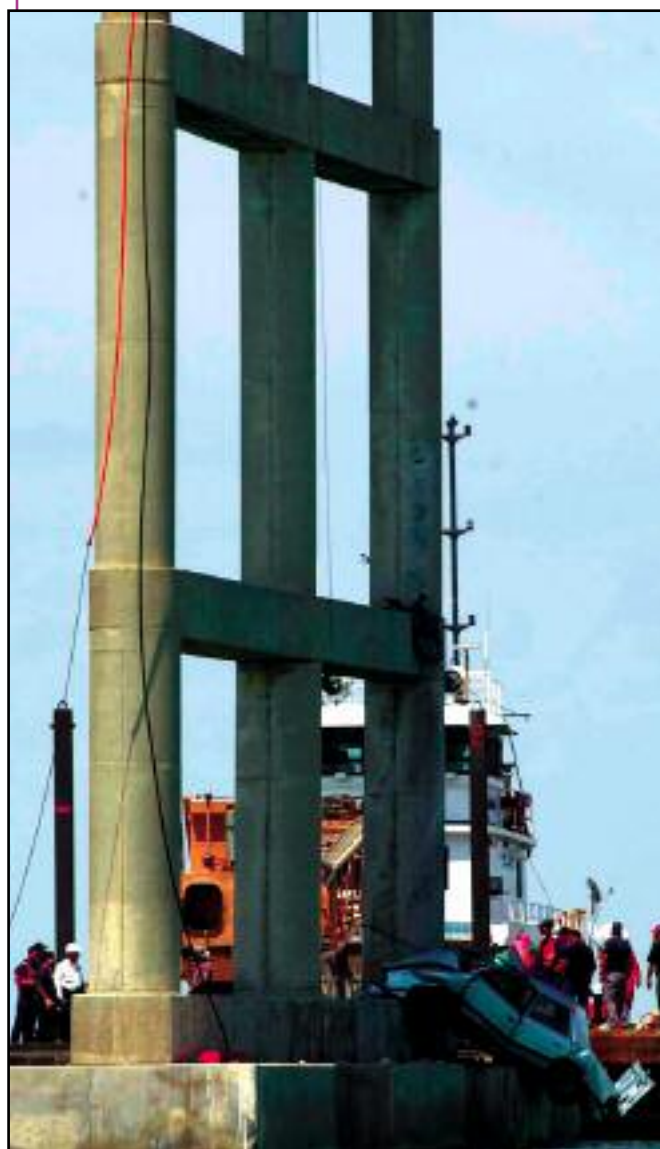
Coast Guard Cutter *Mallett* crewmembers take a look at a car that was damaged when the Isabella Causeway collapsed September 15, 2001. CWO2 Robert Wyman, USCG.

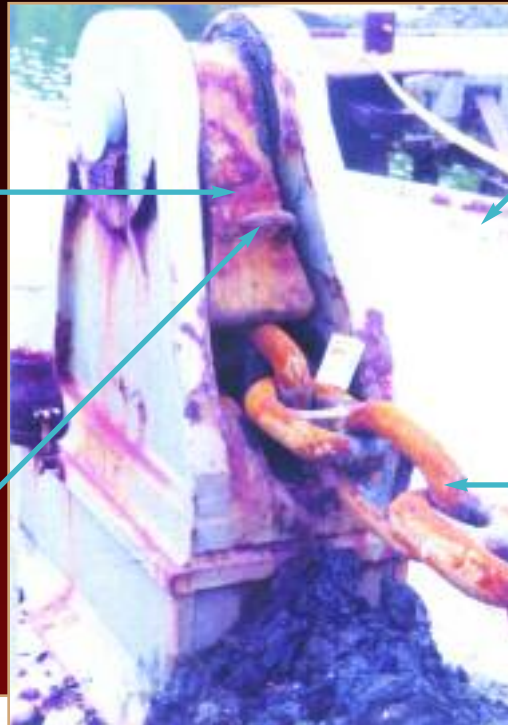
The barge anchor pawl that, had it been in the down position during the transit down the Hudson River, would have kept the anchor from letting go.

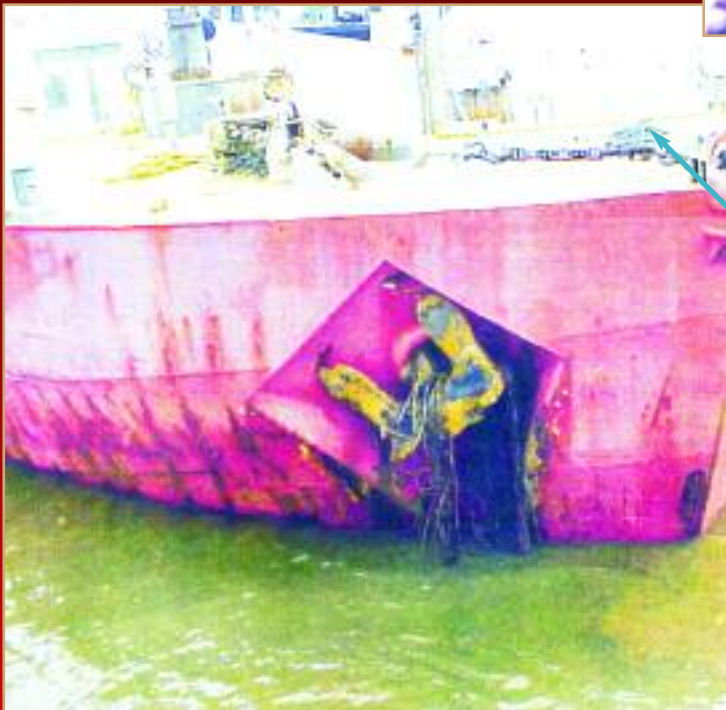
A dry cargo barge moored on August 8, 1999. Anchor shows debris picked up as the anchor dragged along the bottom of the Hudson River earlier that morning. The barge anchor severed a natural gas pipeline crossing the Hudson River at Poughkeepsie, NY. Only the anchor brake held the anchor in place. The towing vessel crew did not use the anchor pawl because the pawl would have prevented the use of the radio-controlled switch installed on the barge to prevent the barge from drifting ashore during ocean tows. The crew of the towing vessel did not know the barge they were pushing was dragging anchor until emergency responders alerted waterway users to the pipeline accident. U.S. Coast Guard Photo.
