National Transportation Safety Board Marine Accident Brief

Fire aboard Offshore Supply Vessel Grand Sun

Vessel name Grand Sun Accident No. DCA19FM001

Accident type Fire/Explosion

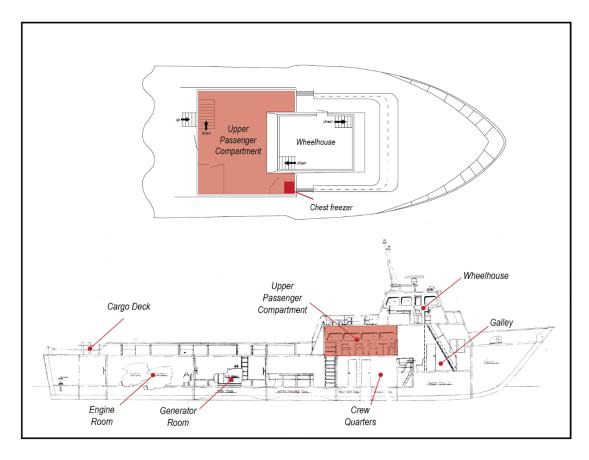
Vessel plans modified to show the wheelhouse, upper passenger compartment, galley, and crew quarters. The passenger compartment where the fire was discovered is highlighted in red, and the chest freezer is marked as a red square. (Source: Y&S Marine Inc.)

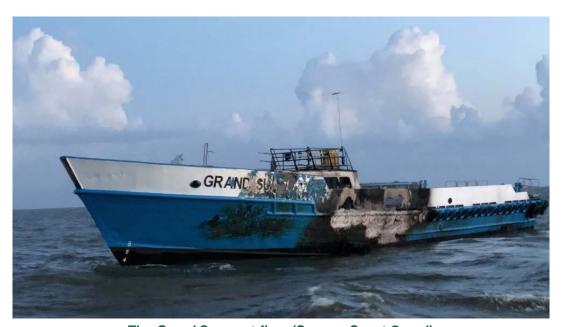
On October 15, a fire investigator examined the docked vessel and found significant fire damage in the location of the wheelhouse and the passenger compartment. The fire consumed the vessel's entire superstructure, including the interior main deck and wheelhouse. The aluminum hull was nearly burned to the waterline amidships with a 3-by-3-foot hole on the port side and a 10-by-10-foot hole on the starboard side. The generator room was fire-damaged. The engine room, just aft of the generator room, had no fire damage but had water damage from flooding during the initial tow.

The Grand Sun post-fire. (Source: Coast Guard)
