# United States Coast Guard

**Report of the Investigation into the  
Circumstances Surrounding the Capsize of  
the Liftboat SEACOR POWER (O.N.  
1115290) Approximately 7 Nautical Miles  
South of Port Fourchon, LA in the Gulf of  
Mexico Resulting in the Loss of 13 Lives on  
April 13, 2021.**

**THE CAPSIZING OF THE COMMERCIAL LIFTBOAT SEACOR POWER (O.N. 1115290) RESULTING IN MULTIPLE LOSSES OF LIFE APPROXIMATELY SEVEN NAUTICAL MILE SOUTH OF PORT FOURCHON, LA IN THE GULF OF MEXICO ON APRIL 13, 2021**

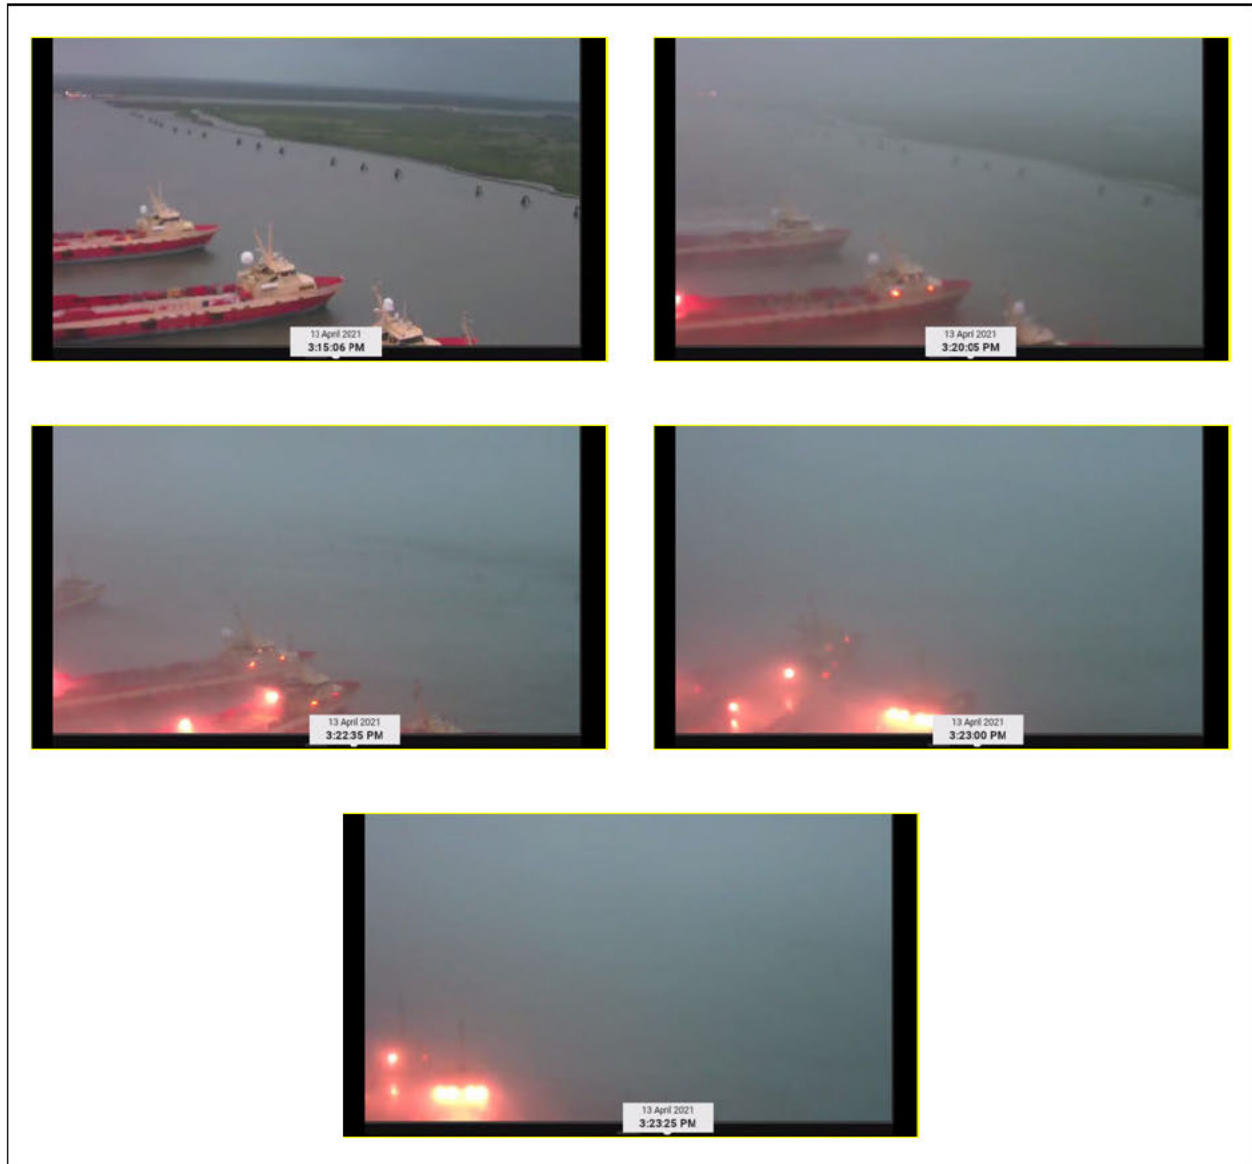
Figure 8: Images from C-Port Drydock Camera

8.1.30. At 1521, C-Port Drydock West camera recorded the arrival of a second, stronger squall.<sup>16</sup> The HOS Port North Yard camera, 100 yards west of C-Port Drydock, also recorded the arrival of the second squall. That camera showed zero visibility at the peak of the squall, and recorded intense winds for 108 minutes, or 1 hour and 48 minutes.<sup>17</sup> At 1522, the second squall reached the camera at the Baroid Dock in Bayou Lafourche, 1.5 miles south of C-Port Drydock. The squall was moving south, toward SEACOR POWER.<sup>18</sup>

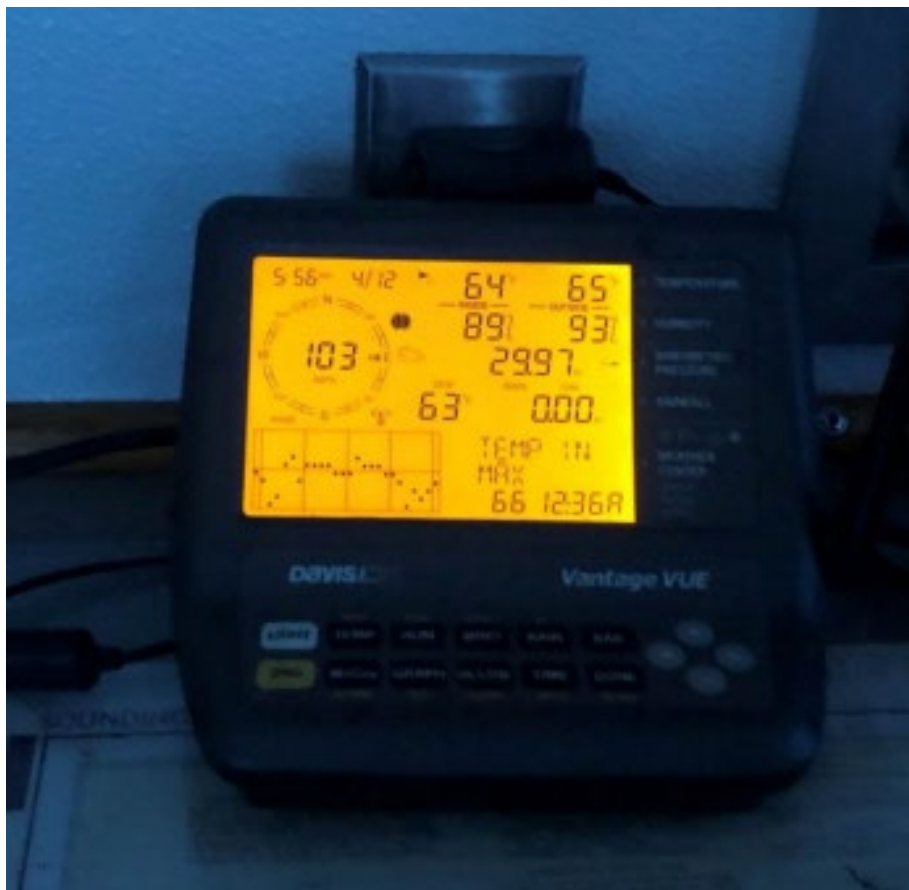
Figure 12: Liftboat VANESSA Anemometer displaying 103mph winds at 1537

- 8.1.38. At 1537, the Liftboat VANESSA Master observed a wind speed of 103 mph. Approximately 3 minutes later he observed a 113 mph wind gust.<sup>22</sup> The vessel was located 4.5 nautical miles west-northwest of SEACOR POWER.<sup>23</sup>

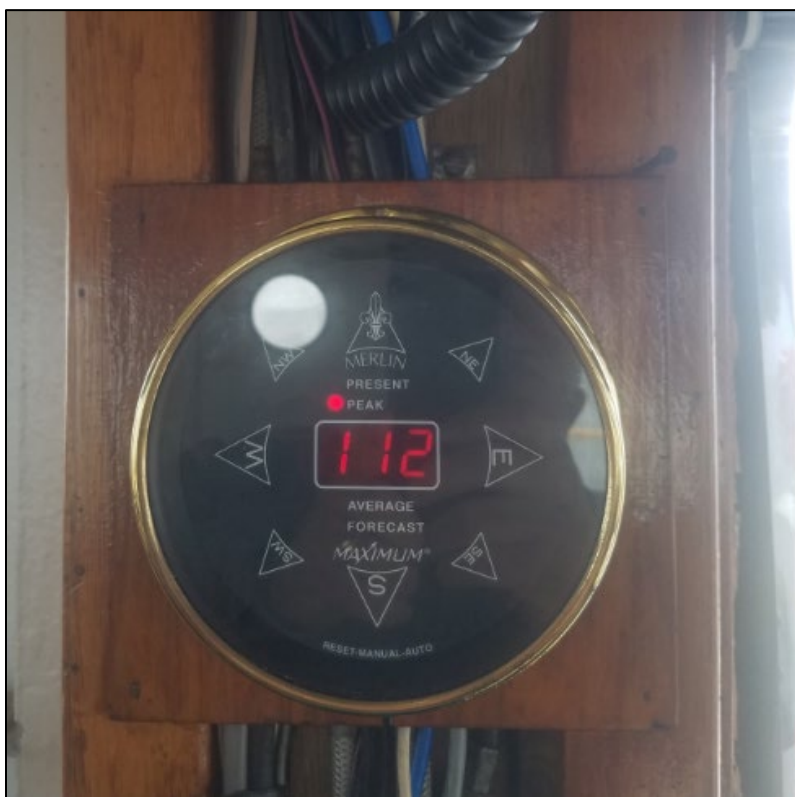
Figure 16: Liftboat ROCKFISH anemometer reading of 112 knots on April 13, 2021 (Exhibit 144)

- 8.1.53. During the hearing the Master of Liftboat ROCKFISH reported that his anemometer measured a wind gust of 112 mph on the date of the incident. The Master did not know what time this gust occurred, but provided a photo of the anemometer reading.<sup>30</sup> He stated that if he had known that type of weather was coming, he would have waited to move his vessel that day. He also stated that if he had moved the ROCKFISH 15 minutes later, then his vessel would have capsized as well.

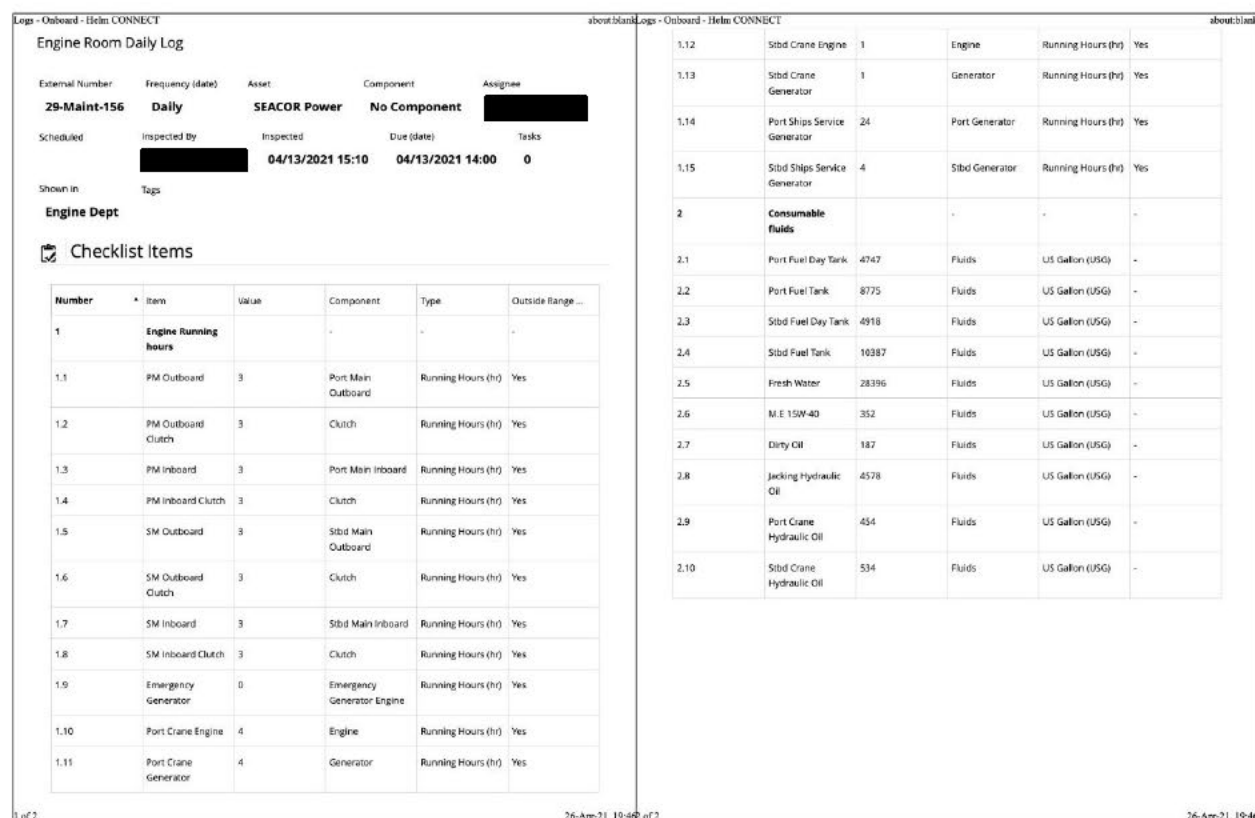
Figure 29: HelmConnect tank loading information at 1510 on April 13, 2021 (Exhibit 86)

8.4.26. The consumable tank loading aboard SEACOR POWER was reported by the onboard HelmConnect system at 1510, just prior to casualty.<sup>133</sup> This tank loading is shown in the following figure.

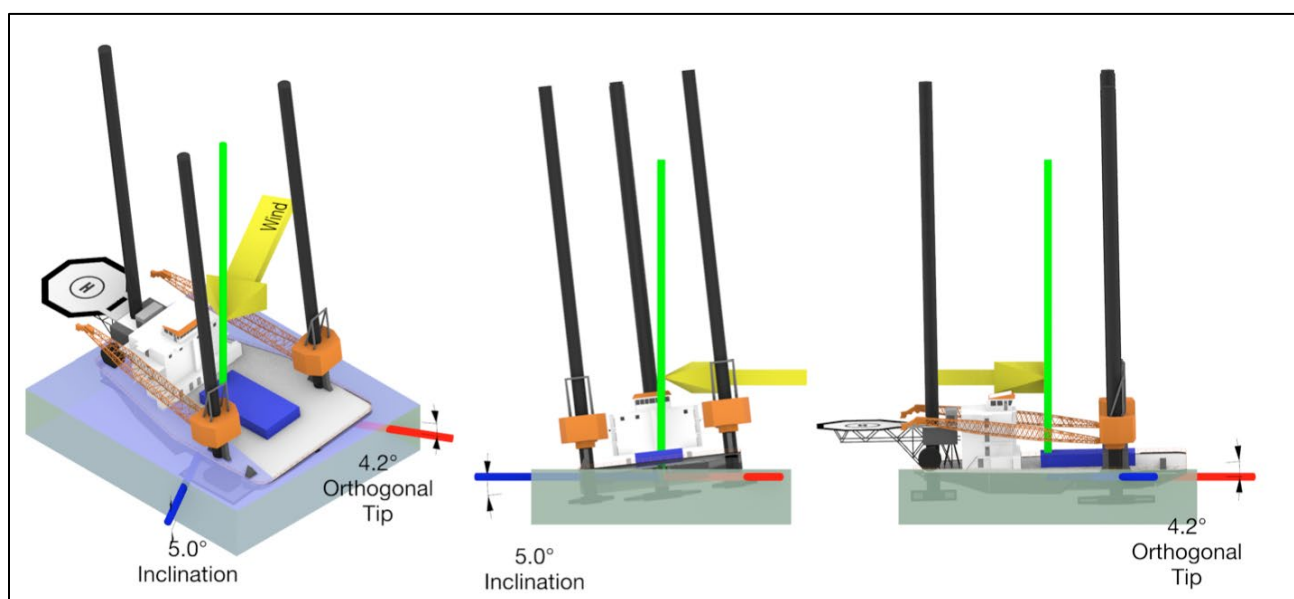
Figure 52: Sketch of SEACOR POWER inclined 5° in still-water from wind at 240° relative (Exhibit 246)

- 9.1.16. Immediately prior to the capsizing, the First Mate observed a 5 degree list. At that angle, part of SEACOR POWER's main deck would be submerged, as noted in the figure below. If any doors or vents on the starboard side of the main deck were open, this would have caused downflooding. There was no evidence to indicate that downflooding was a causal factor in the capsizing.
