UNITED STATES COAST GUARD

MARINE SAFETY ALERT

Safety Alert 01-26

INCORRECT ALLOY FOR VALVE MOUNTING STUDS PRESENTS FAILURE HAZARD

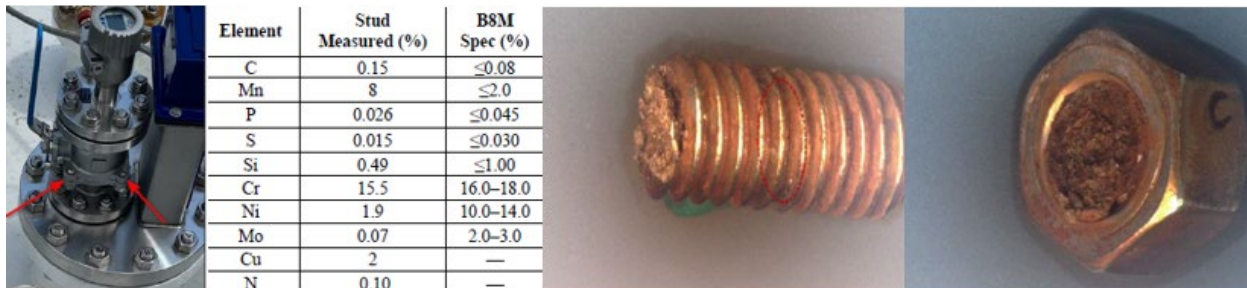
Figure 1

The U.S. Coast Guard recently conducted a marine casualty investigation into an uncontrolled release of isobutane from a 2-inch cargo tank pipe aboard a pressure barge certificated to carry flammable cargoes. The direct cause of the incident was traced to the failure of the studs of a ball valve installed on a cargo tank's gauging pipe which sheared off and caused the ball valve to separate from the cargo pipe. The affected ball valve, manufactured by Ohio Valve Company, was supplied with four body studs for securing the manifold valve block to the valve body and stamped in a manner indicating compliance with American Society for Testing and Materials (ASTM) standard A193 Grade B8M (316 Stainless Steel). These body studs were purchased by Ohio Valve Company from Jian Huang Enterprise Co., Ltd.

Metallurgical testing revealed that the studs were composed of non-conforming steel not meeting ASTM A193 Grade B8M, making them more vulnerable to stress corrosion cracking (see Figure 1) and premature failure. The use of this non-conforming steel in a marine and chemical environment, combined with tensile stress levels exceeding the material's rated strength, led to the failure of the studs.

The Coast Guard **strongly recommends** that owners/operators of pressure vessel barges containing flammable cargoes:

- Determine if any of the ball valves were manufactured by Ohio Valve Company.

- If so, verify the Body Heat Number and Cap Heat Number on each of the ball valves installed. Cross-check the below listed cap and body heat number combinations against the ball valves installed on the pressure vessel. For the valve bolts to be affected, it must include both the corresponding **Body and Cap** heat number combination listed below. Since several different sized valves may use the same body/cap heat number combination, it is important to utilize the full list for each valve checked.
- Remove any affected ball valves from service as quickly and safely possible.
