## **UNITED STATES COAST GUARD**

## MARINE SAFETY ALERT

April 21, 2025 Washington, DC Safety Alert 06-25-CH1

## **BOW SEATING SAFETY CONSIDERATIONS**

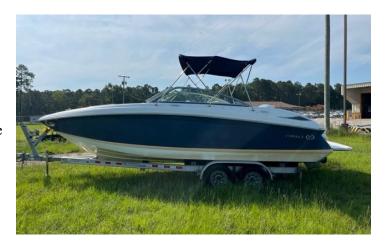
This Safety Alert addresses the safety considerations for captains and passengers seated in the bow area of bow rider style vessels, while the vessels are underway. A 23-foot bow rider style recreational vessel was underway and improperly loaded on the Atlantic Intracoastal Waterway when it encountered a large wake created by another vessel ahead. The wake caused the bow rider to roll severely and pitch forward, swamping the bow. Nine of the occupants were washed out of the

vessel. The passenger seated at the forwardmost bow seat was subsequently struck by the vessel's propeller and killed. A similar fatal accident occurred in July of 2022, when an overloaded 24-foot boat capsized while traveling at high speeds in the Hudson River off Manhattan with passengers seated in the bow area.

The U.S. Coast Guard **strongly recommends** that operators of bow rider style vessels adhere to the manufacturer's occupancy limit for persons and maximum weight capacity as applicable, as well as designated recommended positions if available. If weather or sea conditions impact vessel operation, captains should relocate passengers from the bow seating area to aft seats while their vessels are underway.
