MARINE SAFETY ALERT

Safety Alert 08-21

VERIFY PRODUCTS FROM SOUTHWEST WIRE ROPE COMPANY **Incorrect Terminations Can Lead to Catastrophic Failure**

SAFETY ALERT 7-01-2021

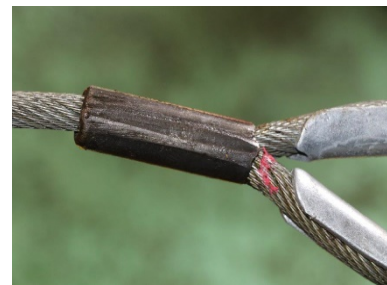
- Verify the source and manufacturer of all wire rope, and if purchased or fabricated by SWWR, carefully observe the specifications of the rope to ensure it matches the product that was purchased (i.e., construction (number of wires per strand and number of strands) and wire rope lay);
- Visually examine wire rope terminations for abnormalities that may indicate improper installation (Figure 1 shows a crimp with a uniform appearance, while Figure 2 shows out-of-roundness and Figure 3 shows ridges created by over-crimping). These ridges or abnormalities **COULD** be indicative of over-crimping, but any abnormalities need to be verified based on the type of crimp

and manufacturing die used in the crimping process (i.e., some manufacturers' dies have chambers for excess material that is then removed and can leave lines that appear similar to ridges);

Figure 3: Fitting is deformed with "ridges" of extra material present from over-crimping.

- If any abnormalities in the wire rope are detected, immediately remove the wire rope from service and make an appropriate replacement.

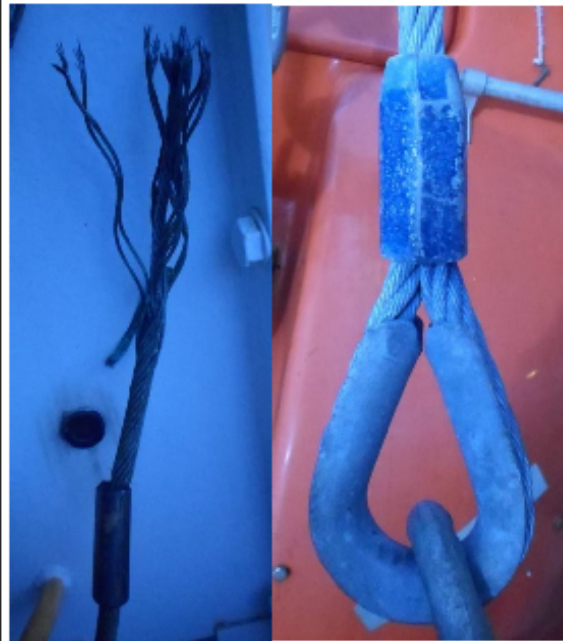
On Jan 4, 2021, 3 offshore personnel were retrieving marine debris by using the Fast Rescue Craft (FRC). The task was completed and the FRC hoisted back up into position. After the 3 personnel exited the FRC, the wire rope assembly (wire rope, thimble, and crimp) broke, and the FRC fell 135 feet to the Gulf of Mexico.

- Incorrect wire rope was used in the construction of the wire rope assembly loop
 - The wire rope ordered was 35x7 with a 12 mm diameter and 30,875 lbs breaking strength
 - The wire rope received was 19x7 with a 0.5 in (12.7 mm) diameter and 21,600 lbs breaking strength
 - Improper swaging procedure includes failures within a quality management system in which material are improperly selected and do not match the specifications of the original equipment manufacturer
 - The cable/wire rope diameter was sized at 0.5 in (12.7mm) and the crimp/swage was specified for a 12mm diameter Wire
- Wire rope supplier failed to conduct a positive verification to ensure the correct material was used to fabricate the assembly loop.
- The larger diameter wire rope contributed to an improper termination of the assembly and was damaged inside the crimp during the crimping process.

- The similarity in diameters between a 0.5 in cable (12.7mm) and a 12mm cable creates a possibility for confusion regarding use of the appropriate cable.
- Verify that the construction of the wire rope ordered is the same as the wire rope received before installation
