MARINE SAFETY ALERT

Safety Alert 11-25

INADEQUATE SNAP HOOKS ON MARLIN AUSTRALIA LIFEJACKET MODELS 320RT & 321RT

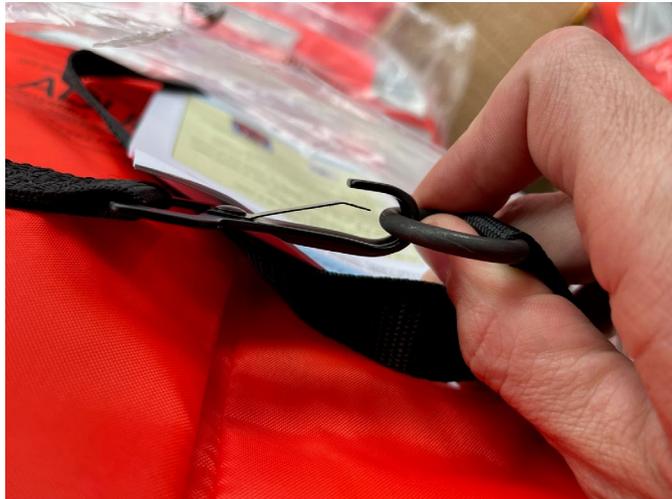
The issue involved a malfunctioning spring-loaded tab within the snap hook that is sewn into the waist belt of Marlin Australia PTY LTD lifejacket models 320RT (USCG approval number 160.055/215) and 321RT (USCG approval number 160.055/216). The spring-loaded tab within the snap hook mechanism failed to “spring back” or return to the closed position after depressing to secure the snap hook to the D-ring. Instead of fully closing once initially depressed, the spring-loaded tab returned to a partially closed position (approximately ½ to ¾ closed), which may allow the D-ring to slide out without additional manipulation of the clasp.

Example of a partially closed snap hook.

The Coast Guard **strongly recommends** that owners/operators that have Marlin Australia PTY LTD model 320RT or 321RT lifejackets onboard their vessels inspect them closely for this potential defect and if defects are found:

- contact Mr. John Murray Jr. of Marlin Australia PTY LTD by phone at +02 9557 3999 or email at JMurray.Jnr@carrycode.com.au for specific directions on how to rectify this issue; and
- contact CG-ENG-4 at TypeApproval@uscg.mil with the lot numbers from the affected lifejackets.

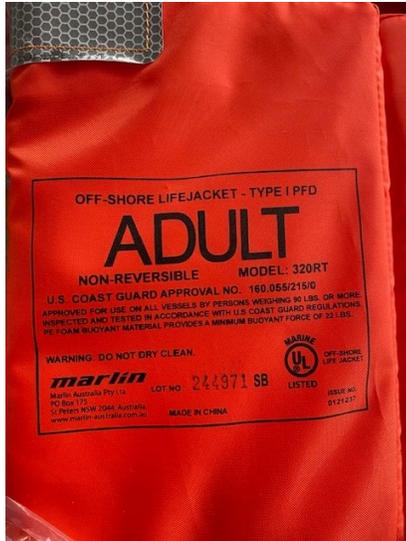
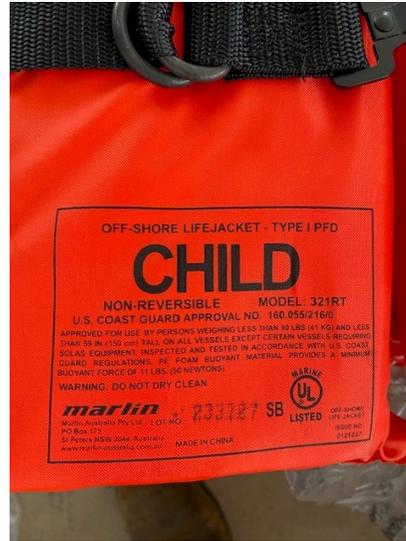
The images above show the defective models only, not the defective lot numbers.
