MARINE SAFETY ALERT

Safety Alert 16-25

LOOKOUT FOR GREEN PATINA BUILD-UP ON HIGH PRESSURE WATER MIST NOZZLES

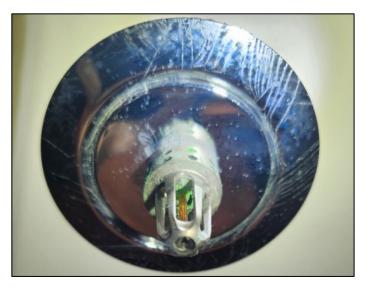
While witnessing routine testing of a fixed firefighting system during an annual exam aboard a foreign passenger vessel, the Coast Guard discovered multiple high-pressure water mist nozzles that were incapable of discharging water. Consequently, the firefighting system failed to activate in multiple accommodation spaces. Upon expanding the examination, Port State Control Officers determined that the highpressure water mist nozzles in question were manufactured by Marioff ("a2000" series) as part of the "HI-FOG" system. The accumulation of green patina on the nozzles, a sign of corrosion, rendered them unable to release water after the glass bulb broke.

The high-pressure water mist nozzles are designed to hold the standard line pressure of 25 bars (363 PSI). When the glass bulb thermal acuator (shown in the photo above) reaches a certain temperature, it breaks, activating the release mechanism which allows water to flow through the nozzle at the standing pressure (International Maritime Organization [IMO] Resolution A.800(19)). The system then senses the drop in pressure and activates the high-pressure pumps which increases the pressure to 140 bars (2,031 PSI). This increased pressure is required for the system to achieve an effective release of water in a mist form.

- Evaluate whether training for crew members responsible for firefighting system maintenance and compliance walkthroughs adequately covers the inspection of high-pressure water mist nozzles for green patina corrosion.

- Conduct an inspection of all high-pressure water mist nozzles across the vessel to identify any potential issues and consider whether more frequent inspections are necessary. Sprinklers with the highest risk of corrosion include sprinklers more than 10 years old and those located in high moisture and corrosive atmospheres. Areas of high moisture could include outer decks, spas, pool areas, galleys, or even normal passenger and crew areas close to external doors. Review the manufacturer's service and quality bulletins for more information.

- Contact the manufacturer if any signs of green patina build-up are observed on high-pressure water mist nozzles and consider replacing the affected nozzles.

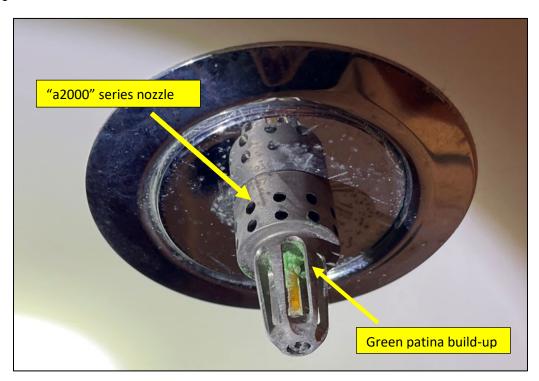
The manufacturer, Marioff, released a Service Bulletin (001/2012) and Quality Bulletin (002/2012), which originated due to failures of the "a1000" series nozzles. The bulletins describe the same failure as that noted on the "a2000" series during the recent examination and includes recommended actions that apply to both the "a1000" and "a2000' series nozzles. Marioff recommends that if a nozzle fails to release at the standing pressure of 25 bars after the glass bulb is broken, the high-pressure pumps must be manually energized to raise the pressure to 140 bars. Doing so will activate the release mechanism allowing water to flow through the nozzle. During the examination the Coast Guard witnessed this recommended action and observed that raising the pressure of the system to the recommended 140 bars did not activate the release mechanism of the nozzles as expected. Thus, in this case, the actions recommended by Marioff in Service Bulletin (001/2012) and Quality Bulletin (002/2012) did not raise the system pressure sufficiently to activate the release mechanisms for the nozzles.
