# UNITED STATES COAST GUARD

## MARINE SAFETY ALERT

Safety Alert 18-25

## SEA-DOO SWITCH CAPSIZING HAZARD

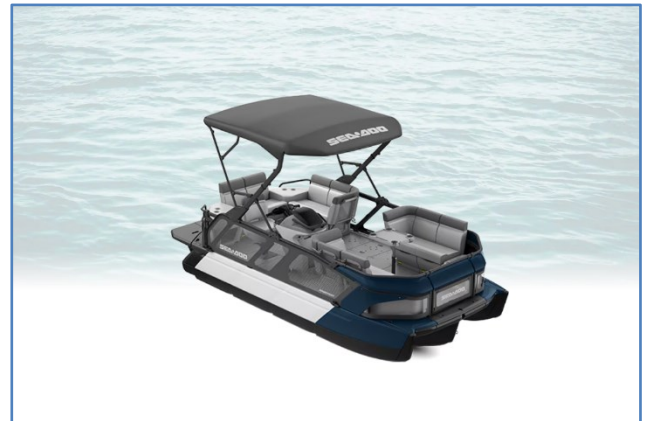
The Switch is designed such that while at rest, its center hull allows water to enter the hull, and while operating on a plane, the entrained water empties. However, until the water fully empties, trim by the bow can occur, especially with passenger weight forward. The dynamics are such that any abrupt change in speed or direction could induce forces sufficient to cause capsizing, especially when slowing down towards idle speed.

Figure 1- Image of Sea-Doo Switch

The recall corrective action includes partial sealant application to specific sections of the hull, two on-product warning labels, and an addendum to the Operator's guide.

- Avoid operating with any trim by the bow. Weight distribution must be towards the stern.
- Avoid sudden changes in speed or direction at non-planing speeds.
- If trim by the bow occurs, gradually reduce the throttle and reposition passengers further aft.
- When approaching or coming off of a plane, exercise awareness of instability or nosediving.
