# UNITED STATES COAST GUARD

## MARINE SAFETY ALERT

Safety Alert 18-25, CH1

## SEA-DOO SWITCH CAPSIZING HAZARD

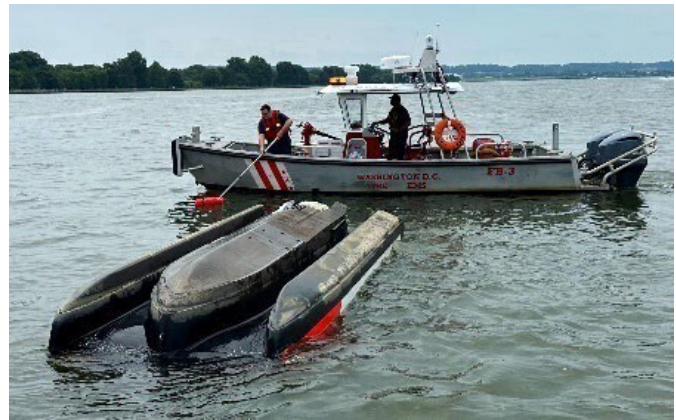
**Hazard:** Due to its design, the Switch reacts sharply to operator input when "bow-down" (trim by bow), especially at slow speeds. Operating the Switch at 6-8 mph with too much weight forward (towards the bow)—or uneven weight on the first two rows of deck tiles—can cause nosediving, bow submergence, and ultimately capsizing.

*Image of a capsized Sea-Doo Switch*

**WARNING:** If the operator accelerates or increases the throttle while the Switch is nosediving, the Switch may capsize, which can result in serious injury or death.

If the bow begins to submerge, the operator must immediately release the throttle and redistribute weight evenly across the vessel from bow to stern to correct the trim of the Switch.

This update has been initiated to install BRP's Intelligent Balance Assist (iBA) system, which helps operators prevent bow-down operation of their watercraft. When iBA detects specific conditions, such as certain speeds, throttle inputs, and negative trim caused by excessive weight forward, it temporarily lowers the throttle to reduce the risk of capsizing. This reduction signals to operators that rebalancing passengers or cargo may be necessary. Current Switch owners should have received communication from BRP regarding this new feature and installation details. BRP will perform this installation at no charge to the owner (parts & labor). BRP has also provided information about capsizing risks, including recommended actions if the bow of a front-loaded Switch becomes submerged. If an owner has not received any communications from BRP about this update, or has any questions, they should visit the company's website

The Coast Guard **strongly recommends** that Sea-Doo Switch owners ensure that installation of BRP's iBA is completed before operating their vessels. Furthermore, owners, operators, and passengers should be aware of the capsizing potential and follow BRP's latest guidance, which can be found at: <http://sea-doo.com/switch-capsizing-risk-information>. While iBA is designed to aid the operator by interrupting the chain of events shown to lead to a capsizing risk by limiting throttle input temporarily under certain conditions, it does not eliminate the responsibility of a Master to continuously monitor vessel response and distribute loads appropriately.
