MARINE SAFETY ALERT

Safety Alert 20-25, CH1

RISK OF PROPULSION LOSS FROM MATERIAL FAILURE OF MAIN ENGINE EXHAUST GAS RECIRCULATION COOLER WELD

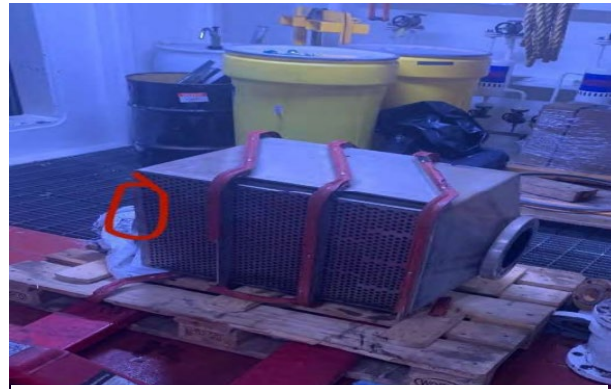
A Coast Guard inspected dredging vessel suffered a loss of propulsion on the starboard main diesel engine and subsequently required a tow into port. The subsequent investigation revealed that the engine's exhaust gas recirculation (EGR) cooler was cracked and leaking, which led to a high jacket water temperature alarm and an eventual shutdown of the starboard main engine. Coast Guard Marine Investigators traced the cause to a weld seam crack on the corner of the cooler belonging to a Wabtec Environmental Protection Agency (EPA) Tier 4/International Maritime Organization (IMO) Tier III Marine Engine. After reviewing the vessel's service history, Marine Investigators discovered that on six separate occasions over the previous two years, the vessel's Wabtec engine EGR cooler had failed due to a weld seam crack. Each failed cooler was well below its designated overhaul interval.

EGR cooler with location of weld failure indicated

- Closely monitor the condensate drain tank for the presence of cooling water, antifreeze, or other water treatment chemicals during engine operations, especially prior to entering or leaving port. The presence of cooling water at the condensate drains can be indicative of EGR cooler weld failures.
- Closely monitor the level of cooling water in engine expansion tanks during periods of both heavy load and low loads.
- Regularly inspect and clean the EGR cooler condensate drain hose and tubing.
- Ensure the inspection, servicing, and monitoring of EGR coolers and associated condensation drain tank are included in the vessel's Safety Management System or preventative maintenance program as applicable.

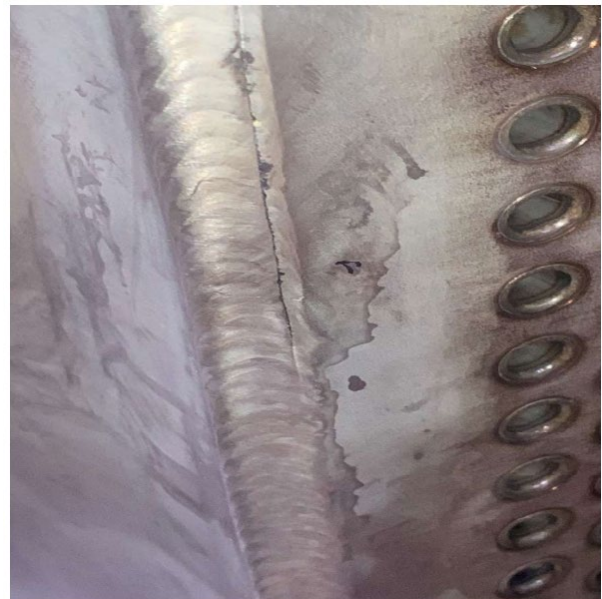
Close-up of cracked weld
