## REPORT OF INVESTIGATION INTO THE LOSS OF LIFE ONBOARD THE ATLANTIC OCEANIC (1 163367) WHILE MOORED AT PORTSMOUTH MARINE TERMINAL IN PORTSMOUTH, VIRGINIA, ON OCTOBER 26<sup>TH</sup>, 2024.

MISLE ACTIVITY NUMBER: 8026695

**INVESTIGATING OFFICER'S REPORT**

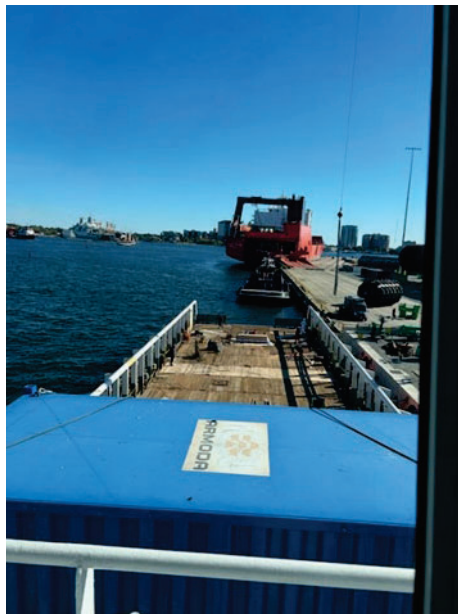
*Figure 3 The ATLANTIC OCEANIC moored with CAPE STARR at Portsmouth Marine Terminal.  
Source: USCG personnel*

4.1.15. The US flagged cargo vessel, CAPE STARR (ON: 1335005) was moored approximately 150 yards astern of the ATLANTIC OCEANIC.

was discovered floating next to the pier in the vicinity of the CAPE STARR (ON: 1335005), approximately 100 yards from the location of where the ATLANTIC OCEANIC was moored at the time of the incident.

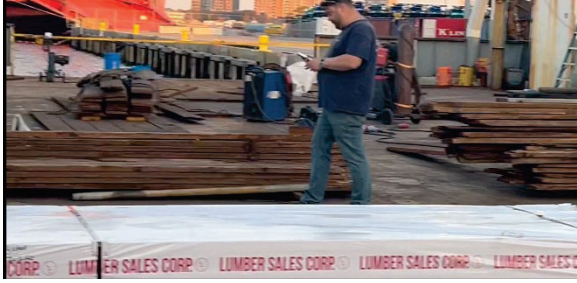
Figure 4 Stern of vessel during initial vessel search for Contractor #1. Source: Contractor #2 video

4.2.11. The ATLANTIC OCEANIC's stern bulwark was removed to support work on the vessel to return it to pre-contract status.

4.2.12. There was no evidence illustrating the standard of fall protection at stern of the ATLANTIC OCEANIC prior to the determination that Contractor #1 was missing. During and after the searches for Contractor #1, there were initially one and later two straps positioned across the center of the stern as illustrated in Figure 4 and 5.

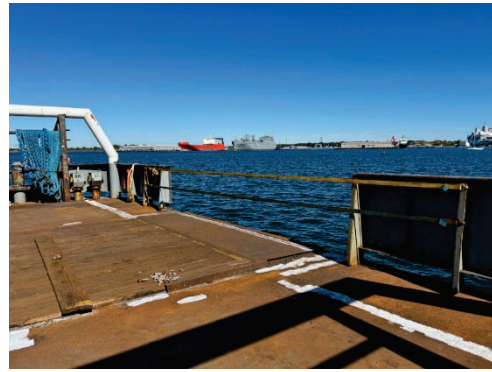
Figure 5 Stern of ATLANTIC OCEANIC with straps installed moored at Portsmouth Marine Terminal. Source: USCG personnel

5.3. *Unapproved removal of the stern bulwark onboard the vessel.* The ATLANTIC OCEANIC is an Offshore Supply vessel and subject to both US and international regulations. These regulations include the requirement for bulwarks (guardrails) around the cargo deck. Any deviation from this requirement shall be approved by the flag state or recognized organization, American Bureau of Shipping (ABS). The vessel was being demobilized from its contracted operations and the stern bulwarks were removed without authorization from any regulatory agency. There were no equivalent structures installed to prevent people from falling over the stern of the vessel. If the stern bulwark or an equivalent structure was installed on the stern while work was being done on the cargo deck, it is likely Contractor #1 would not have fallen overboard while working near the stern.

7.1. The US Department of Labor's local Occupational Safety and Health Administration (OSHA) office issued DEME and Coastal Services citations each for \$33,100 for failure to conduct a hazard assessment and provide PFDs or guarding on the stern.
