**REPORT OF THE INVESTIGATION
INTO THE
COMMERCIAL GOLD DREDGE VESSEL
CHARLOTTE (AK 5879C), CAPSIZING
AND CREWMEMBER LOSS OF LIFE
2NM SOUTHWEST OF CAPE NOME
NEAR NOME, AK ON OCTOBER 15,
2020**

**CAPSIZING OF THE GOLD DREDGING VESSEL CHARLOTTE (AK5879C) AND
SUBSEQUENT LOSS OF TWO LIVES IN THE BERING SEA, 2 NAUTICAL MILES
SOUTHWEST OF CAPE NOME, ALASKA ON OCTOBER 15, 2020**

INVESTIGATING OFFICER'S REPORT

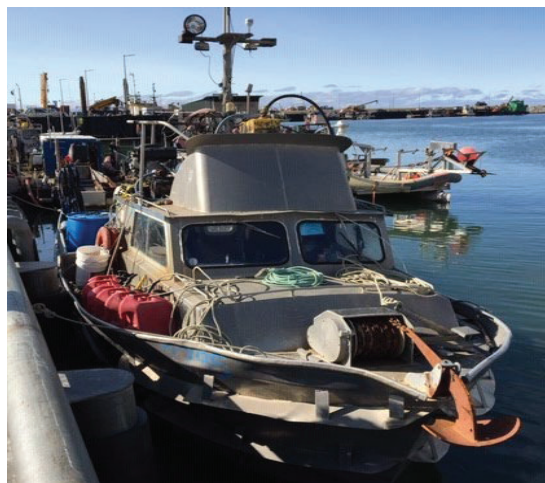
Figure 1. Photo of the CHARLOTTE Bow Aspect taken in 2018.

4.2.1. The CHARLOTTE was an aluminum vessel with two outboard gas engines outfitted to be a gold dredging vessel. Alterations were made to the vessel for gold dredging operations to include holes in both sides of the vessel to install a sluice box for gold dredging operations. The sluice box was never screwed in or secured directly to the vessel. Holes were cut out at the stern of the vessel for the two outboard engines. The vessel was frequently overloaded with equipment.

5.6 Vessel's overall lack of stability and freeboard. The surviving deckhand a previous deckhand on board the vessel stated that the vessel frequently overloaded and had excess equipment on board. Additionally, the vessel had water ingress from the stern cut out and sluice box cut outs. The holds were routinely filled with water and the crewmembers had to bail out the water. The previous deckhand noted that the vessel was often listed over. Due to these issues, the vessel had an overall lack of stability and freeboard. Had the vessel had better stability and greater freeboard, the vessel may have not capsized when the wave struck the side.
