**REPORT OF THE INVESTIGATION
INTO THE
MAN OVERBOARD WITH LOSS OF LIFE ON
THE TOWING VESSEL CHERYL STEGBAUER
(O.N. 568268) AT LOCK AND DAM 25, MILE
MARKER 241.5 ON THE UPPER MISSISSIPPI
RIVER NEAR WINFIELD, MO ON DECEMBER 1
1, 2022**

MISLE ACTIVITY NUMBER: 7608546

**FALL OVERBOARD FROM THE INSPECTED TOWING VESSEL CHERYL STEGBAUER
(O.N. 568268) AND SUBSEQUENT LOSS OF ONE LIFE WHILE TRANSITING THROUGH
LOCK AND DAM 25 AT MILE MARKER 241.5 ON THE UPPER MISSISSIPPI RIVER NEAR
WINFIELD, MISSOURI ON DECEMBER 11, 2022**

INVESTIGATING OFFICER'S REPORT

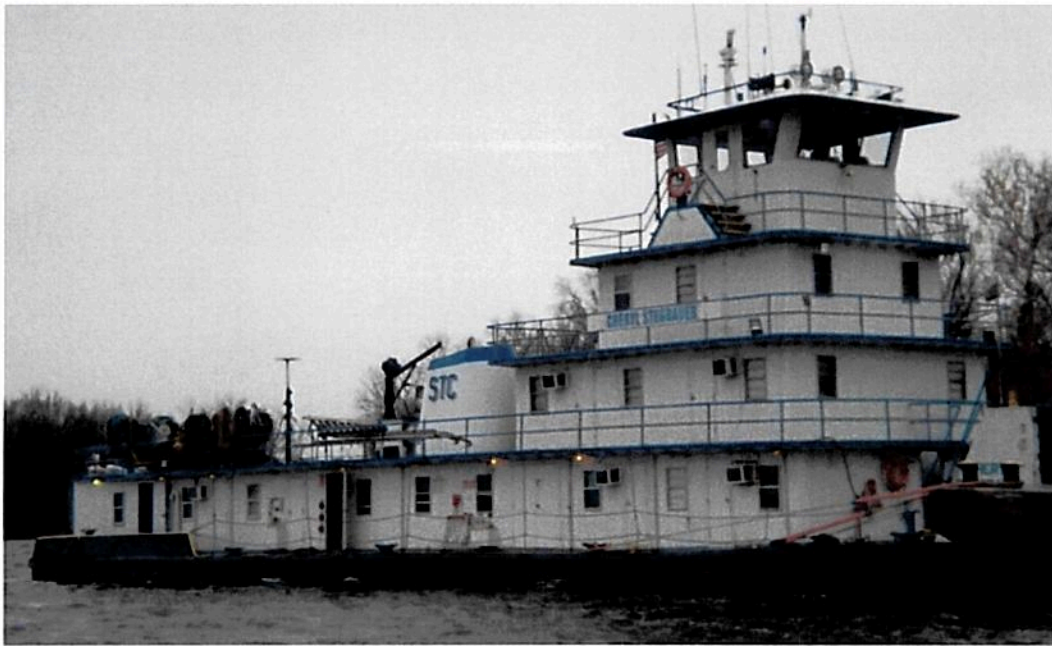
Figure 1. Post incident photograph of the CHERYL STEGBAUER taken on December 12, 2022, by USCG.

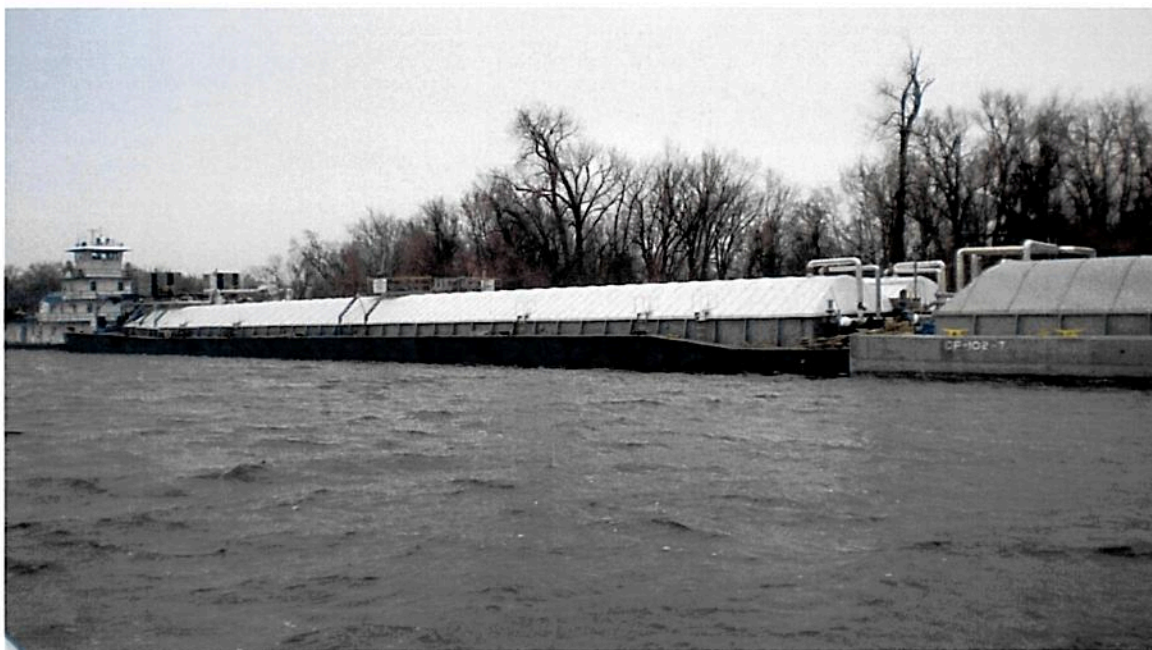
Figure 2. Post incident photograph of the CHERYL STEGBAUER and A-1 barge taken on December 12, 2022, by USCG.

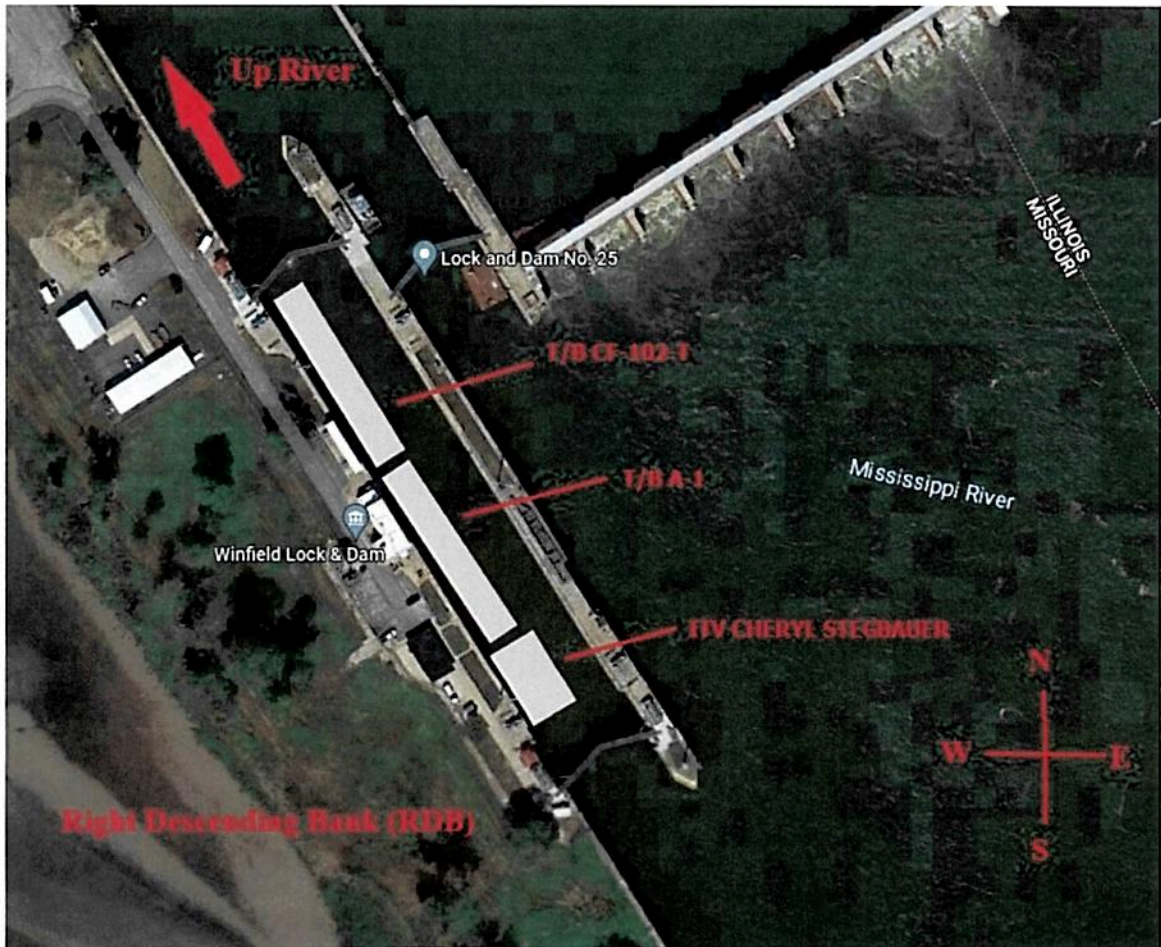
Figure 3. General arrangement of CHERYL STEGBAUER and tow inside Lock and Dam 25. CHERYL STEGBAUER is faced-up to the A-1 heading upriver. Vessels not to scale.

4.1.3. At 1445, the Pilot began his approach to Lock and Dam 25 at MM 241.5 on the UMR. Due to the lock chamber length (600 feet) and overall length (707 feet), the CHERYL STEGBAUER had planned to break tow to lock all vessels through in one evolution.

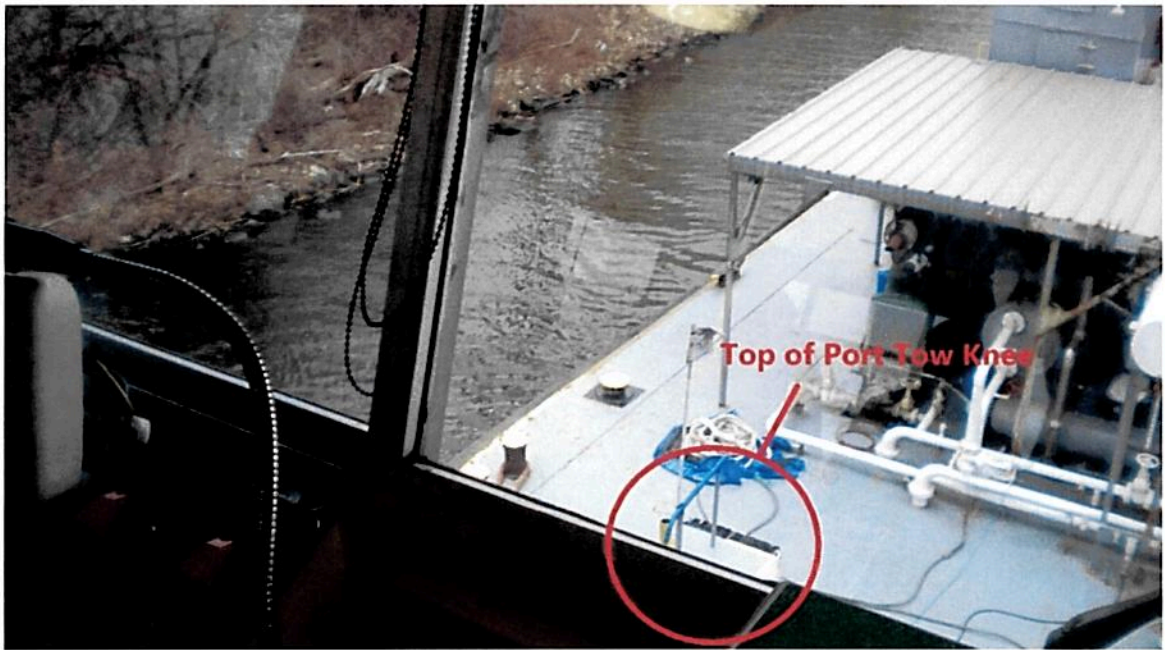
4.2.7. *Vessel Conditions at the Time of Incident.* The steep angle of visibility from the Wheelhouse to the port bow created a blind spot for the Pilot over the crossing point on the port bow taken by Crewmember 2 and Crewmember 3 as pictured in Figure 4.

Figure 4. Post incident photograph of view towards port bow (normal stance) from CHERYL STEGBAUER wheelhouse taken on December 12, 2022, by USCG. Only top of port tow knee is visible.

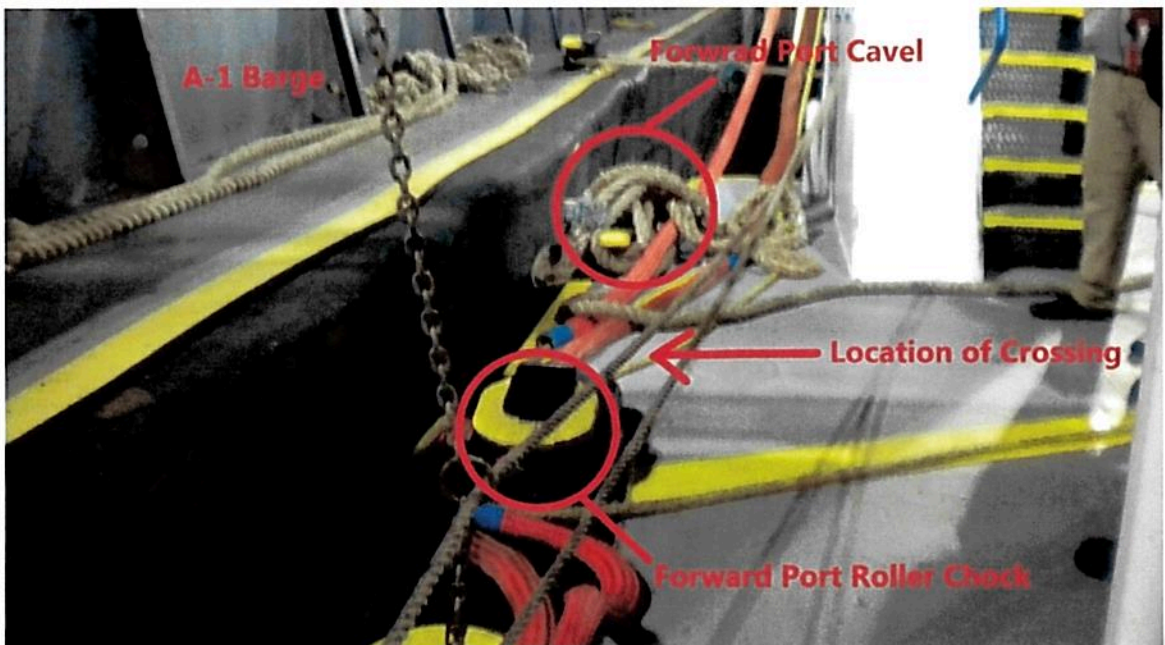
4.2.8. With the CHERYL STEGBAUER alongside the A-1 barge, the difference in deck height between the vessels was approximately 24 inches as pictured in Figure 5.

Figure 5. Post incident photograph of the CHERYL STEGBAUER port bow and A-1 taken on December 11, 2022, by USCG.

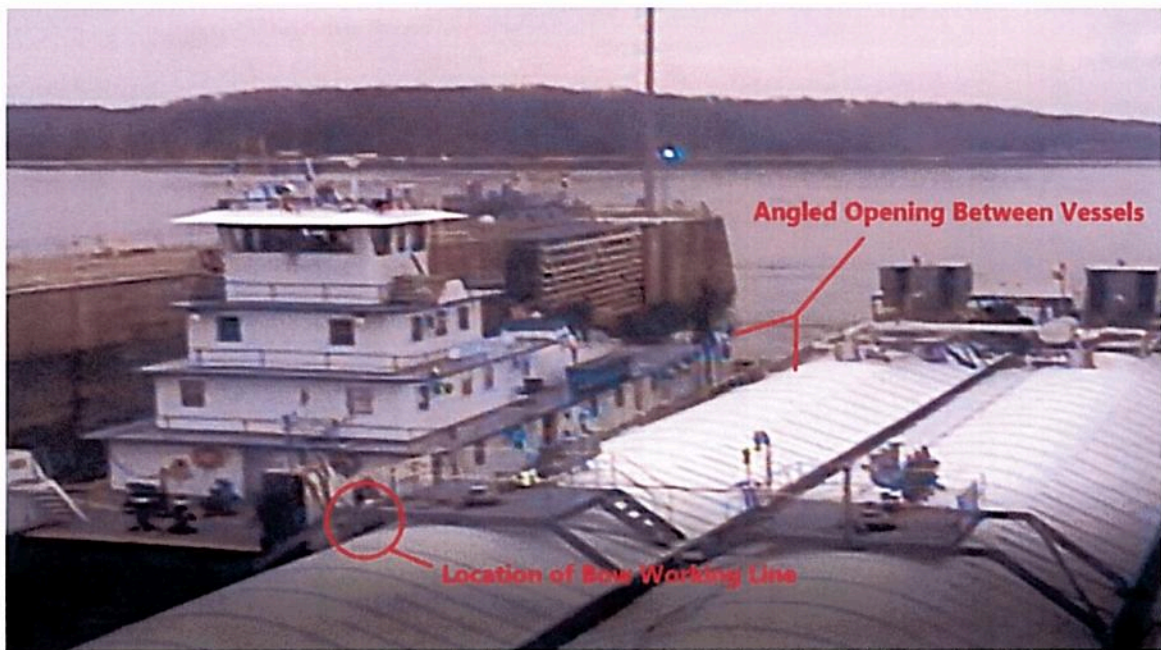
4.1.11. Approximately 4 feet of slack in the working line allowed the CHERYL STEGBAUER to drift about while alongside the A-1.

4.1.13. Due to the approximate 4 feet of slack in the working line and natural drift/movement of the floating towing vessel, the bow of the CHERYL STEGBAUER was drifting away from the A-1 barge.

4.2.9. This mooring arrangement with a slacked single working line from the bow of the CHERYL STEGBAUER to the A-1 allowed for an angled gap between the vessels as pictured in Figure 6. This gap varied as the approximate 4 feet of slack in the working line allowed the CHERYL STEGBAUER to drift about while alongside the A-1.

Figure 6. Pre incident photograph of the angled opening/gap between CHERYL STEGBAUER and A-1. Snapshot taken from video on December 11, 2022, by USCG.
