**REPORT OF THE INVESTIGATION INTO THE SINKING
AND LOSS OF LIFE ONBOARD THE
COMMERCIAL FISHING VESSEL (CFV)
CONCH'RD (NJ8244GN), APPROX. 15 MILES
EAST OF CAPE MAY, NEW JERSEY, ON
DECEMBER 03, 2020**

**CAPSIZING AND SINKING OF THE COMMERCIAL FISHING VESSEL CONCH'RD
(NJ8244GN) AND SUBSEQUENT LOSS OF ONE LIFE WHILE FISHING IN THE
ATLANTIC OCEAN APPROXIMATELY 15 NAUTICAL MILES NORTHEAST OF
CAPE MAY, NEW JERSEY ON DECEMBER 3, 2020**

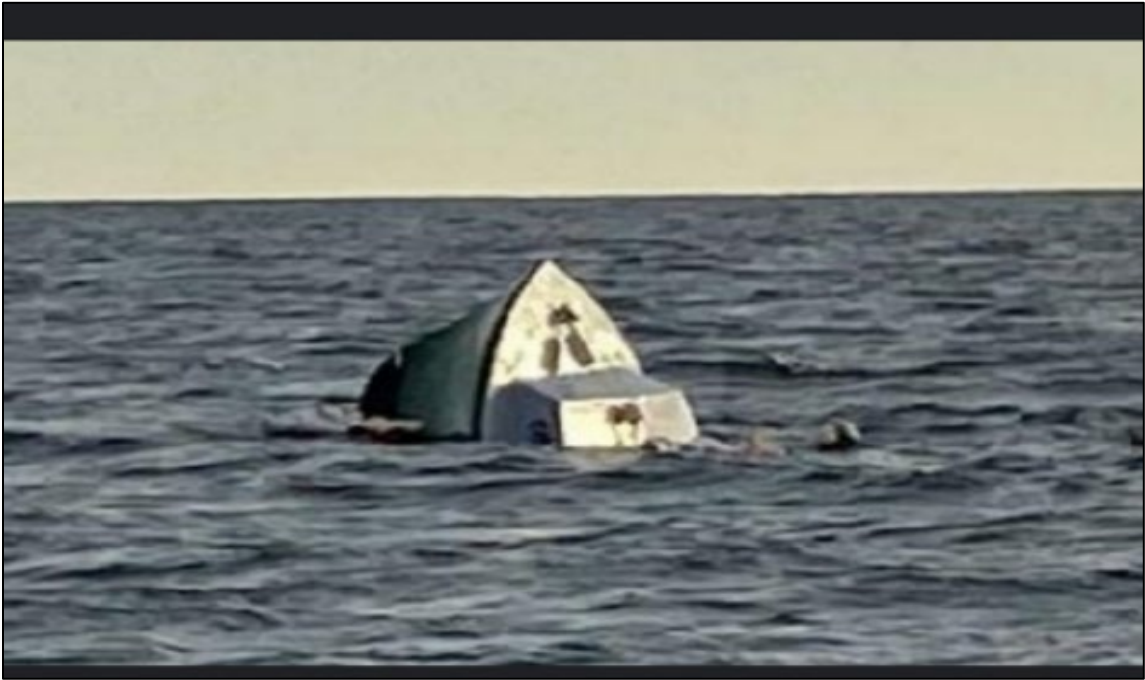
4.1.58. At 1520, the JERSEY BOY arrived in the vicinity of the sinking CONCH'RD and observed the vessel sinking stern first with the bow sticking approximately 3' out of the water and saw a person hanging on to the bow of the vessel.

Figure 6. Image of the CONCH'RD sinking stern first with the bow up in the North Atlantic Ocean. Taken by the JERSEY BOY after the owner/operator was recovered. Photographer is unknown.

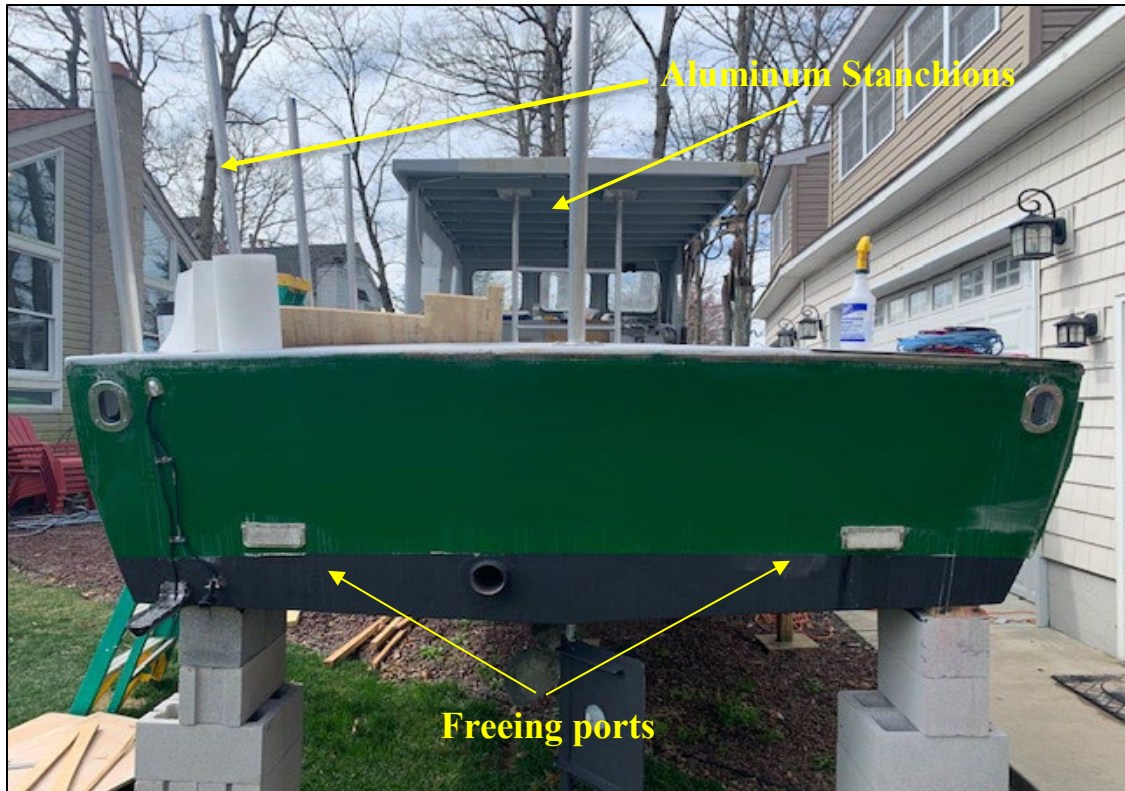
4.2.13. The vessel had two stern freeing ports that cleared water off the deck. The freeing port sizes measured approximately 8" long by 2"- 3" wide. Commercial fishing vessels less than 79' in length with bulwarks are not required by law or regulation to be fitted with freeing ports.

Figure 7. Photograph of transom of CONCH'RD while on blocks taken some time in 2020 during the construction of the stanchions.

5.2.3. The CONCH'RD had two freeing ports (see figure 7) that measured approximately 8" long by approximately 2"-3" high. This provides for approximately 48 in² of drainage and is suitable only for protected waters. Protected waters are defined by Sector Delaware Bay's OCMI as "all waters inside the Barrier Islands from Shark River Inlet, New Jersey to Cape May, New Jersey from Cape Henlopen, DE. south to the MD/DE line." At the time of the sinking, the CONCH'RD was approximately 15 miles off the coast of Cape May, which would be considered partially protected waters and just 5 miles from fully exposed waters.

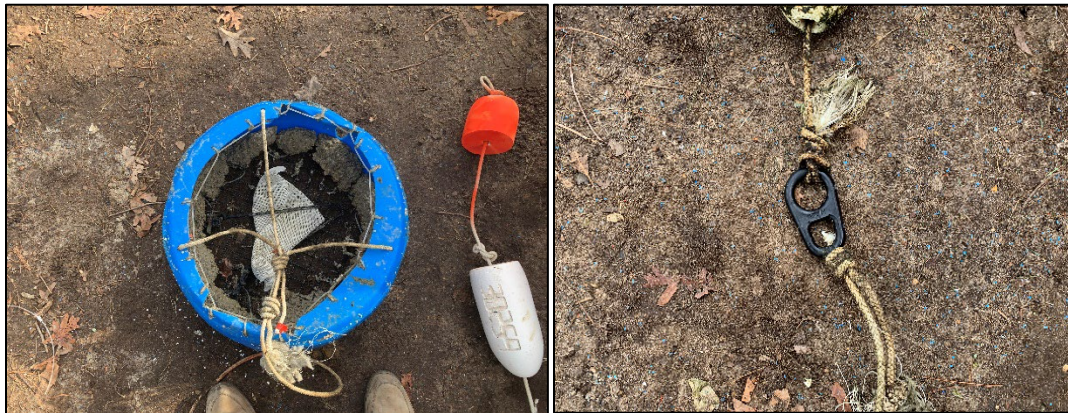
Figure 8. Homemade conch pot with internal concrete weight, line connection, pot buoy and “Whale Break” from CONCH'RD.

4.2.15. The owner/operator of the CONCH'RD constructed homemade conch pots that consisted of plastic 55-gallon drum tops and bottoms. The owner/operator would pour mixed concrete into the bottom of the trap as a weight to ensure the pot would sink to the ocean floor. The owner/operator did not weigh the concrete weight or pots but poured an amount of concrete mixture that he felt was suitable for the weight. The estimated weight was approximately 35-50 lbs. per pot.

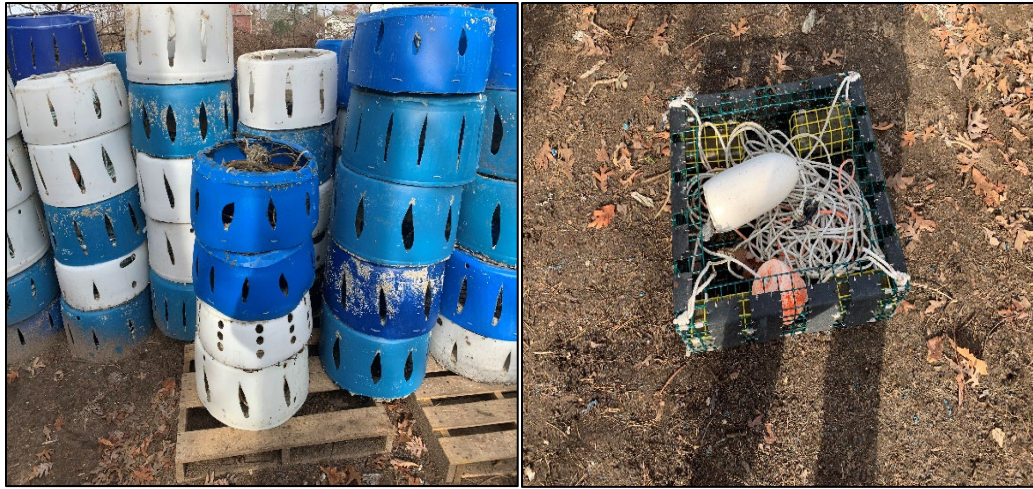
Figure 9. Homemade conch pot overview and manufactured “Ketcham” conch pot taken at owner/operator’s residence.

4.2.16. The owner/operator additionally used purchased conch pots made by Ketcham Supply out of New Bedford, MA. The individual pots come with four brick weights which weighed approximately 50 lbs. The pot dimensions were approximately 24” x 24” x 7.5”.

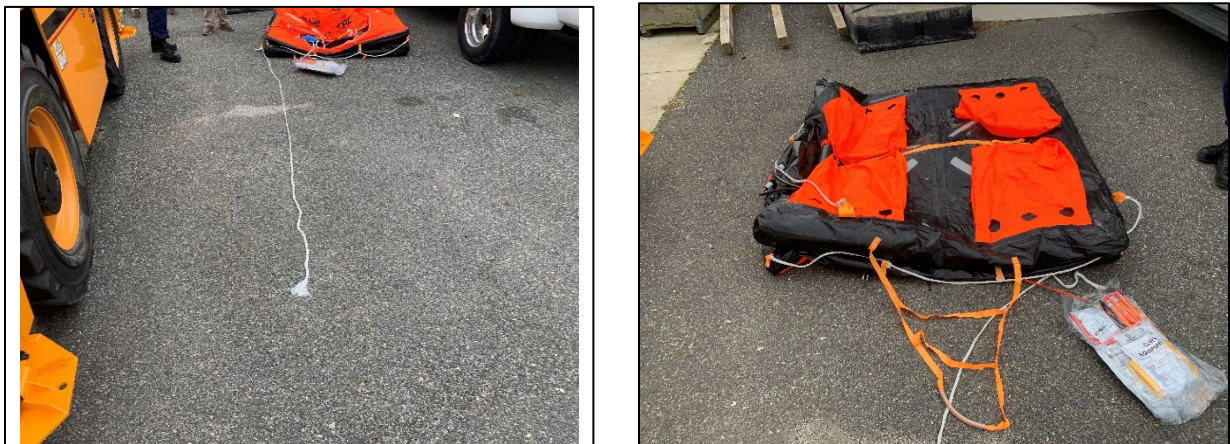
5.6.1. The investigation revealed that the vessel’s inflatable life raft did not deploy until approximately four hours after the vessel initially capsized. The decedent indicated to the owner/operator that he was going to attempt to manually launch the life raft after the vessel capsized by trying to swim underwater, locate the inflatable life raft and then manually deploy it. The investigation did not reveal if the decedent was able to locate the raft and/or make any physical attempt to deploy the raft. It could not be determined if the decedent had any success locating the raft or if his actions had any positive or negative impact on raft deployment. Interviews were conducted with the life raft manufacturer REVERE and the hydrostatic release unit (HRU) manufacturer Hammar. A technical specialist from Hammar stated that the HRU’s are designed to automatically activate when the appropriate water pressure is reached. This usually occurs when the HRU is submerged to a depth of 1.4 to 5 meters (approximately 5’ – 13’). The water pressure releases the blade in the HRU and cuts the life raft line attached from the cradle where the inflatable life raft would typically rise to the surface. As the container rises to

5.6.3. The raft, its cradle, and the HRU were purchased by the owner/operator’s father in November 2020. They were purchased in new condition, so it is highly improbable that the inflatable life raft and HRU were expired. The life raft was recovered and examined post-casualty and was determined to not have any discrepancies. The HRU and the life raft cradle were not recovered and therefore not examined. Additionally, it is unknown if the inflatable life raft was initially installed properly. The installation of the life raft was not verified by a CG Fishing Vessel examiner.

Figure 15. Images of the recovered inflatable life raft from the CONCH’RD. Life raft cut sea painter and top of raft (left) and bottom of life raft overview (right). Photos taken at USCG STA CAPE MAY.

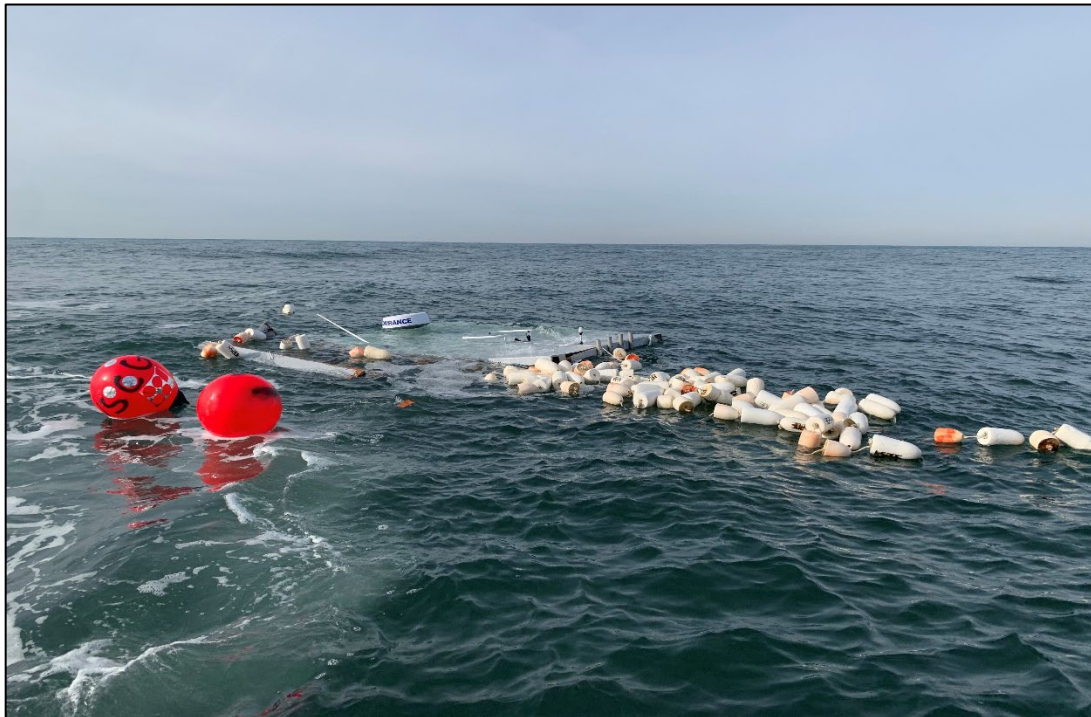
Figure 17. Photograph taken by STA CAPE MAY on Dec 23, 2020, after reports that the CONCH'RD had surfaced days after the incident.
